Site:	Pigeon House Fort	Nat. Grid Ref:	320380
	233650		
Road:	Pigeon House Road	O. S. 6" Sheet No:	DU 019
Townland:	Ringsend	Arch-Tech Project Ref:	09-005
Parish:	Donnybrook	Excavation Licence:	09E 259
County:	Dublin 4	RMP Ref.:	DU019-027

- 1.1. This report is an archaeological and architectural survey of the Pigeon House Fort, an 18th century artillery fort on the South Wall of the Poolbeg Peninsula in Dublin Bay (refer Fig. 1).

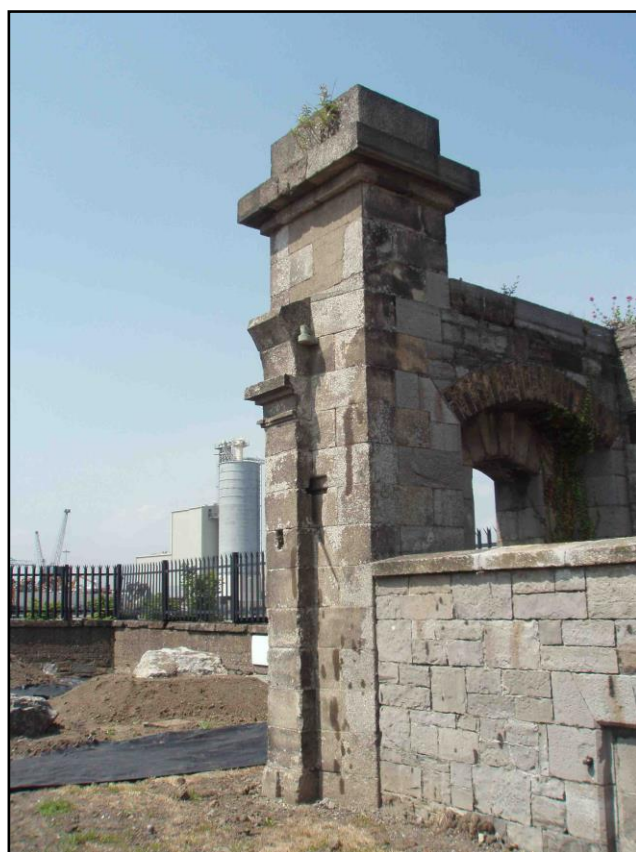
4.2.1. A portion of the western gatehouse or guardhouse survives on the northern side of Pigeon House Road. It comprises part of the entrance archway into the fort, and flanking the gate a gun platform accessed by steps and a small guard-room with musketry-loops overlooking the (now in-filled) harbour basin. Part of a the wall of the soldier's quarters building shows evidence for a previous non-military function, and may be associated with the site of the original Pigeonhouse blockhouse of c. 1760. The gatehouse building was constructed in 1798-1813 and originally stretched across the Pigeon House Road. It is marked as the 'Soldier's Quarters' in De Courcy's reconstruction of the Pigeon House Fort c. 1861 (1996, 301).

- 4.2.2. The entire upstanding portion of the gatehouse complex covers a maximum area of 22.5m east-west and 8m north-south. It is in relatively good condition. It was covered with ivy at the time of inspection, and this was partially cleared in order to facilitate recording of the remains. The interior of the guard-room is filled with rubbish. The granite capping on the solid balustrade and parapet wall, and much of the granite landing paving, has been removed. A detailed written, drawn and photographic survey of the gatehouse complex is included in this report (refer below Section 5.0).

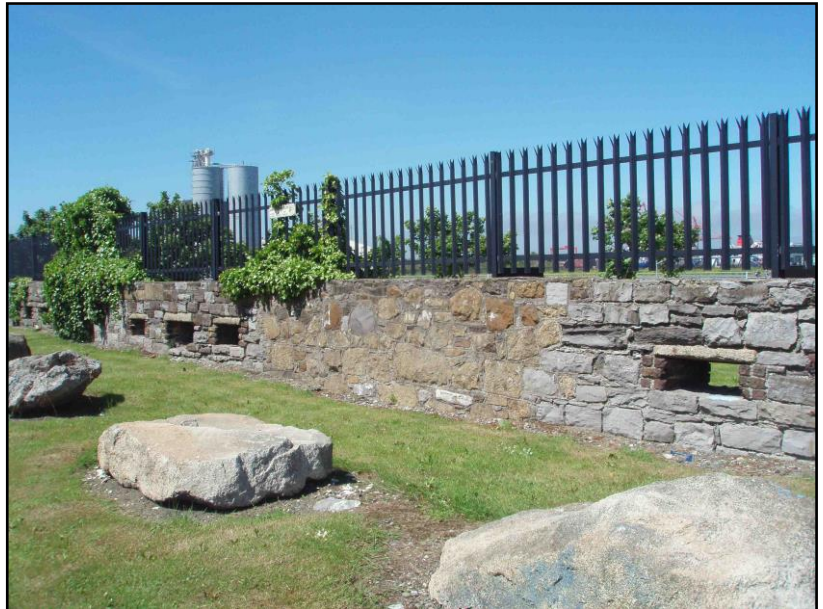
- 4.3.1. The northern boundary wall of the fort runs for over 260m east-west on the northern side of the Pigeon House Road, running from the western gatehouse to the Pigeon House Harbour. The wall is of limestone and granite 0.74m thick, pierced at intervals with musketry-loops, granite-lintelled openings with machine-made red-brick surround, usually arranged in groups of three, overlooking the harbour. Parts of the wall have been pierced in the more recent past, mostly to facilitate the Wastewater Works, and the wall in these areas has been replaced with modern or replica-masonry walling.

Various iron metal fittings are present along the course of the wall, and may have served a variety of functions, including possible breeching line eyelets (refer Fig. 16).

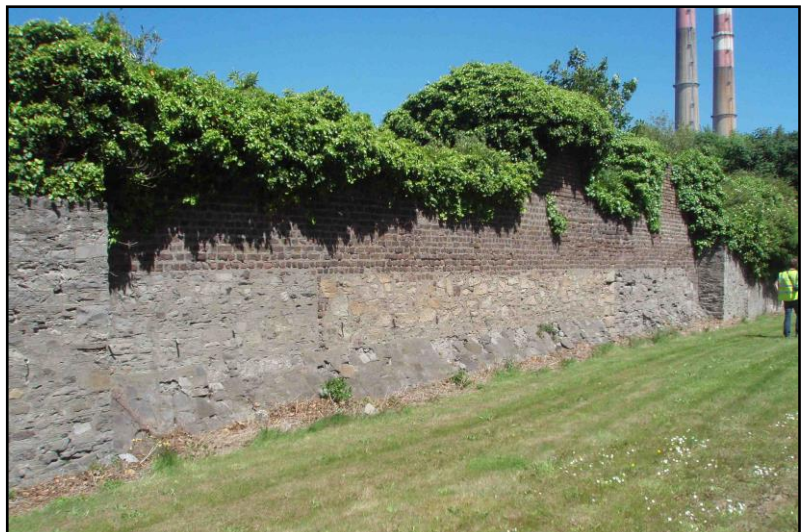
The boundary wall runs southwards from the Pigeon House Road for a distance of *c.* 42m returning eastwards for a further *c.* 125m. The wall is mostly constructed from limestone with granite basal courses, however large parts of

the east-west wall are of yellow brick and some altered portions, particularly in the southwest corner, have been reconstructed from concrete blocks (c. 7-8m on either side of the corner). Large blocked limestone-surrounded round-headed windows are situated along the western wall face, facing onto the main approach to the fort, and in the same manner as the gatehouse these were likely to have held cannons positioned on a raised platform adjacent to the wall. This area is presently heavily overgrown, but the platform and steps are still likely to survive. Blocked red-brick-surrounded opes are also visible. The wall currently forms the boundary of the Ringsend Waste Water Treatment Plant, and is in reasonably stable condition. There are no openings in the wall at present, however openings could easily be made by unblocking earlier opes without affecting the integrity of the monument.

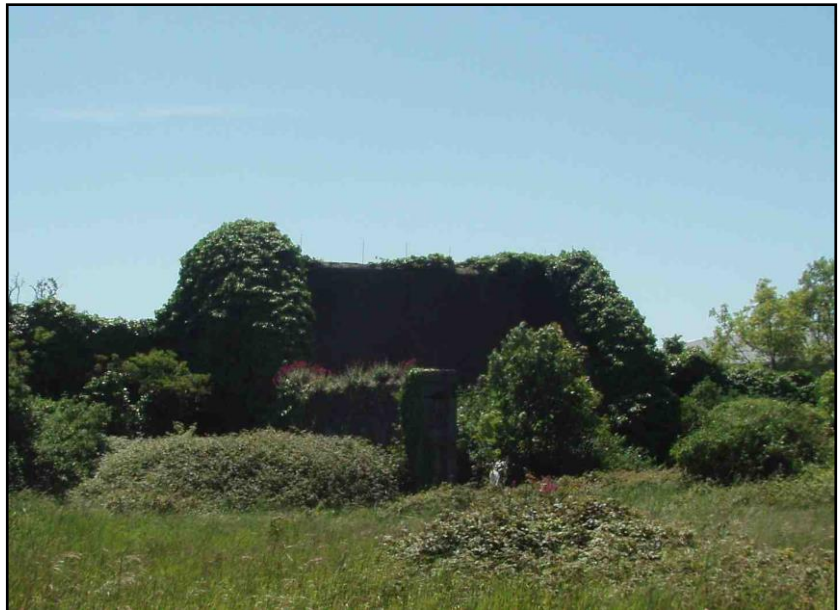
The most visible structure in the southwestern portion of the fort complex is the very tall limestone and cement handball alley. This does not appear to be marked on the 1830s OS map, however it does appear to have

been constructed by the time of the 1910 Edition OS map, and De Courcy (1996, 300-301) suggests that it had been constructed by 1861. The alley is heavily overgrown, but its form is clear comprising three walls in the usual arrangement and measuring approximately 18m by 9m in size, the size of the standard 'Big Alley' prior to the 1970s. Handball Alleys are a vernacular building form unique to Ireland and are

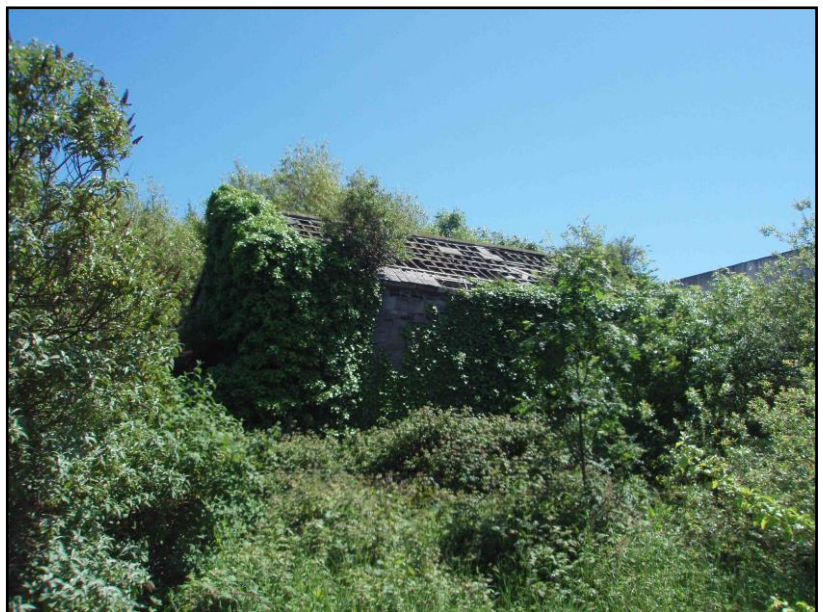
Known locally as 'The Stables', the single remaining roofed

building in the southwestern quadrant is in terrible condition and unsafe to enter. It was assessed in 1999 by Neill O'Flanagan who noted few original features surviving in the interior except, remarkably, the crane on the upper floor. The façade, however, is of attractive limestone and occasional granite construction with a large masonry pediment and brick-surrounds on door, window and crane opes. The outer façade of

this structure could be retained and the structure re-used within any future development in the area.

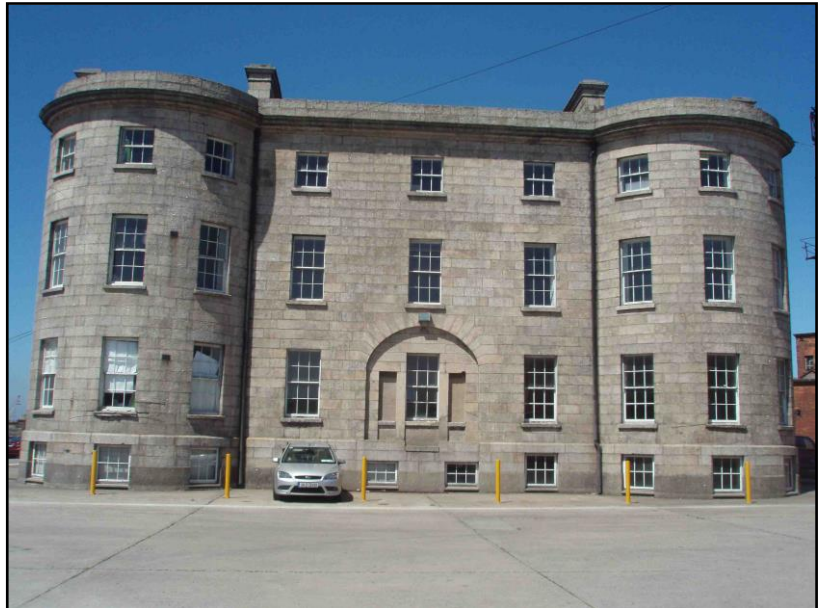
incongruously on the Pigeon House Harbour at the foot of the hulking mass of the power plant. It is, in fact, the earliest upstanding element of the complex, predating the fort. It was constructed in 1793 to accommodate the

increasing cross-channel passenger traffic (De Courcy 1996, 298- 299; Pearson 2000, 451). The hotel, and later the fort, derived its name from John Pidgeon who had established a popular restaurant and bar called 'Pidgeon's House' to cater for the passing traffic in 1761. After 1798, when the hotel and harbour were requisitioned by the British Military and the artillery fort was established, the hotel was converted to officers' quarters. The hotel is a Protected Structure, and, as part of the military fort, a Recorded Monument. It is currently in use as Dublin City Council ESB offices and is in good condition.

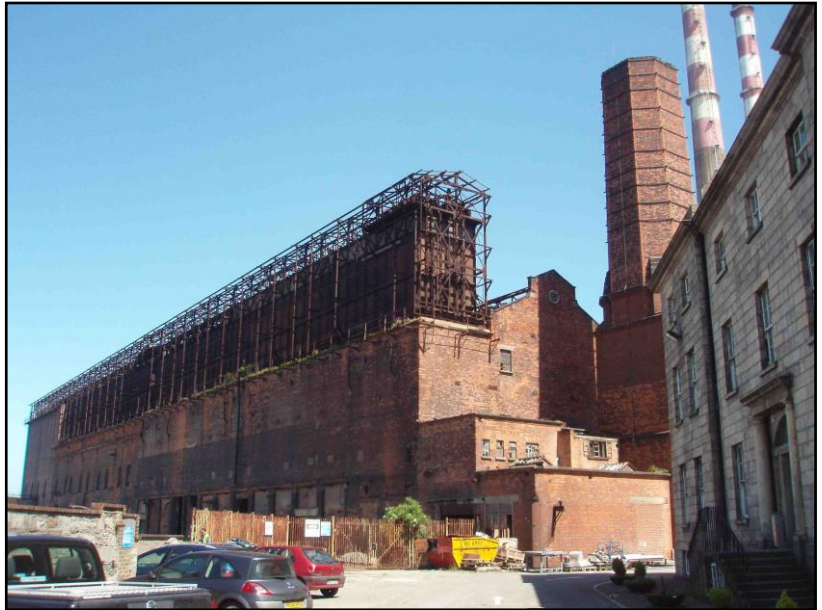
times so that it presently takes up much of the northern end of the former fort. The harbour frontage of the fort to the west of the plant appears to have been completely reorganised during the 20<sup>th</sup> century to cater for the power plant's requirements. At present the power-plant has lost much of its roof and numerous

ominous cracks are visible at the northern end of the structure. It is in terrible condition and urgently requires a full survey and restoration. The plant is a Protected Structure, but not a Recorded Monument, and also appears on the Dublin City Industrial Heritage Record 2007.

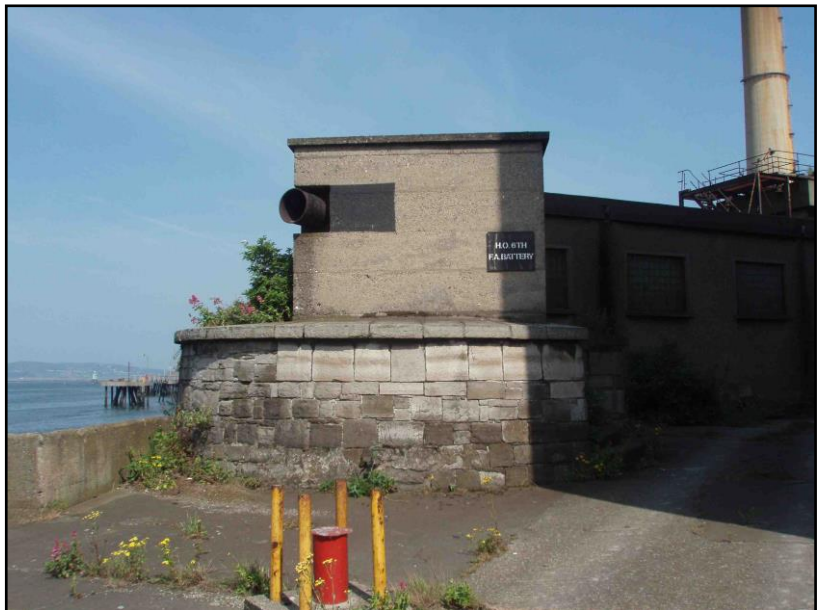
4.8.1. To the north of the power plant, and situated at the edge of the harbour, a small rectangular structure is situated on a large masonry circular base. Although the rectangular structure may be more recent, the circular base clearly belongs to the

military fort and formed part of the military defensive rampart protecting the harbour. Comparisons with 19<sup>th</sup> century cartographic sources suggest that the circular structure in the northernmost (n only surviving element) of three gun emplacements overlooking the harbour. It appears to have held a rear-pivoted gun with fields of view east and northeast (Kerrigan 1995, 177)

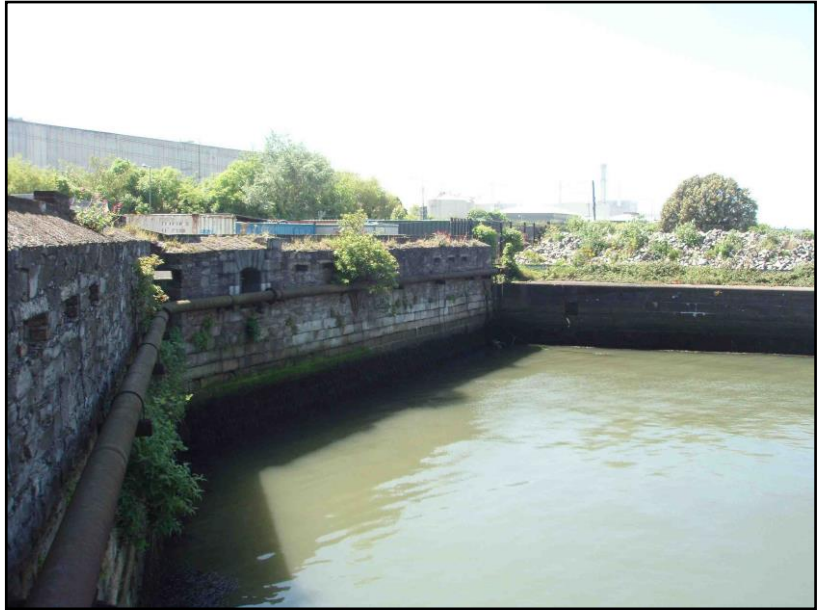
The eastern harbour wall is still present and part of the harbour basin is still potentially useable. The harbour predates the Pigeon House Fort, however a number of military defences were installed around it during the late 18<sup>th</sup>

and 19<sup>th</sup> century which are still present, particularly the gun loops in the northern boundary wall of the fort. The existing elements of the harbour were heavily reconfigured during and after construction of the Pigeon House Power Station in 1903, but earlier 18<sup>th</sup> century elements are still visible throughout. Fragments of timber and rusty metal machinery and harbour fittings are present.

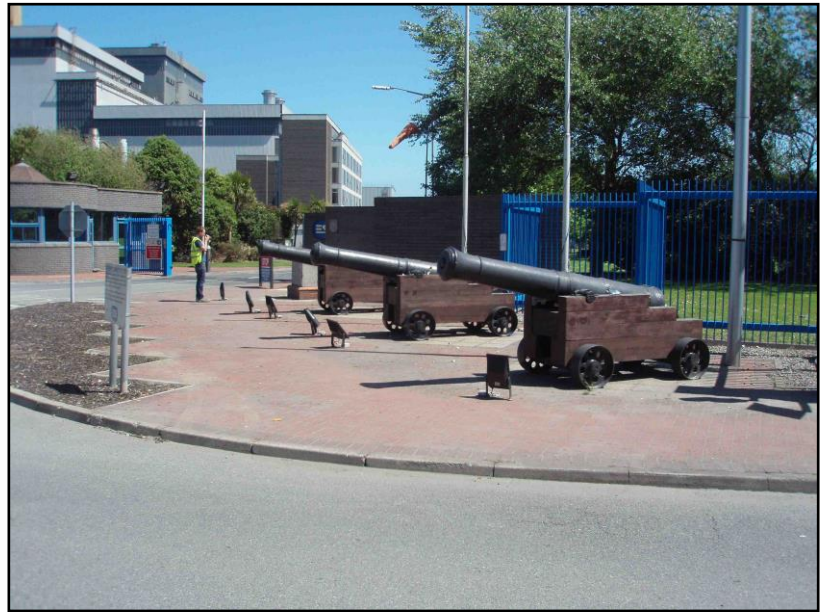
4.13.1. There are two areas of particular relevance to the military fort situated outside of its former boundaries. The first is the modern cannon emplacement to the southeast of the former fort and outside of the ESB compound. Three cannons are arranged on a road

corner near the gate, placed on sensitively-constructed modern wooden frames, in an attractive setting which includes lighting. These cannons are may have originally come from the western gatehouse of the fort complex. Indeed, a photograph from 1898 shows two cannons half-buried vertically in the ground just outside of the gate in use as bollards. As a result, the cannons should be considered to form part of the Recorded Monument of the fort. Despite the pleasant presentation of the cannons, their location divorces the features from the Pigeon House Fort. It would be better if these were relocated to the western gatehouse at the entrance to the fort.

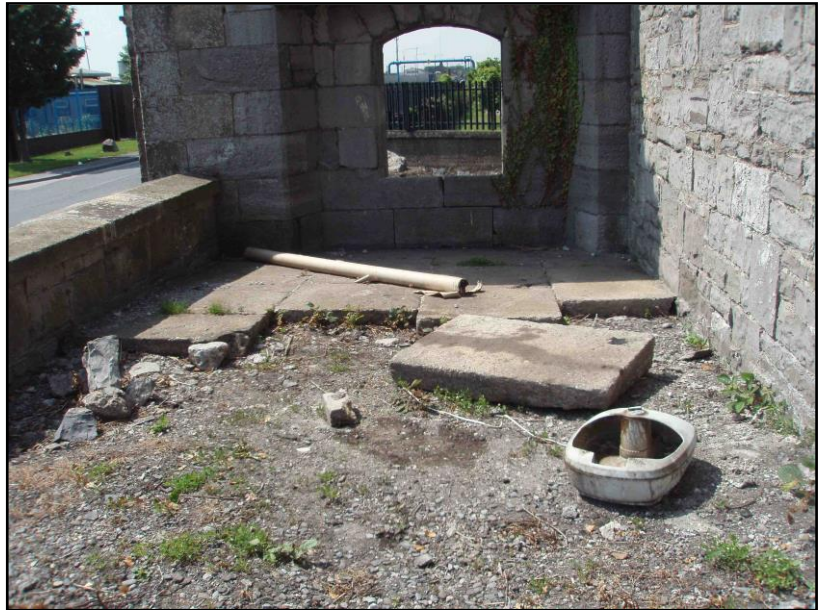
The westernmost third of the granite paving of the platform remains *in-situ*, comprising 17 blocks averaging 0.76m by 0.70m in size and 0.10m in thickness, and one block *ex-situ*, bundled with rope, which was in the process of being stolen over the course

of June and July 2009. An area of approximately 11m<sup>2</sup> has lost its paving.

6.4.2.2. Together, these factors make the gatehouse particularly suitable for conversion into a small visitor and orientation space for the fort. This could be carried out with minimal cost: involving the replacement of stolen granite balustrade capping and paving (from the DCC granite store nearby); the erection of a sign visible from the Pigeon House Road stating that a visitor is entering the Pigeon House Fort complex; the unblocking of five blocked gun-loops within the guard hut; and the placement of historical information and photographs in the interior of the guard hut (suggested historical photographs are included as Plates 1-3). The metal fittings of the gatehouse have been analysed by a conservator and they will not require any special treatment to conserve. Serious consideration should also be given to moving the three cannons

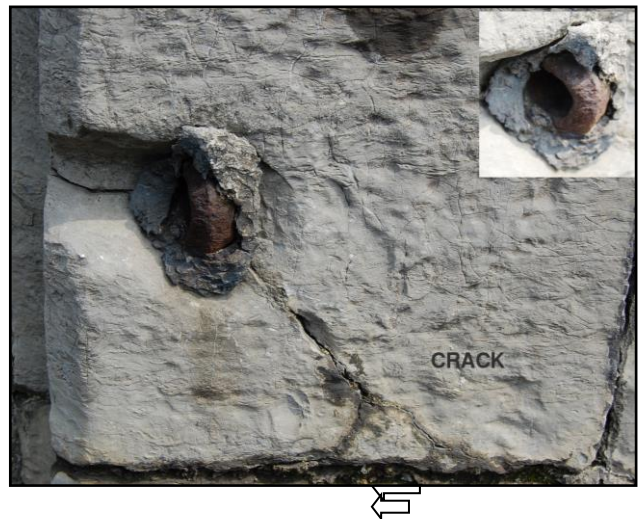
Object 1 consists of an iron fitting inserted almost fully in to the stone, with only the head visible. It is located on the left (east) side of an opening, which has been blocked at some stage.

The object presents a relatively good state of conservation, the internal structure is still in perfect condition and has stabilised with the environmental conditions. Despite this, there are a number of alterations to consider.

- The original surface suffers superficial corrosion presenting the characteristic dark-orange red colour of iron corrosion.

- The main alteration to consider is the appearance of a crack in the stone that continues along the lower left corner. This crack is due to the corrosion of the metal within the stone, or to a poor re-fitting of the object.

Keeping in mind the state of conservation of these metals after so long in their present environment, it is recommended that the best option is to monitor them and see if they are still stable in a few years time. It looks like the metals have attained a good balance with the maritime environmental conditions, with the consequence of stabilisation.

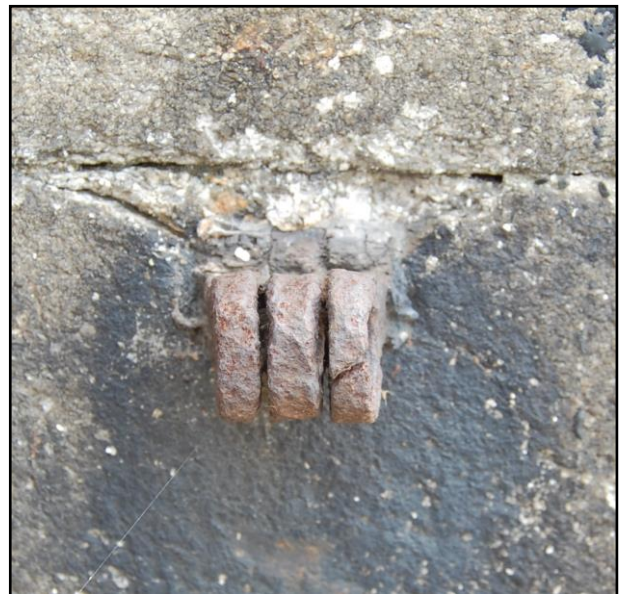
Object three is located on the front (west) of the building about fifty centimetres from the ground. It is a small iron loop. The original use is still unknown, however there is a possibility that it was an eye for taking breeching lines (refer Fig. 16), or a gate fitting. The state of conservation of this is similar to the other objects. Very superficial corrosion presenting the characteristic red-orange colour, without significant loss of material or deformation. One of the three sections presents a clean fracture. This may have happened during the period of use of the object.

- Chromatic alteration: black colour on the lower part, produced from the use of chemicals.
- Pulverisation of the stone in the area above the object: the stone suffered pulverisation in this area due to several possible factors: (a) as it is close to the edge of the block, (b) it suffered forces of traction which damaged the fabric of the stone during the use of the object or (c) the presence of salt in the air.

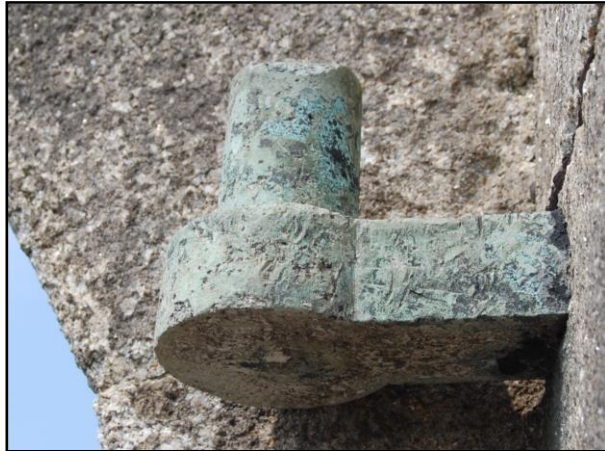
Object 4 is located on the eastern side of the gate pier. It is a large hinge made of bronze. The visible alterations look like they are superficial: scratches, deformities on

the surface, and the characteristic irregular patina. This alteration does not affect the integrity of the object, which appears to be in good condition overall.
