Archaeological Report James' and Thomas Street QBC Dublin 8

archaeology plan

Quality Bus Corridor, James' Street and Thomas Street, Dublin 8

Monitoring License 13E401
Ministerial Consent E4507 (C615)

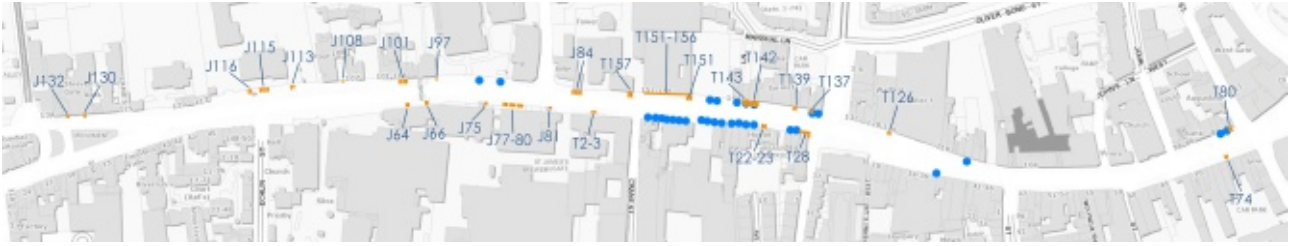
cellars (in orange), light wells and goods drops (in blue)

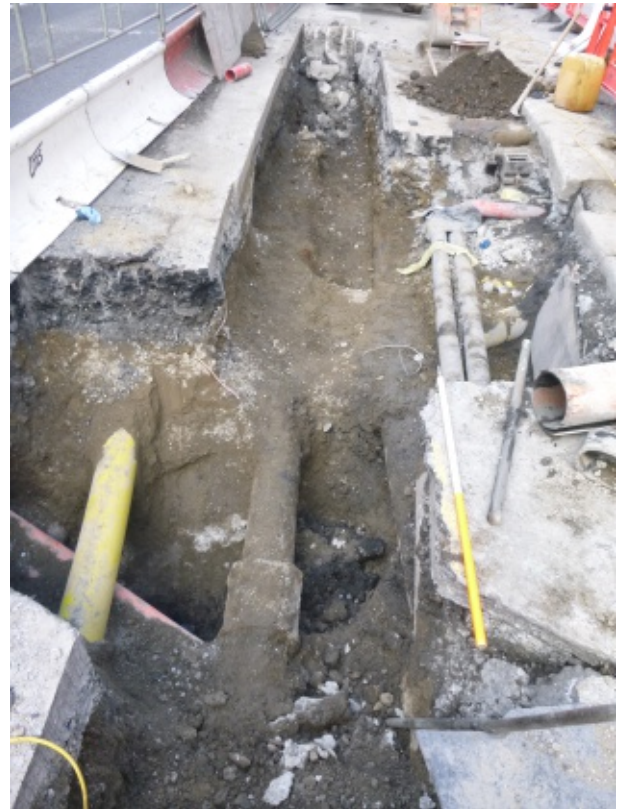
deep services along James' Street

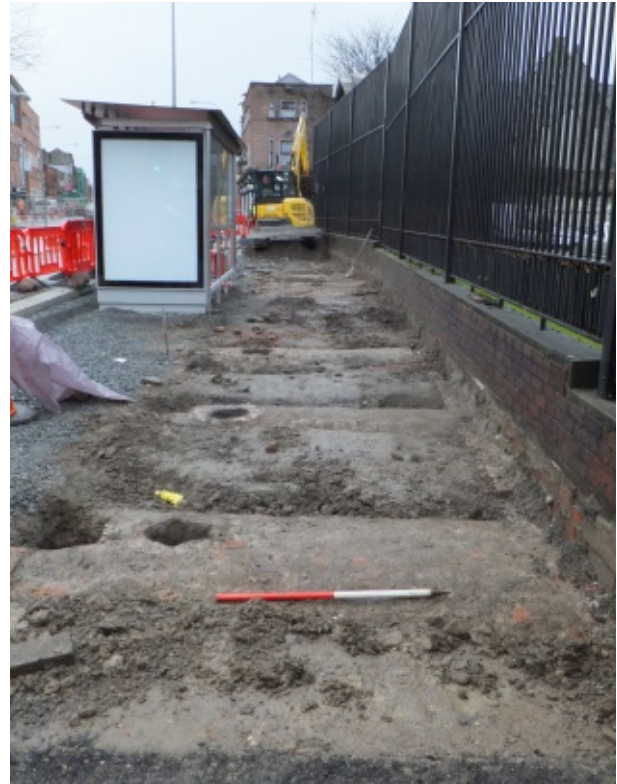
cellar crowns at Nos. 115-116 James' Street

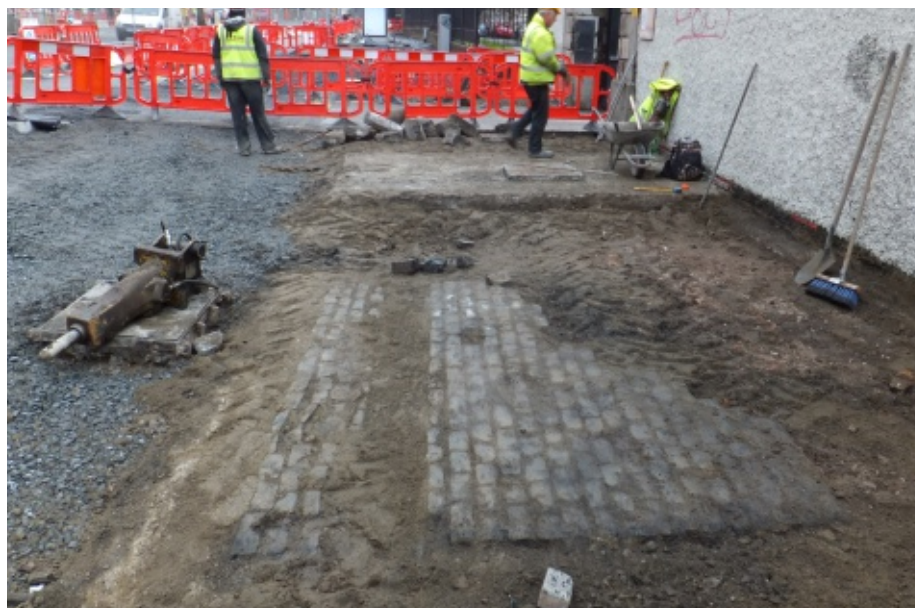
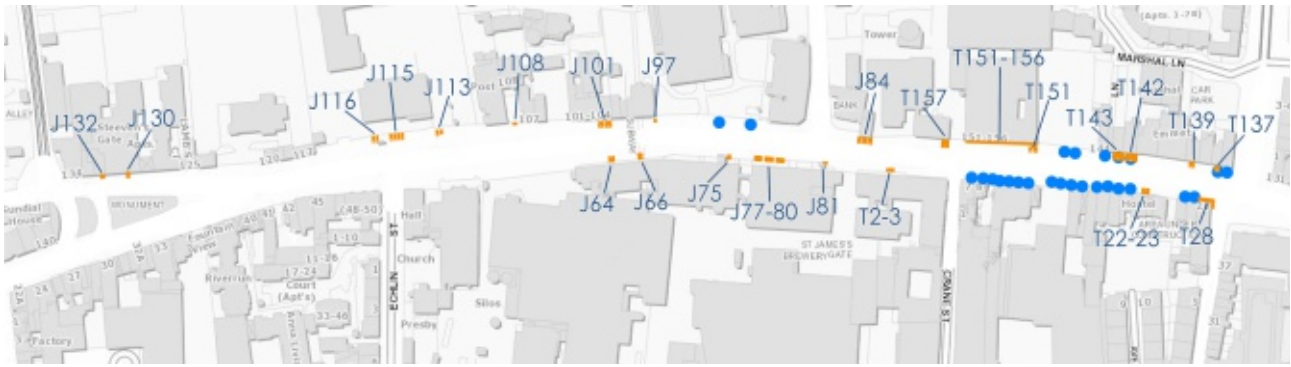
above: map showing cellars in orange, and light wells and goods drops in blue
 below: crown of cellar of No. 113 James' Street

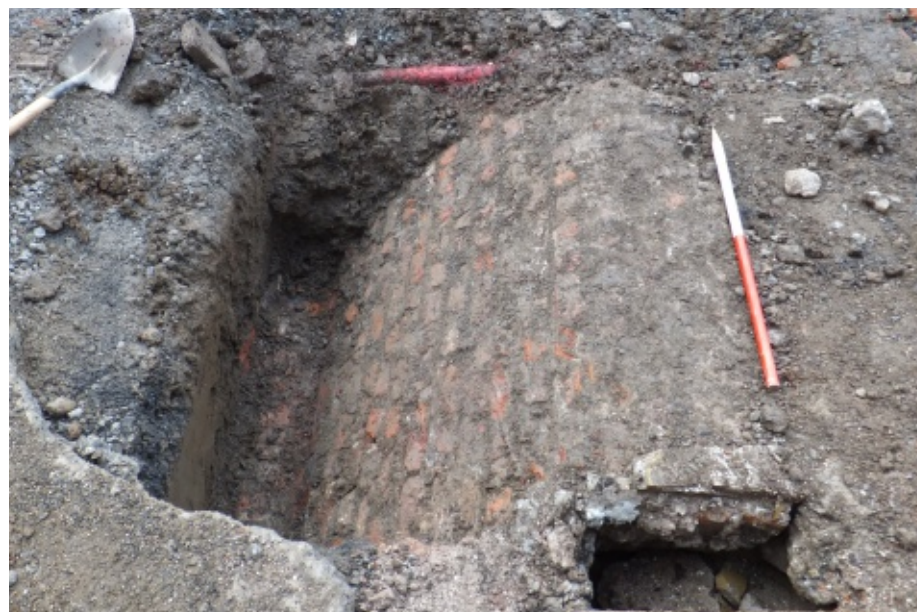
James' Street cellars

Plot	No. of cellars	Condition	Action
64	1	Truncated and backfilled	Recorded and preserved in situ
66	1	Truncated and backfilled	Recorded and preserved in situ
66	1	Truncated and backfilled	Recorded and preserved in situ
77-80	3	Intact and not filled	Recorded and preserved in situ
81	1	Truncated and backfilled	Recorded and preserved in situ
84	3	Intact and not filled	Recorded, sealed and preserved in situ
97	1	Truncated and backfilled	Recorded and preserved in situ
101	2	One good (not filled), one average	One preserved in situ, one recorded and partially in-filled
108	1	Poor. Incomplete	Recorded and preserved in situ
113	2	Poor, one truncated and second	Recorded and in-filled to make safe partially truncated
115	4	Good, relatively intact, mostly filled	Recorded and preserved in situ
116	2	Good, relatively intact, mostly filled	Recorded and preserved in situ
130	1	Truncated and backfilled	Recorded and removed

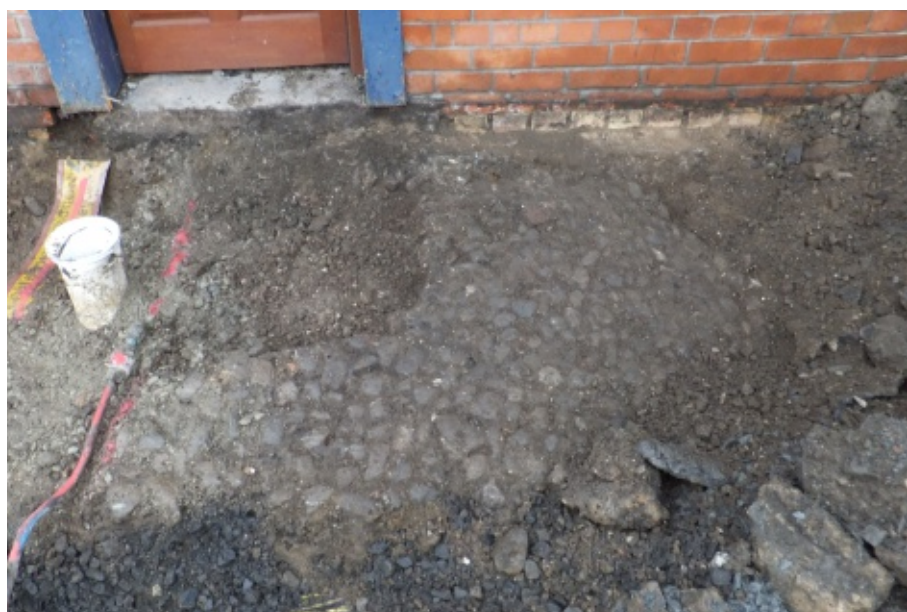
cobbled street surface c. 1700 at No. 119 James' Street

The former street surfaces of various phases of James' Street was uncovered at a number of locations during the monitoring works. The most recent of these was a cobbled surface, which was noted at numerous points along the street and possibly dates to around 1700. This surface was generally quite level and was found in most places to be approximately 300-350mm below the present ground level. To the west it was identified at a depth of 500mm below the present ground level suggesting the slope off to Bow Lane may originally have been more severe than it is at present. To the front of 105-108 James' Street a second earlier cobbled surface was apparent at a slightly lower depth, from 420-580mm below the present ground level. A separate context number was given for the material retrieved between the two layers of cobbled street surface (C18). The depression here may represent a localised dip in the street that was later levelled up during the later phase of cobbling.

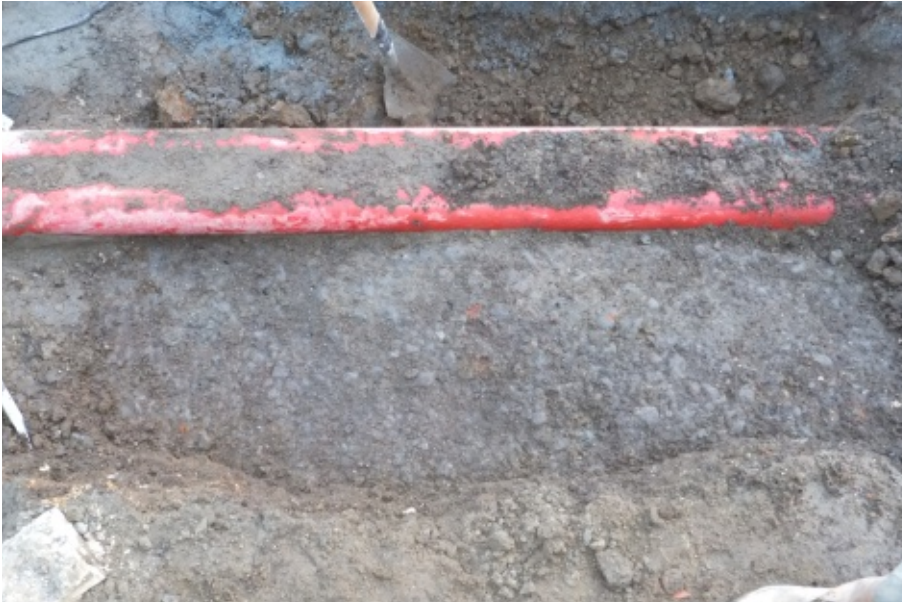
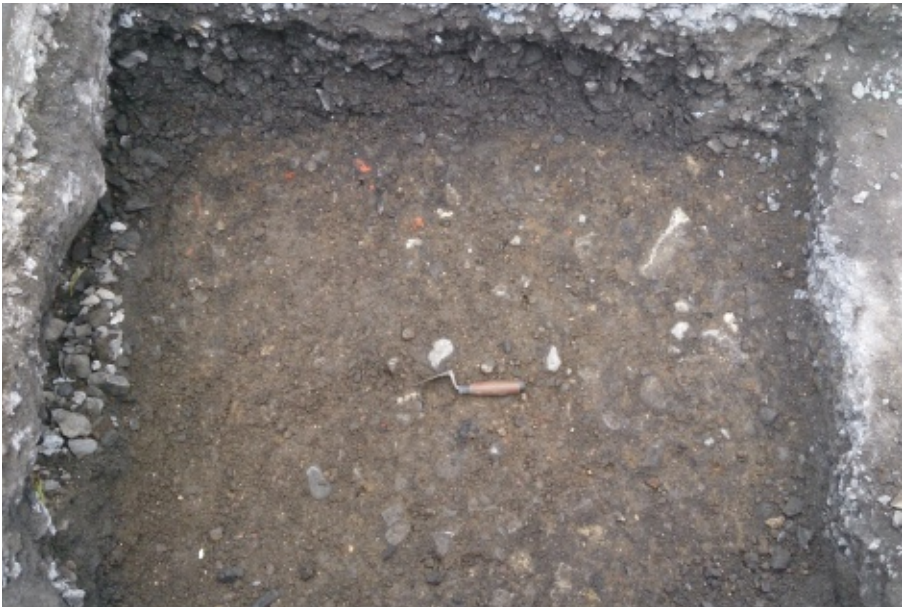
medieval metallated street surface C2 on James' Street (above and top)

An earlier metalled surface (C2) was identified at a number of points along the street also. This was formed from small angular and sub-rounded pebbles well-beaten in place, with cobbled sections also apparent, possibly indicating repaired sections. The highest point of this surface was to the front of St. James' Church to the north of the street. It was identified at 16.873m OD immediately to the west of the current entrance to the church, where it survived c. 250mm below the present ground level. The surface sloped off to the west and the east, marking this as a local high point. The surface sloped down to the west for 4.9m before rising slightly again. This dip in the surface to the front of the church may mark the original entrance from the street to the churchyard. After this

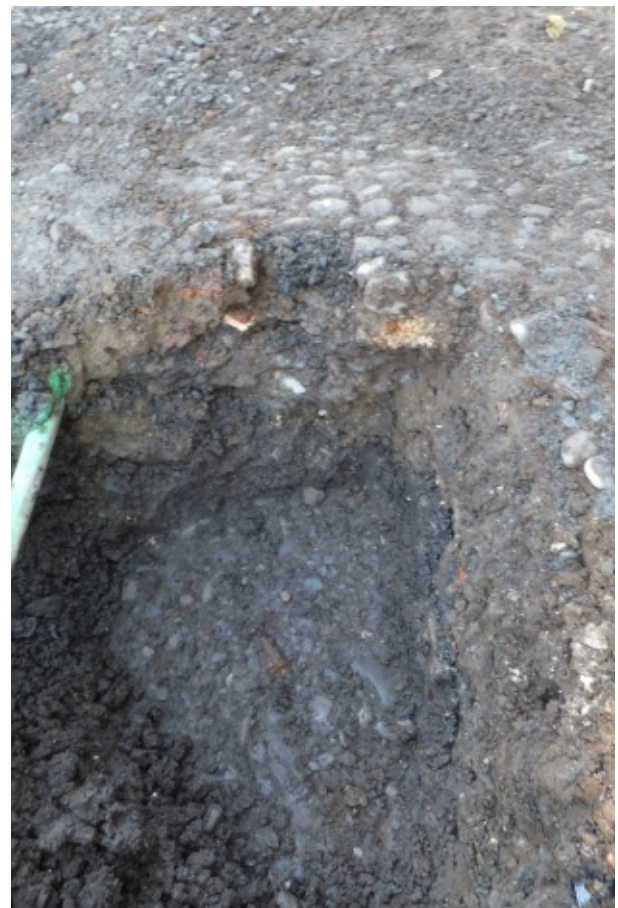
To the west of this in front of 48-49 James' Street, another section of this metalled surface was uncovered 1100mm from the building façade 850mm below the present ground level at 15.835m OD.

below: metalled surface C2 running underneath the c. 1700s cobbled surface at Nos. 48-49 James' Street

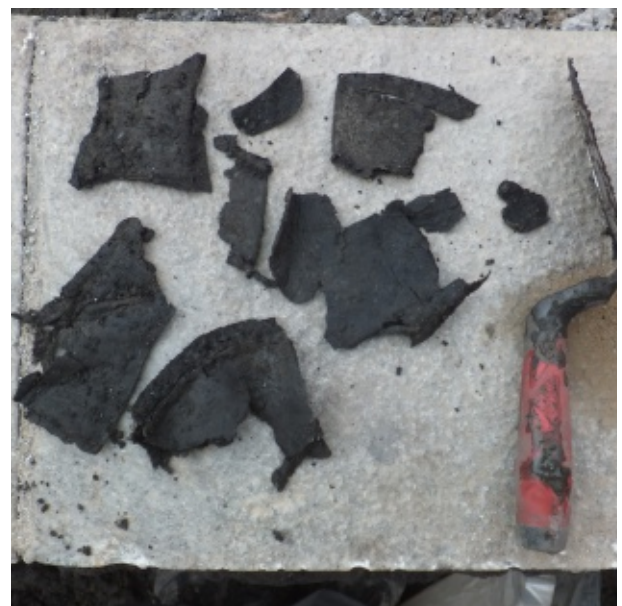
above: profile of tanning pit C19

below: leather from tanning pit C19

Fourteen fragments of leather shoe were found within the tanning pit with clear stitching markings noted on five of the pieces. These were placed back within the tanning pit within the material they were found in and the tanning pit was preserved *in situ* following a slight re-design of the proposed works in this area. A layer of geotextile and fine sand was placed over the remains of the pit prior to it being covered over.

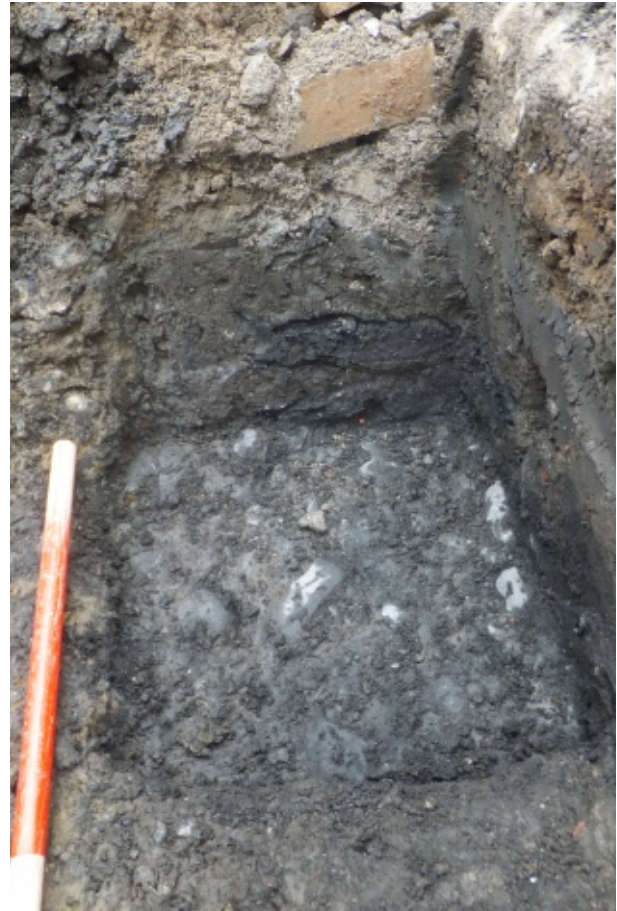
above: cobbled base of tanning pit C19

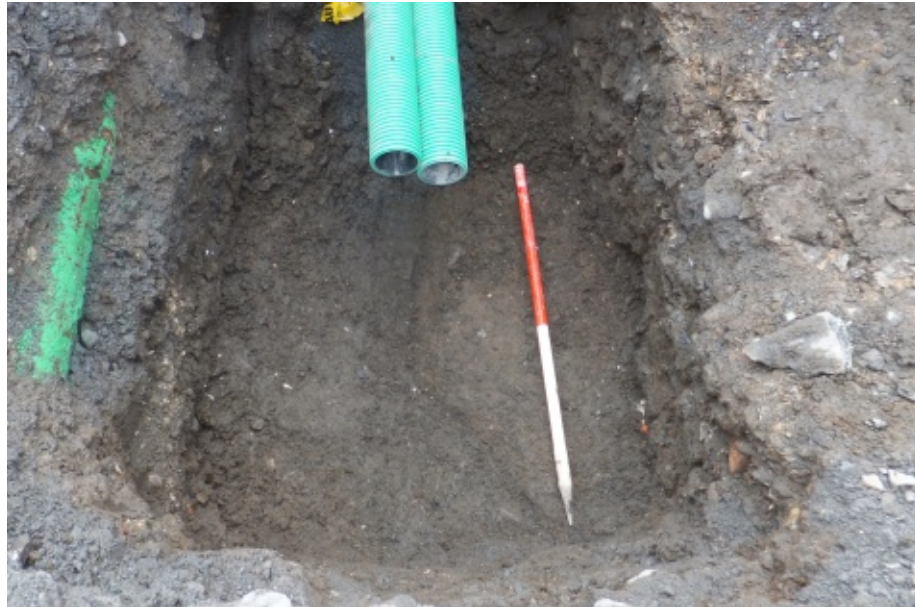
box section through ditch C4 with two layers visible in base

A large medieval ditch running east-west was uncovered along the north side of James' Street to the front of the Guinness Power Station, from Nos. 88 to 95 James' Street. It measured at least 50m in length and a minimum of 5m in width, though no edges were identified. The ditch survived 840mm below the road surface to the front of 93-94 James' Street (14.525m OD) and was a minimum of 480mm in depth at this point. At various other points along the ditch it survived at a depth of 750-850mm below the present ground level. The northern side of the ditch was encountered to the east in front of 89

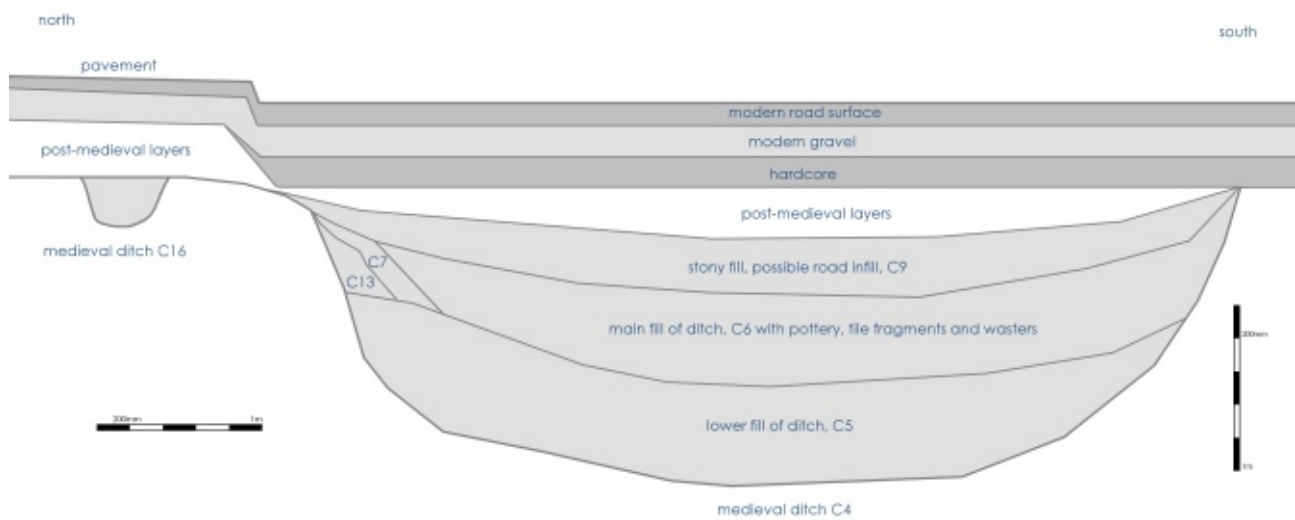
reconstructed profile through ditch C4

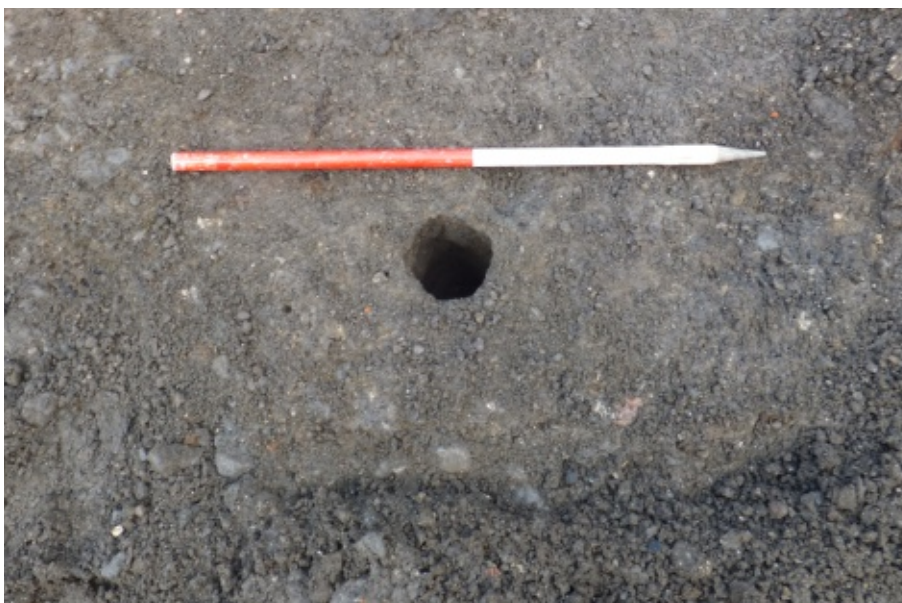
posthole C11 cut through upper stony fill of ditch C4

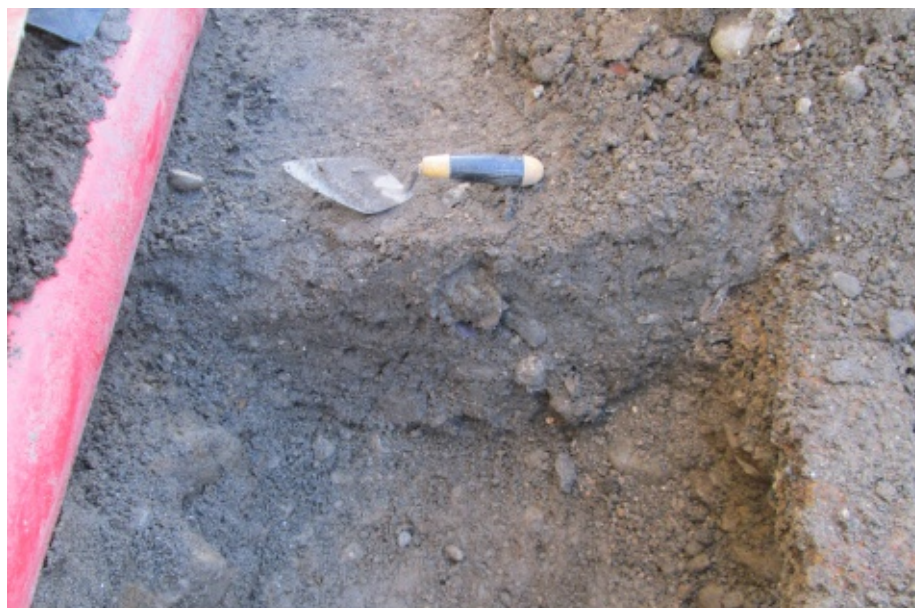
profile through parish boundary ditch C14

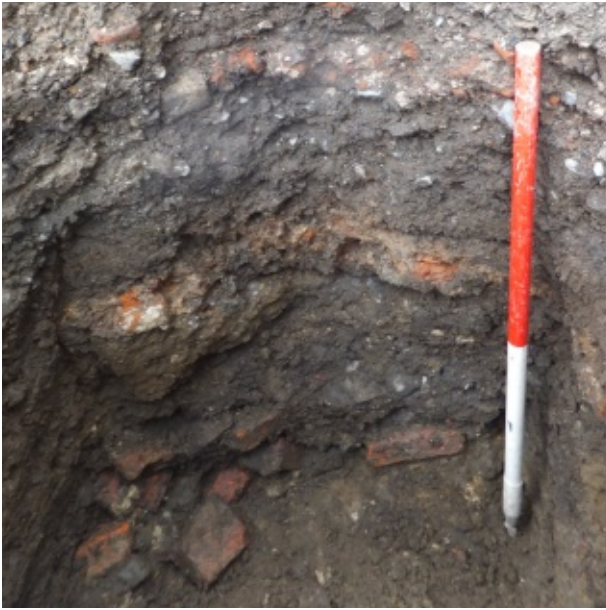
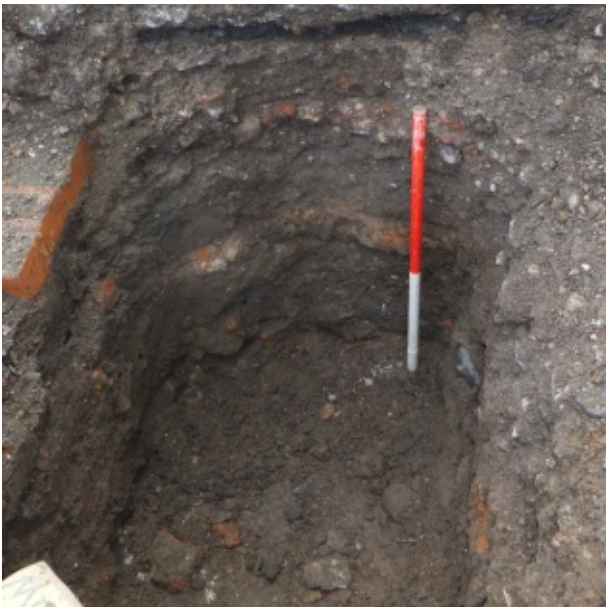
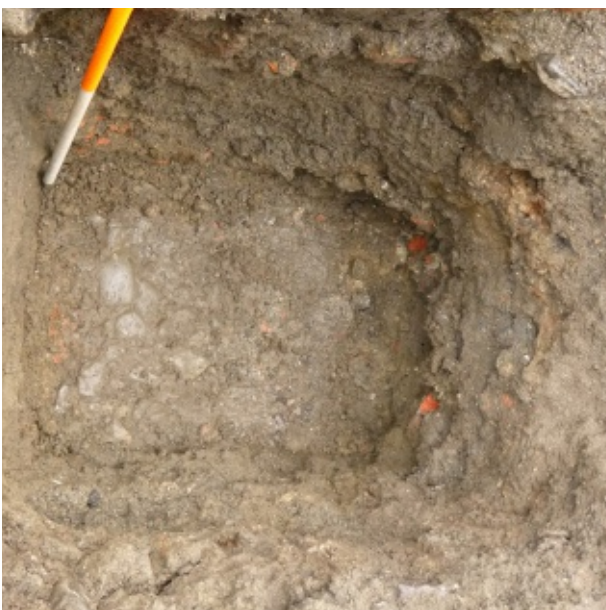
The lower layers within the cut feature (C14) would appear to have been filled with organic material, possibly filling up slowly over time to 550mm above the cobbled base. The feature would then appear to have been backfilled intentionally with building rubble (C15), with some of the heavier rubble possibly sinking into the soft organic material below. The upper deposit appeared to relate to building demolition in the vicinity. It is located in close proximity to the site of St. James' Gate and given the depth of the feature, it may be a defensive ditch associated with the gate. The orientation and position of the ditch corresponds with the defensive ditch shown on the Down Survey 1650s map, and the parish boundary (between St. James' and St. Catherine's) crossing James' Gate on 19th and 20th century Ordnance Survey maps. It also appears to correspond with an angled wall depicted on the southern side of James' Gate on Rocque's 1756 map of Dublin, and with a likely location of a watercourse on the FOMD/Irish Historic Towns Atlas map (vol. 1).

left top and middle: layers and brick in ditch C14
 left bottom: cobbles at base of ditch C14
 below right: Down Survey map of Newcastle Barony showing the city defences of Dublin c. 1655

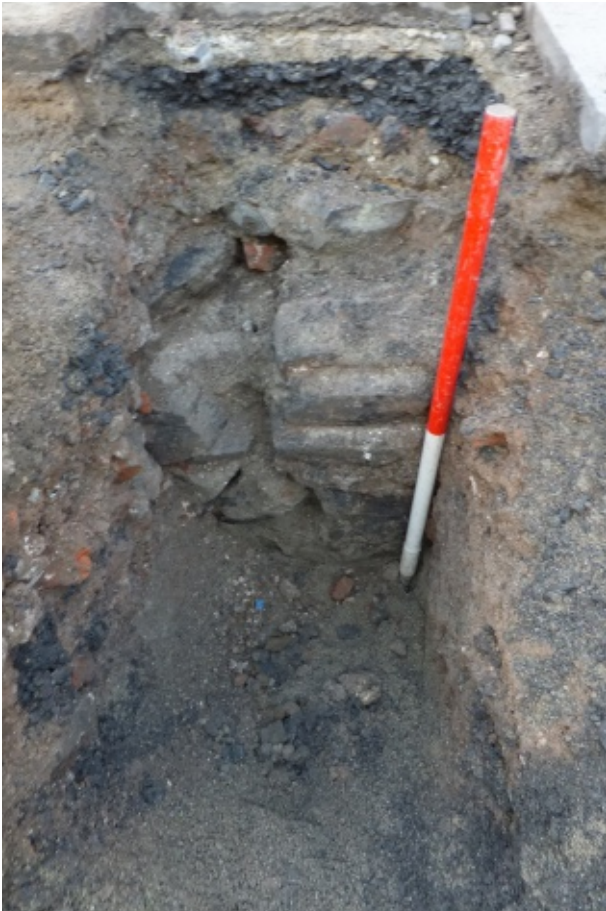
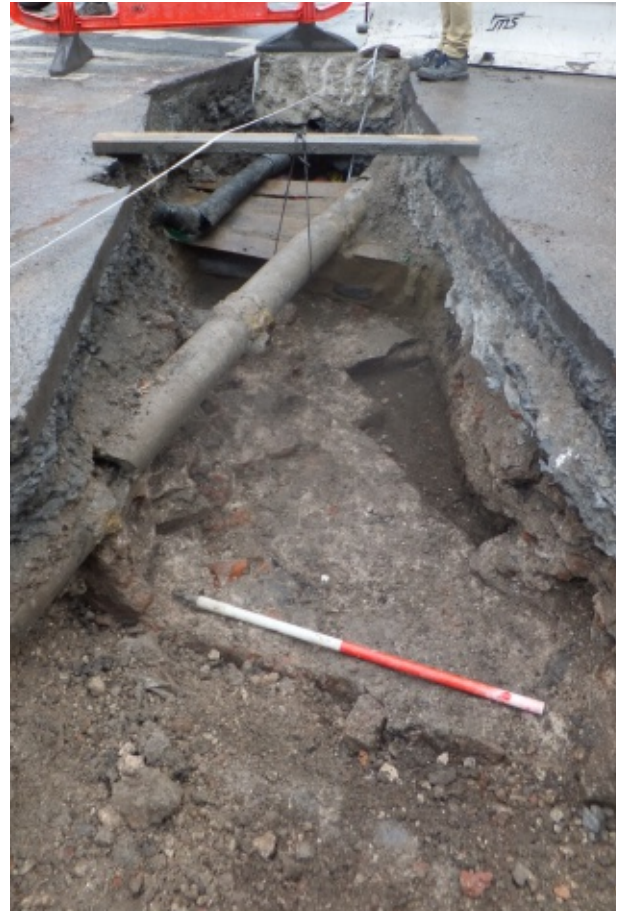
left: large limestone wall on north side of St. James' Gate. Right: structural remains below Watling Street

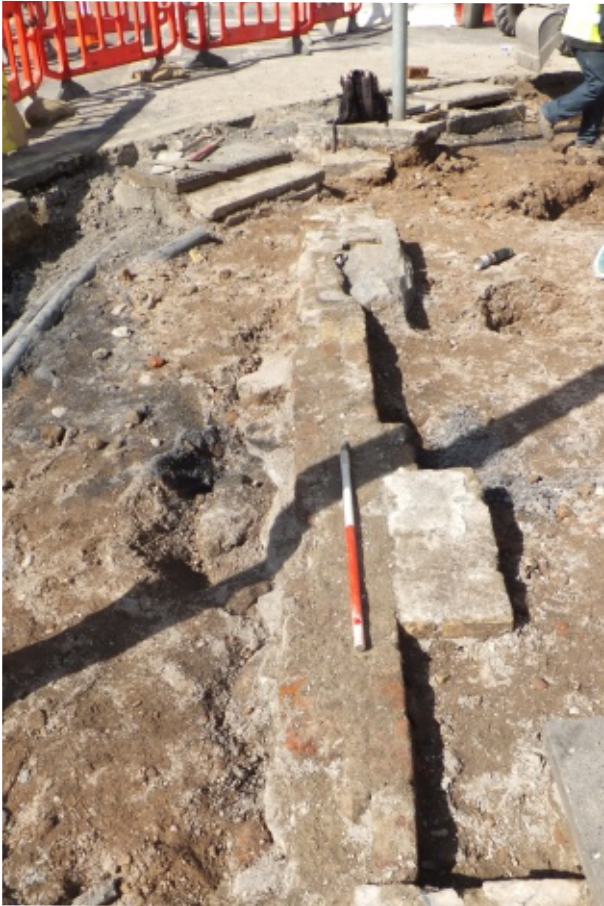
left: structural remains at James' Gate
right: plan view of structural remains at James' Gate

One large curving brick wall appears to represent a water management feature, splitting water into two channels. A number of additional drains were evident running into a brick-lined

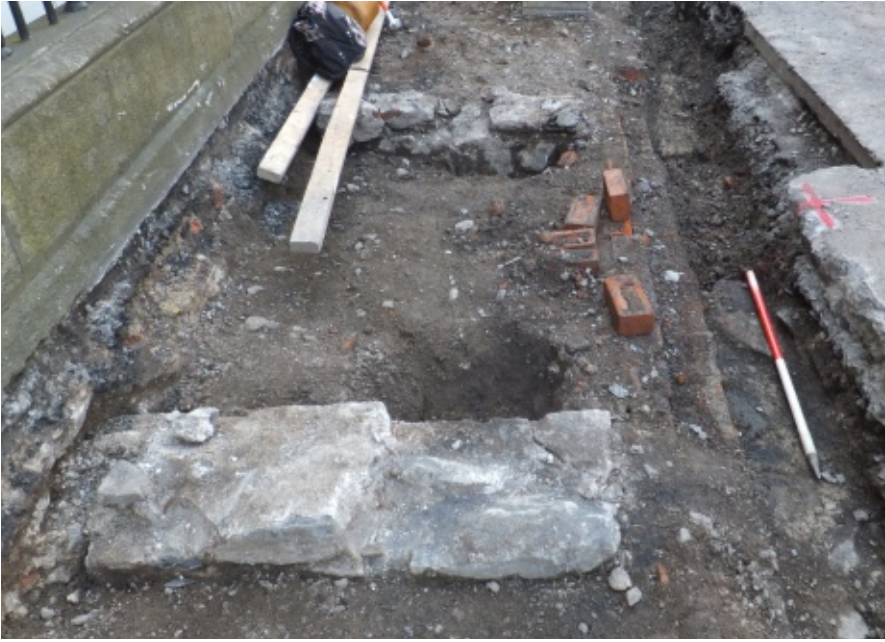
Structural remains at Nos. 2-3 Thomas Street

The flagstone floor consisted of decaying limestone blocks 70mm thick overlying a sticky grey clayey silt with inclusions of brick and mortar fragments. A coin was also retrieved from this material. The flagstone floor was at 15.53m OD and sloped slightly from south down to the north. It abutted the eastern wall and ran for 1010mm east-west and 1400mm north-south, being truncated in the vicinity of the western wall by services.

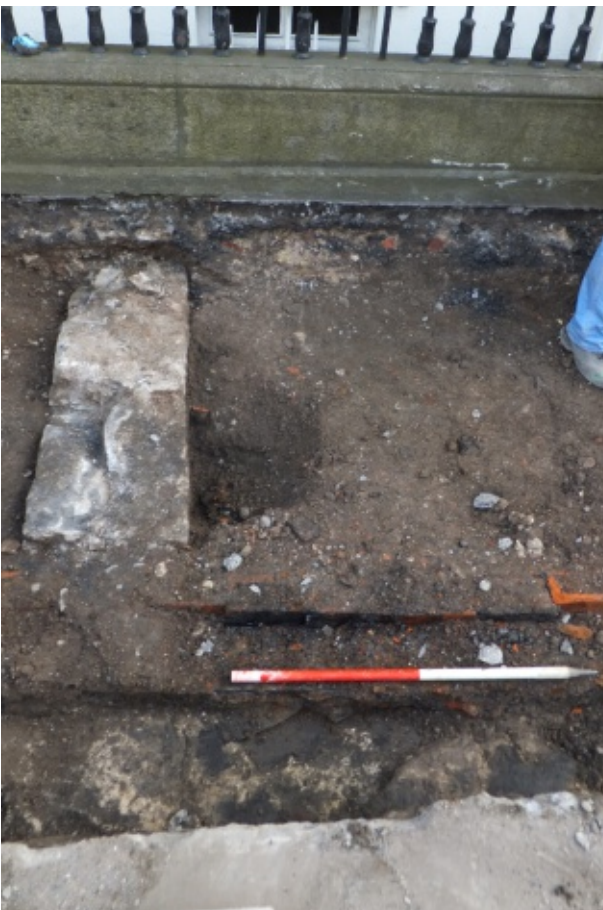
Structural remains at Nos. 2-3 Thomas Street

To the west of the western wall a mortar bedding was recorded abutting the wall at 15.41m

OD, which is likely to represent the bedding of a second floor, which has since been removed. This ran for 1260mm to the west of the wall before being truncated by services.

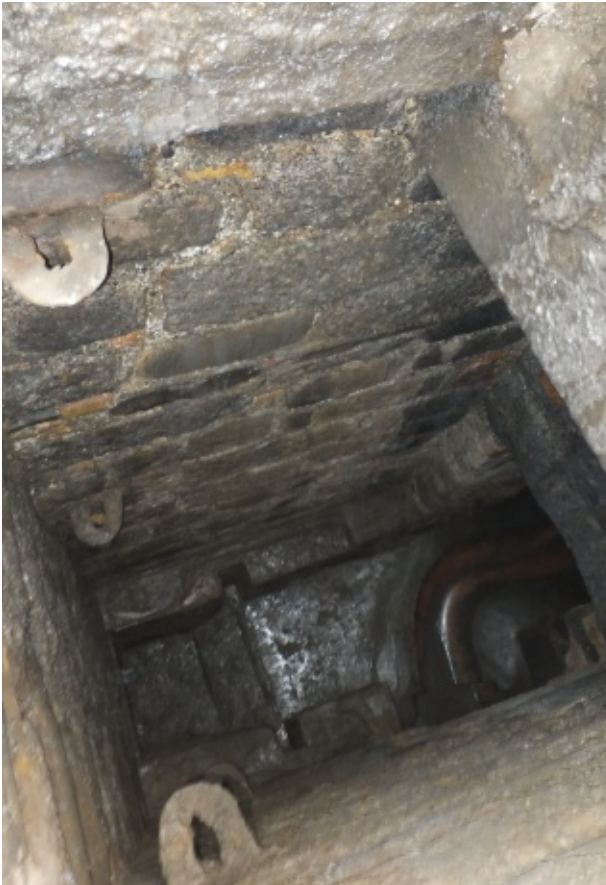
view into deep water culvert running east-west under James' Gate

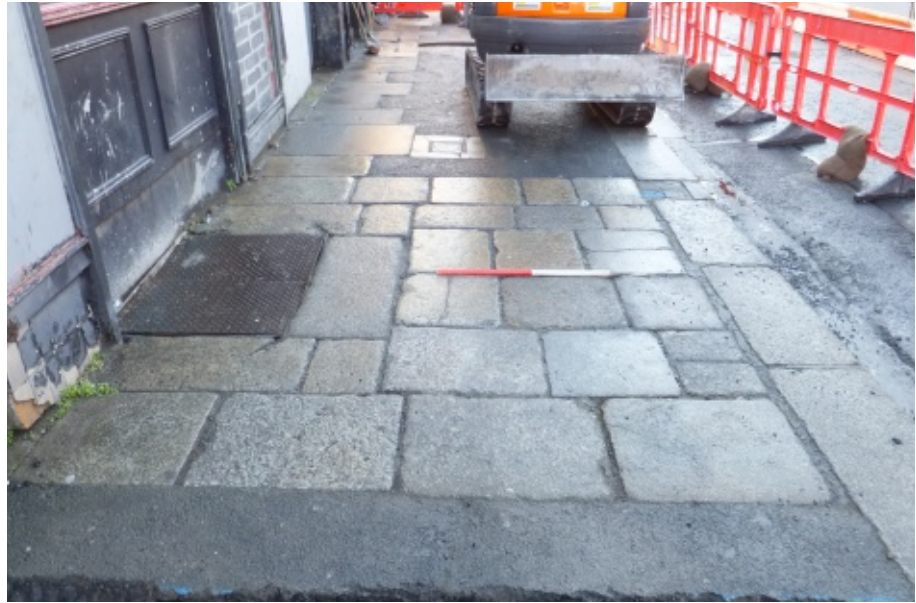
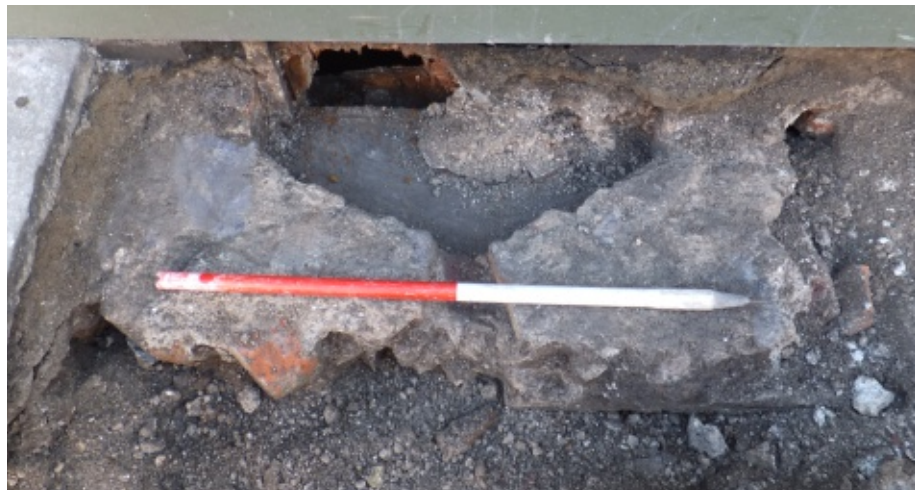
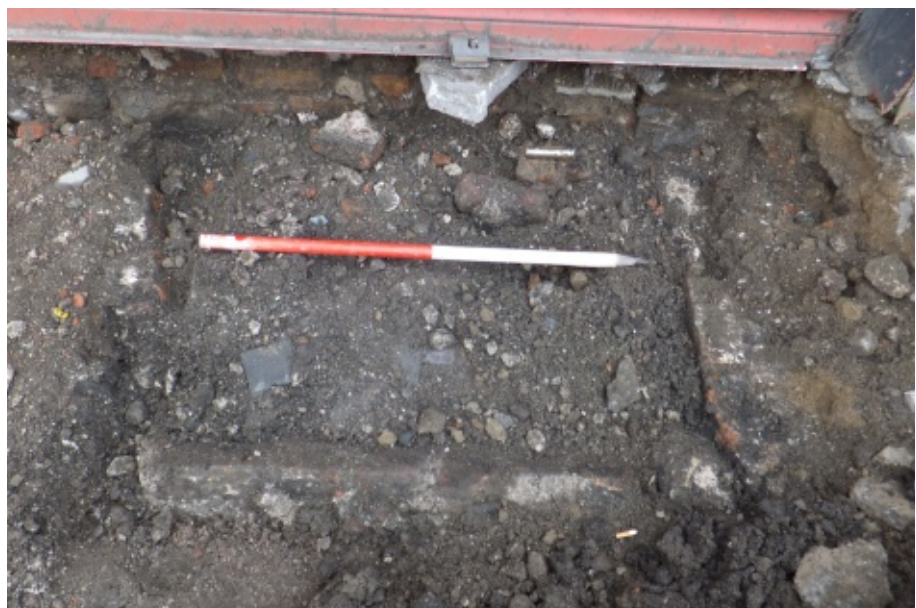
above: granite pavement at No. 144 Thomas Street
below (middle): lightwell on Thomas Street
bottom: a second type of lightwell on Thomas Street

The change in below ground sub-pavement features, i.e., goods drops, light-wells and coal cellars, was notable from James' Street to Thomas Street, with substantially more goods drops and light-wells identified along Thomas Street. There are a number of possible explanations for this. Given the closer proximity of Thomas Street to the city, the majority of the buildings here are likely to have had both a commercial and residential function, and as such would have a greater need to use the basement

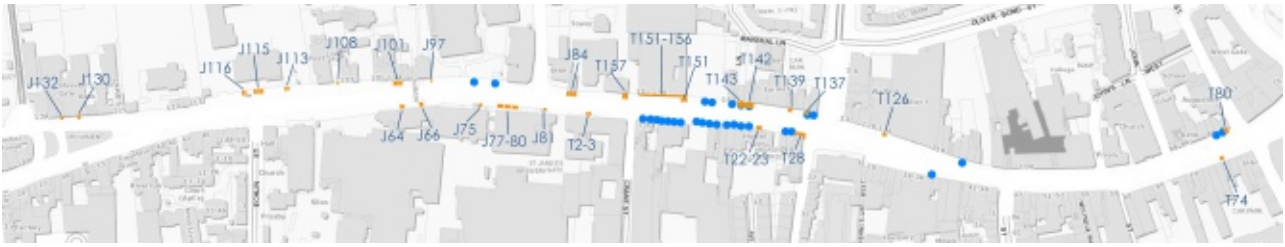
above: map showing cellars in orange, and light wells and goods drops in blue

A total of 14 cellars were identified along Thomas Street during the project. While many of these were fragmentary or previously truncated, 8 were relatively intact.

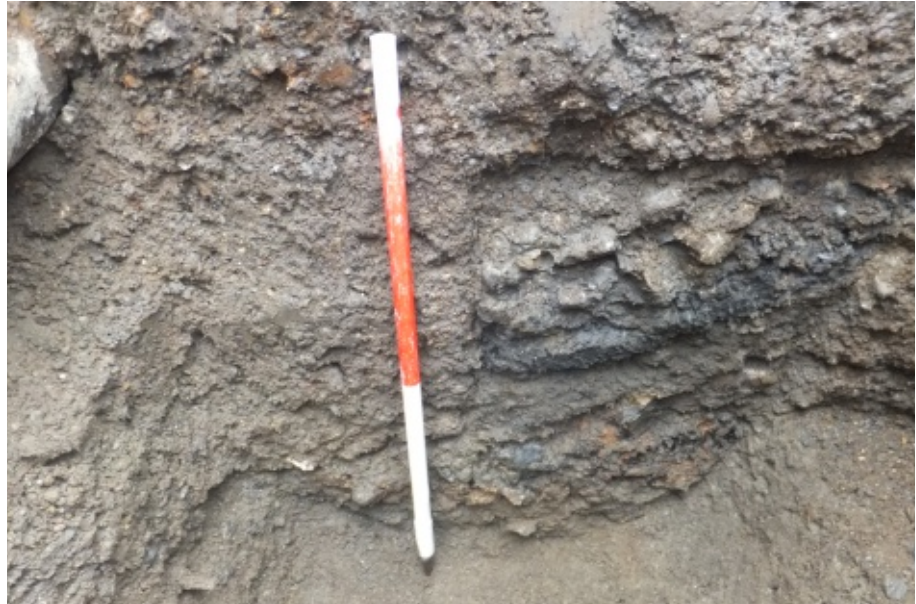
The medieval ditch (C23) was U-shaped in section with a suggestion that it was flaring out towards the top. At the highest point of the ditch's survival, 960mm below the current ground level, it was 1200mm in width. At 1550mm below the ground level it was 920mm in width. The ditch had five fills. The basal fill (C32) was a mixed gravel with occa-

sional charcoal, pebbles and shell fragments and is likely to relate to the initial sediment within the ditch. No finds were retrieved from this fill. Overlying this was a layer of burnt clay and charcoal (C24) with large charcoal chunks evid-

ent. Occasional animal bone and medieval pottery were retrieved from the fill. This was in turn overlaid by a light grey clayey silt (C25) with occasional stone, animal bone, oyster shell and medieval pottery. Overlying this was a dark

above: south-facing section of ditch C23
below: profile through ditch C23

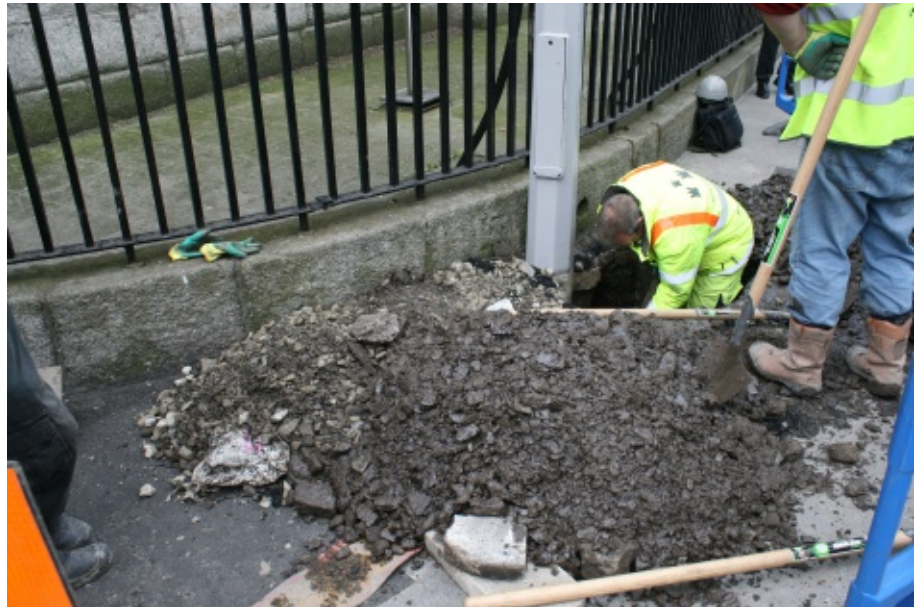
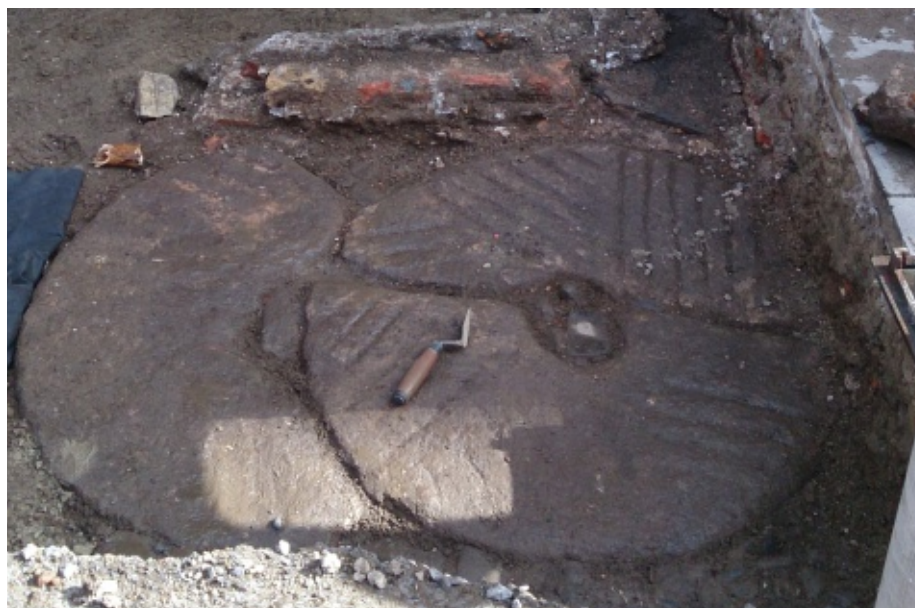
One of the millstones was complete, though it had been broken in two. It was a runner stone (the upper rotating stone) and distinct parallel grooves in seven 'harp-shaped' sections were noted on its surface, being 5mm deep, 15mm wide and 60mm apart. The millstone was 940mm in diameter, 220mm thick and the central circular hole was 160mm in diameter. Less than half of the second millstone survived, though it would originally have been of a similar scale to the first. No grooves were noted on the second millstone.

Dublin City Council water service workers found human remains outside St. Catherine's Church, Thomas Street, on 25th May 2015. They reburied them the same day in the same location, near a lamppost under the pavement at the junction of Thomas Street and St Catherine's Lane at a depth of c. 1m. These were re-exhumed by Gardai under the archaeological supervision of Laureen Buckley

above: excavation of human remains at St. Catherine's Church
below: millstones at No. 138 Thomas Street

The presence of these broken millstones within the fabric of the former cobbled street is unusual and was not noted elsewhere along the street during the works. It is possible that they merely represent a repair to the original pavement, however it is also possible that they represent an intentional marking at the entrance to No. 138, possibly acting as an advertisement for the business being conducted

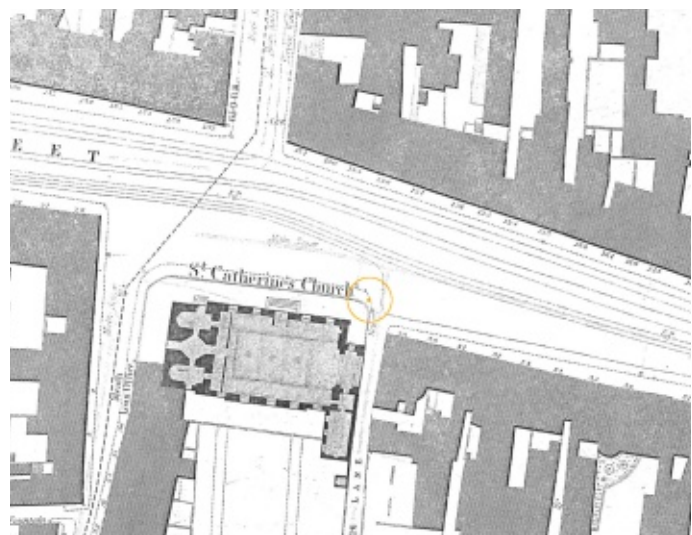
Right (top) modern survey showing location of human remains at St. Catherine's Church, Thomas Street

National Museum of Ireland Topographical Files 1973:29-31 & 1974:93 describe how human remains were recovered on a number of occasions under the pavement outside St. Catherine's Church. Some of these appear to have been disarticulated, and were recorded in a 1.5m deep trench in the footpath, 5m from Thomas Street and Thomas Court junction. These are likely more of the same.

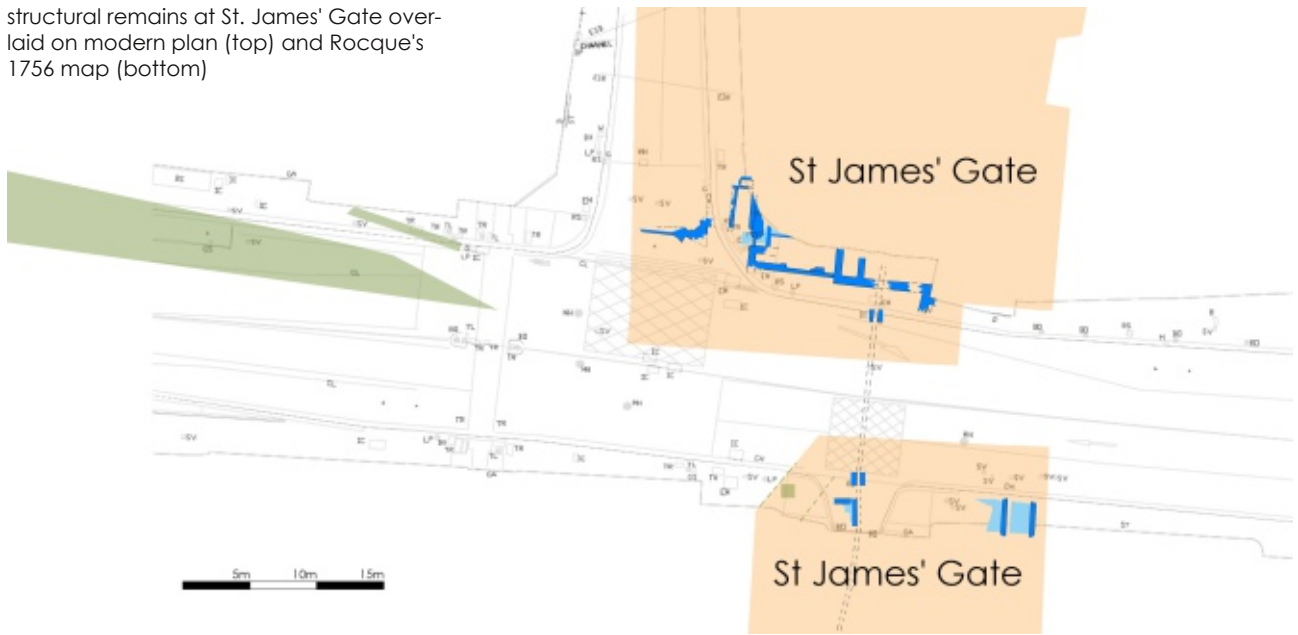
structural remains at St. James' Gate overlaid on modern plan (top) and Rocque's 1756 map (bottom)

associated with the 18th and 19th century structures that stood here. One of these walls had an unusually wide and deep foundation (running east-west) that is very likely to be directly associated with the original 15th gate structure. The structural remains were preserved *in situ*. Smaller structural remains to the south consisting of the remains of two parallel walls with a flagstone floor between them, could have formed a small room or passageway within the gate structure. A coin uncovered near the structural remains was too corroded for identification.

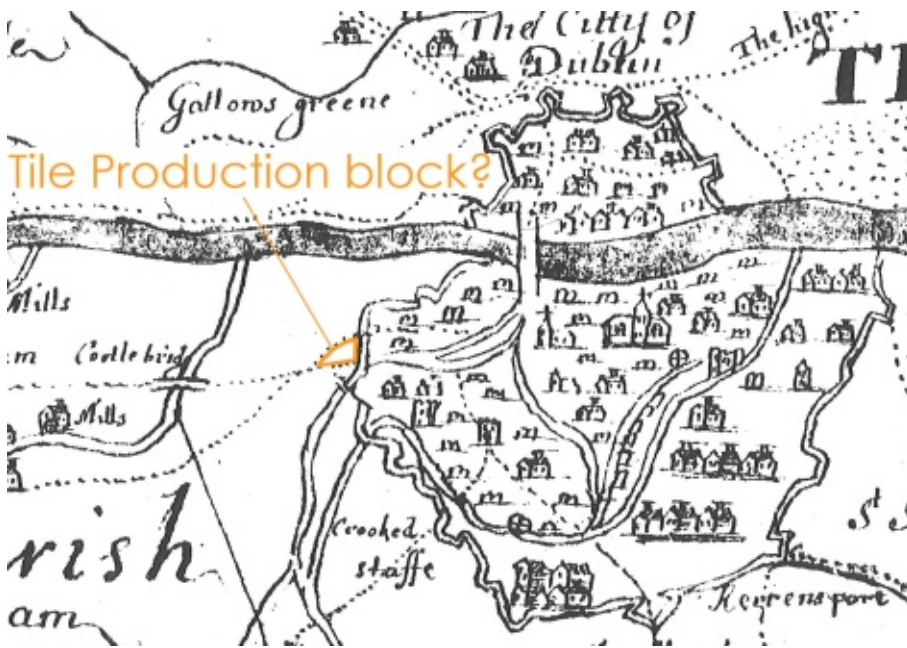
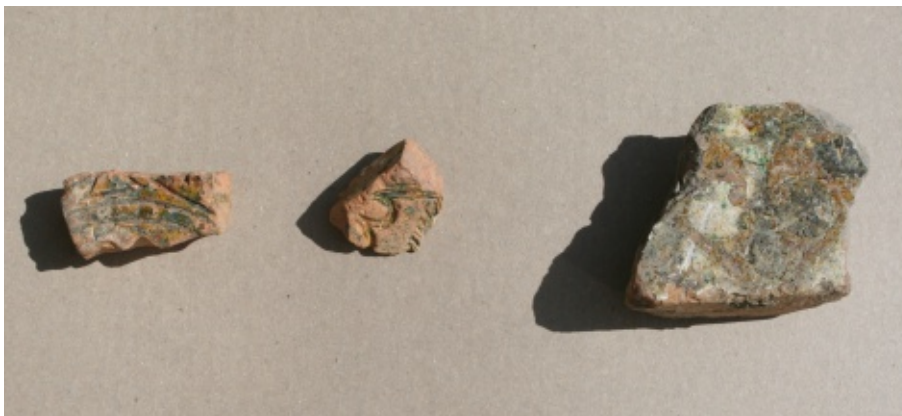
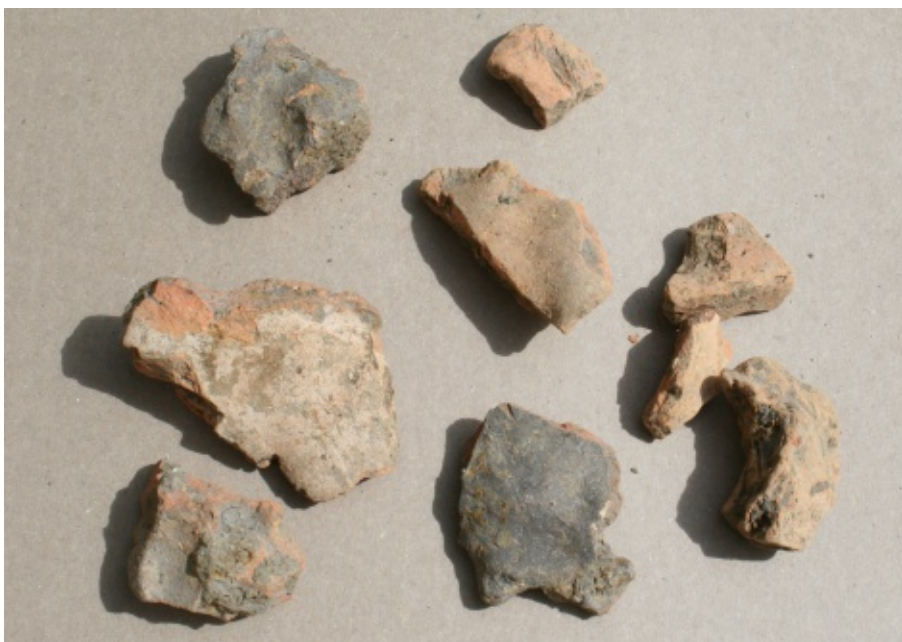
above: location of possible tiliary on Crocker's Alley on Down Survey map of c. 1655
 below (middle) decorated floor tiles James Street; two incised 13E401:6:420-421 and one two-colour tile 13E401:6:216
 bottom: ceramic wasters 13E401:6:229-237

wasters within the fill. These wasters do not appear to be from pottery, and may instead be derived from tile manufacture or other ceramic industry.

The evidence from the ditch C4 may suggest that a tiliary was located in this block off Croker's Lane.

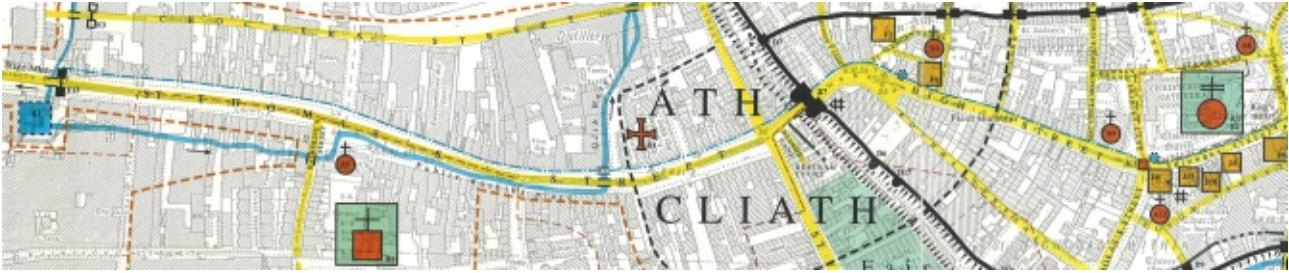
map of medieval Dublin c. 840-c. 1540, (Clarke 2002) showing medieval watercourses on James' and Thomas Streets
