Archaeological Report James' and Thomas Street QBC Dublin 8

archaeology plan

Quality Bus Corridor, James' Street and Thomas Street, Dublin 8

Monitoring License 13E401
Ministerial Consent E4507 (C615)

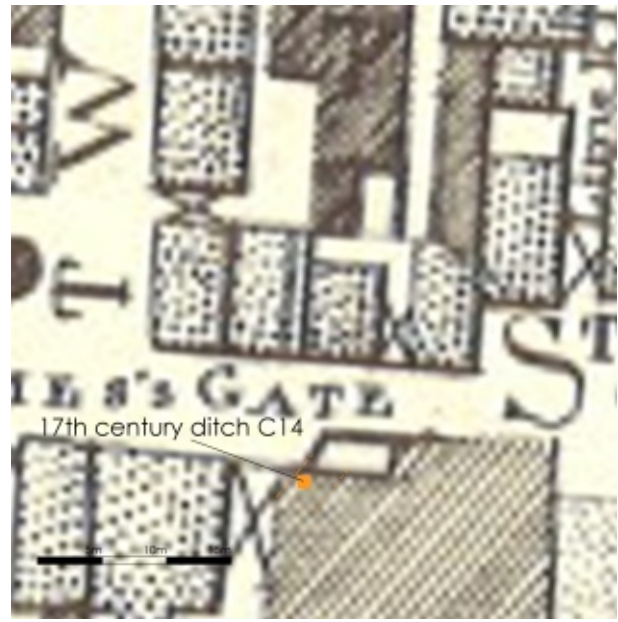
17th century ditch C14 in relation to Rocque's map of Dublin 1756. Note how ditch line is reflected in the diagonal line of small structure at St. James' Gate.

The orientation and position of the ditch corresponds with the defensive ditch shown on the Down Survey 1650s map, and the parish boundary (between St. James' and St. Catherine's) crossing James' Gate on 19th and 20th century Ordnance Survey maps. It also appears to correspond with an angled wall depicted on the southern side of James' Gate on Rocque's 1756 map of Dublin.

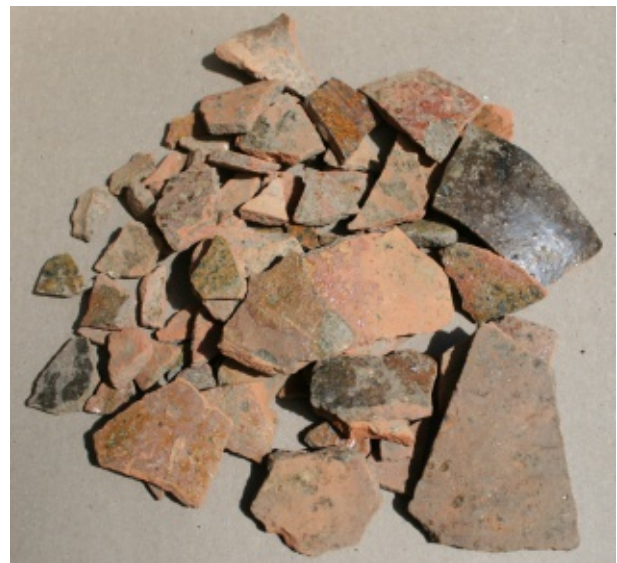
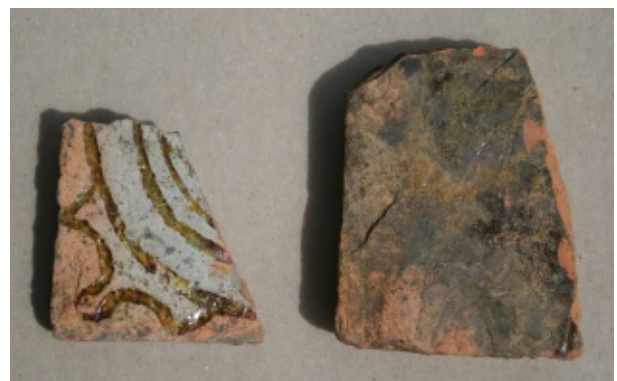
Top: Dublin-type ware body sherds 13E401:6:286-365

Bottom: Decorated floor tiles from Thomas Street 13E401:29:36 & 23

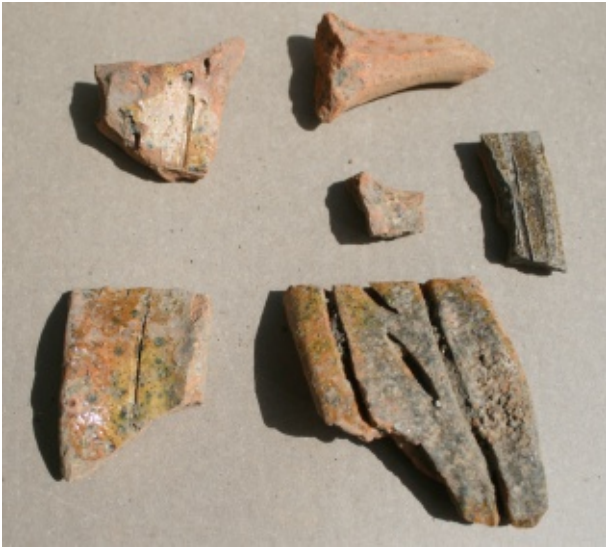
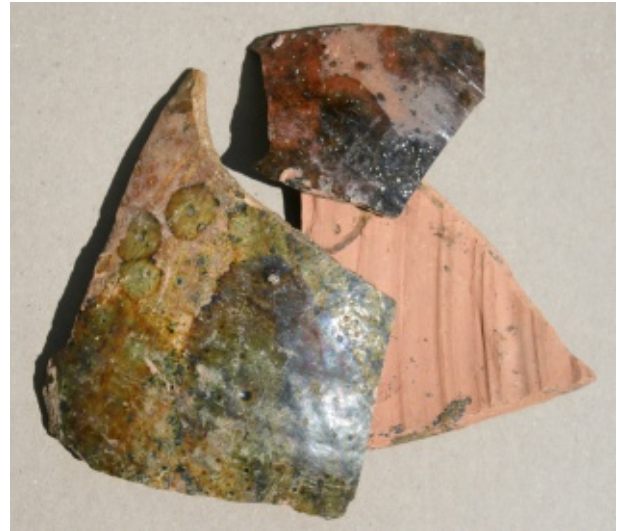
Top left: Dublin-type ware handle sherds 13E401:6:249-254
 Top right: Dublin-type fineware 13E401:27:15-18

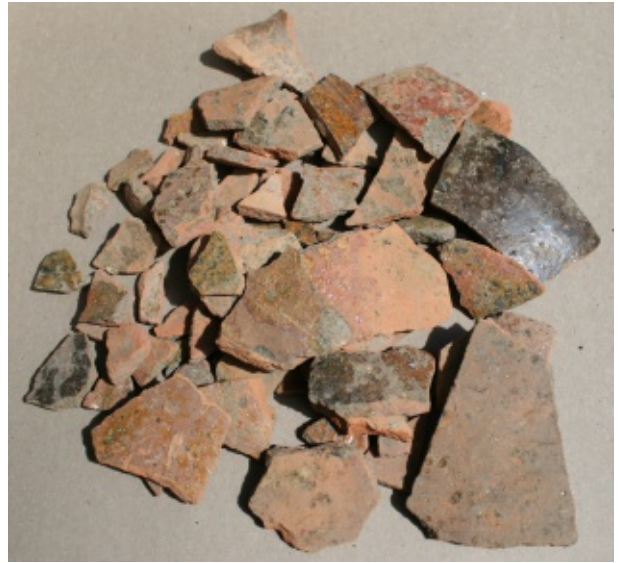
right: dublin-type ware body sherds 13E401:6:286-365

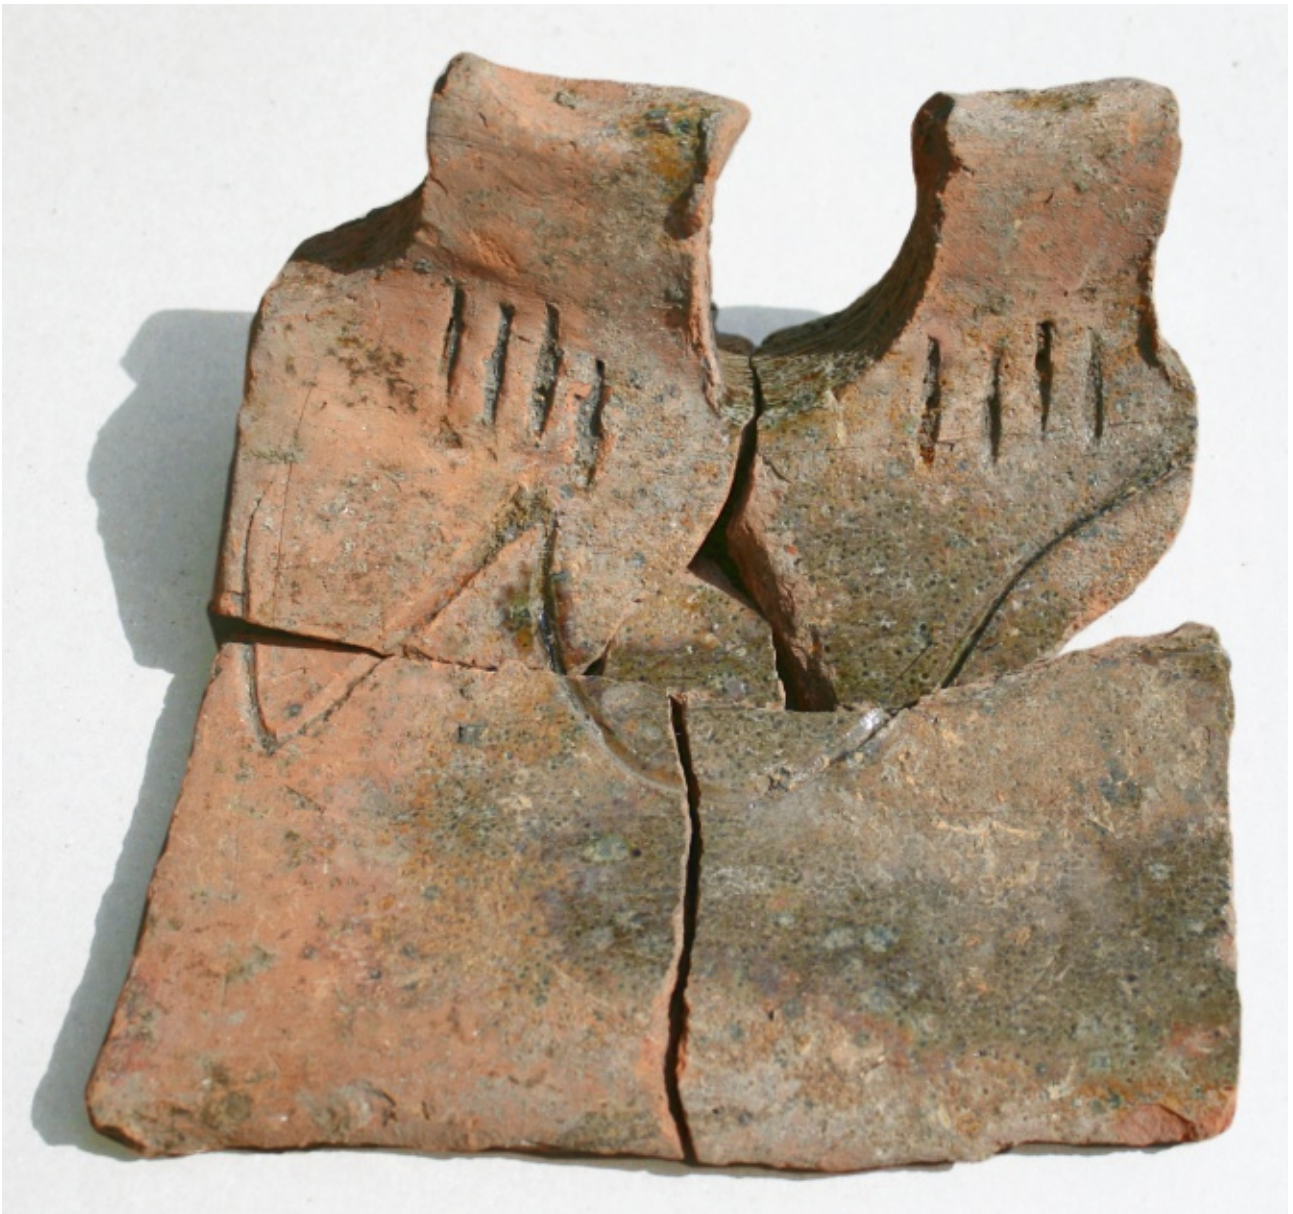
below: medieval ridge tile 13E401:6:217
