Phoenix Park Magazine Fort 2016 Excavations

archaeology plan

Magazine Fort, Phoenix Park, Dublin 8

Office of Public Works

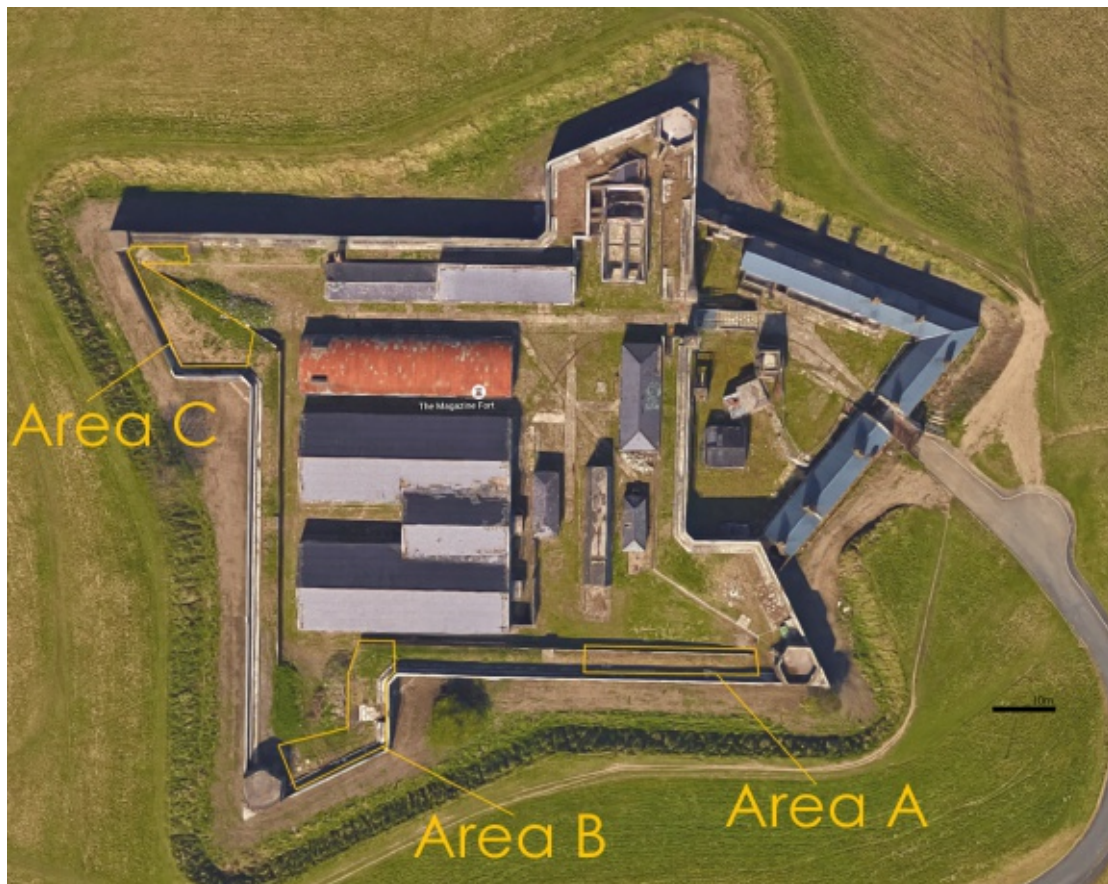
Areas A, B and C described in the report (no work took place in B)

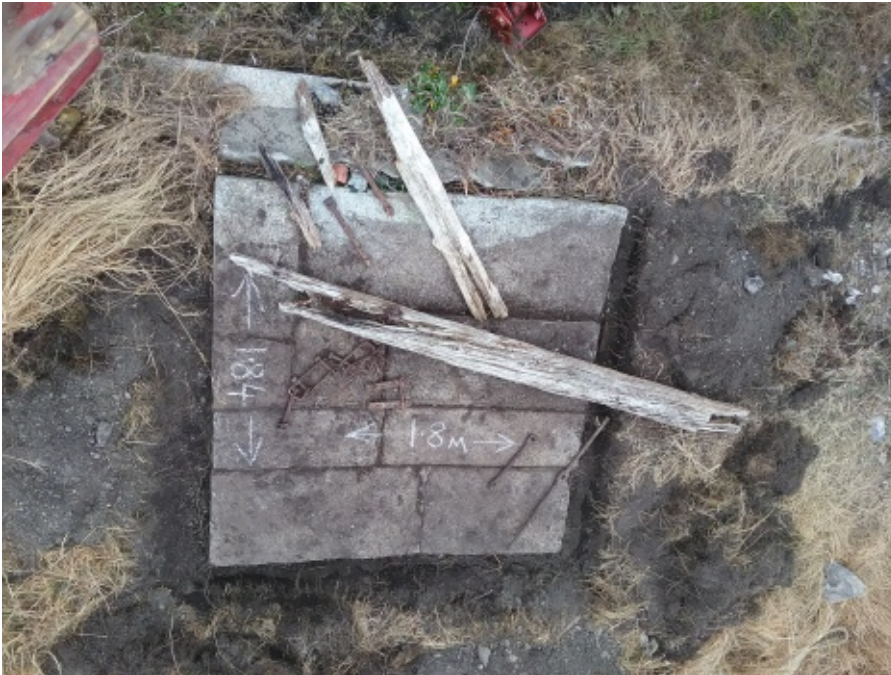
Sentry post SP2 (top) with machinery, and sentry post SP1 (below)

The sentry platforms probably held light wooden sentry shelters. The sentry posts are not positioned to provide views out from the fort walls. Rather, like the sentry walks and promenades in the interior of the fort, they provide views within the fort and around the magazines, and they may also allow an officer in the centre of the fort to rapidly ascertain all key lookout points are occupied.

The Area A (SP1) and Area C (SP2) posts were identical and comprised six to eight granite flags set out in a square 1.8m across. The timber and ferrous fragments of a possible crane or pylon found on sentry box SP2 in Area C were recorded and photographed in situ, then wrapped in shrink wrap and placed in Building B with the granite slabs from the platforms.

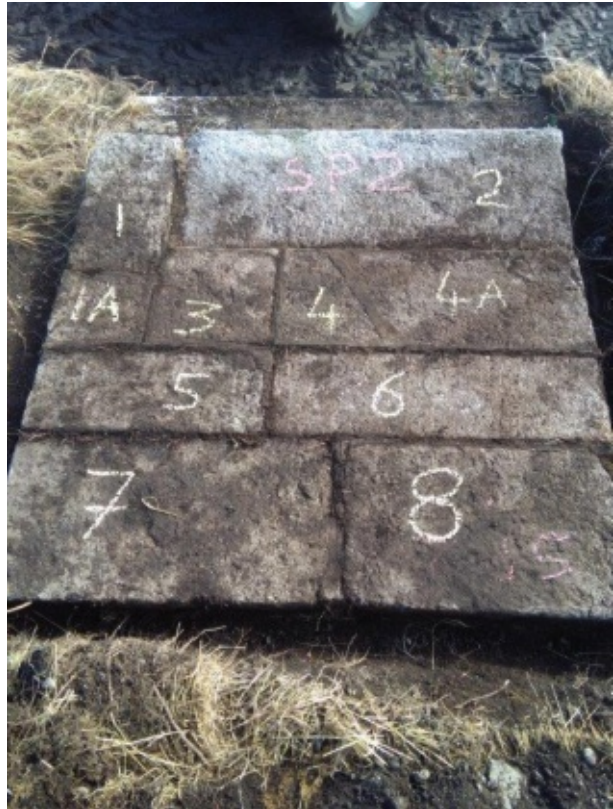
Area C - numbering of sentry post SP2

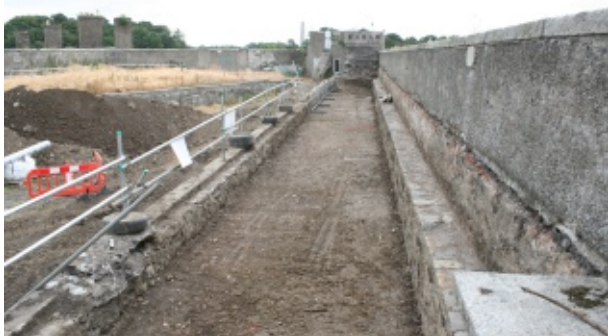
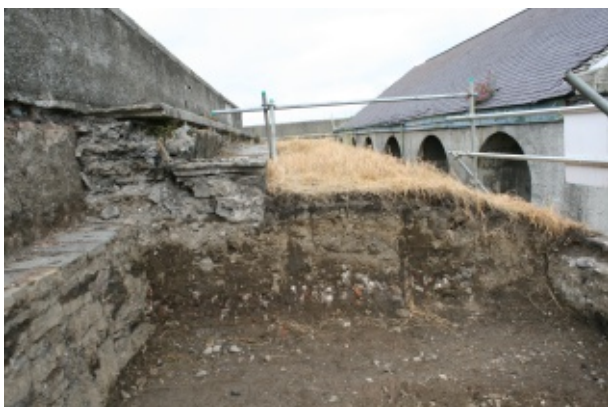
Rampart ground reduction in Area A

The uppermost layer in the Area A rampart was a dark brown sandy-clay topsoil containing infrequent inclusions of charcoal and pottery (C1) measuring 210mm deep. Below this was a loose mid-brown sandy-clay 210mm in depth (C2). Animal bone and oyster shell were identified near the base of the deposit. Bullets of probable 20th century date were found in this layer and in the layer below (15E0540:2:1 & 15E0540:3:2).

This was underlain by a thick layer of compact mid-brown sandy-clay (C3) containing fragments of red-brick, animal bone, oyster shell, pottery and sporadic flecks of charcoal. The layer was at least 400mm in depth and extended down below the base of the excavation. This layer was the primary fill material of the upper rampart, dating probably from the 18th century. Early 18th century pottery, including North-Devon gravel-tempered earthenware, Bristol-Staffordshire slipware, and a Dutch-style hand-painted tin-glazed wall tile (15E0540:3:3-9) support the interpretation of this fill as original to the 1736 construction of the fort.

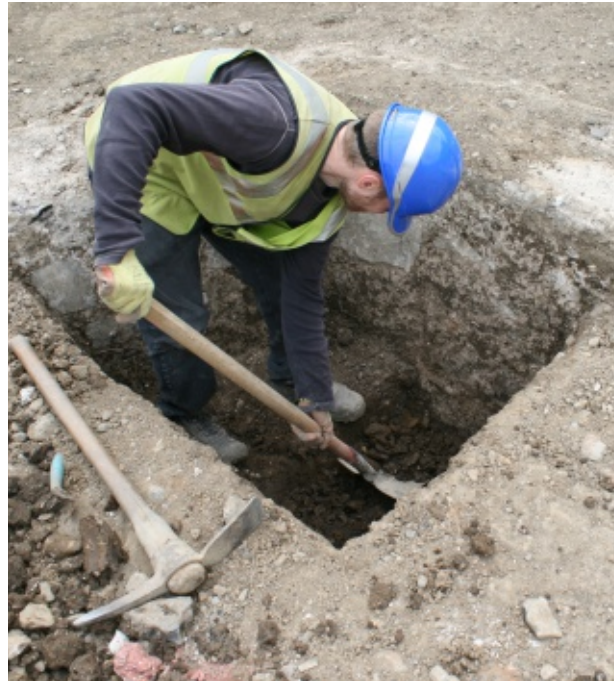
1m by 1m hand-excavated square test-pit through later rampart fill (C9)

Below these upper layers the earlier rampart wall became visible, running northwest-southeast through the Area C rampart. Either side of the wall was a mid-brown sandy-clay with inclusions of broken red brick, pottery and sporadic flecks of charcoal. This was termed C9 (later rampart fill) to the northeast of the wall, and C17 (earlier rampart fill) to the southeast of the wall. Both layers measured at least 400mm deep and extended below the base of the excavation. A 1m by 1m and 1m deep test-pit in the later fill (C9) identified nothing of interest.

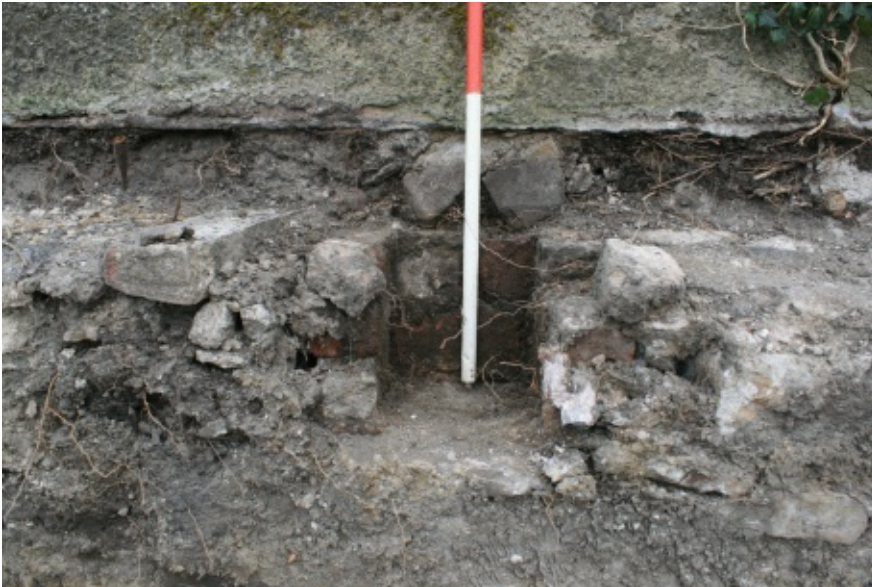
Gun emplacement drain base cut into outer rampart wall

Surface drains had previously been noted in the form of grooves along the edge of the gun platform closest to the parapet, draining into a hole in the platform. The underground parts of the drains were exposed following removal of the platform. The entry shaft of each drain was brick-lined and square in plan (0.2-0.27m across) and had been cut 0.25m deep into the original masonry rampart wall. The drain shaft was located centrally to the southern gun platform, but off-centre to the western gun platform. This off-centre location in the latter case was due to the former presence of two gun openings: the shaft is centred on the northern, now in-filled opening.

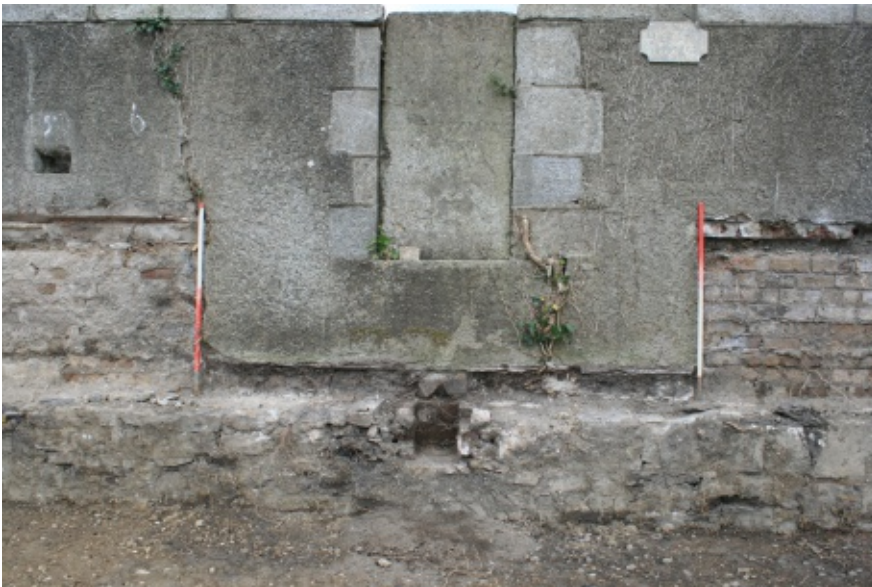
Detail of gun emplacement following ground reduction

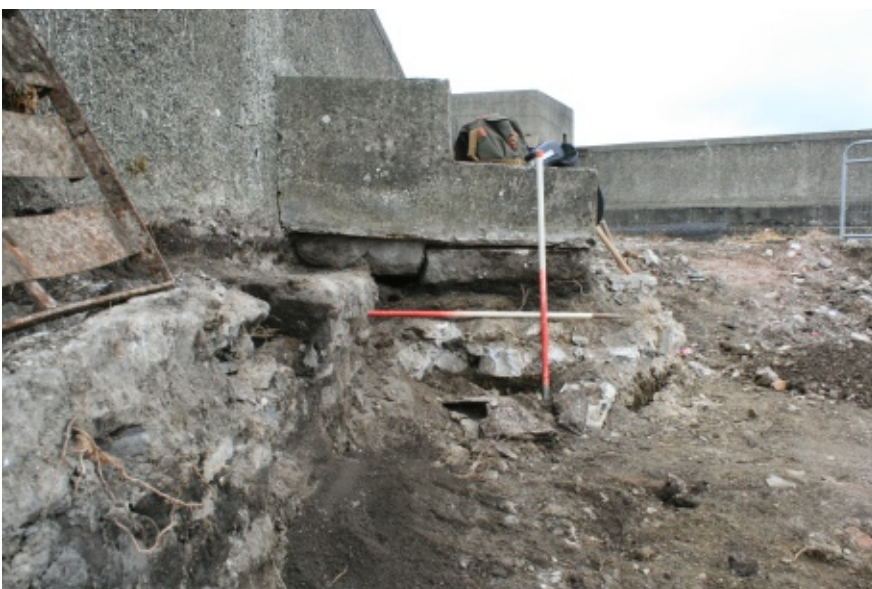
Profile below concrete walkway, showing gun platform and masonry fill directly below concrete

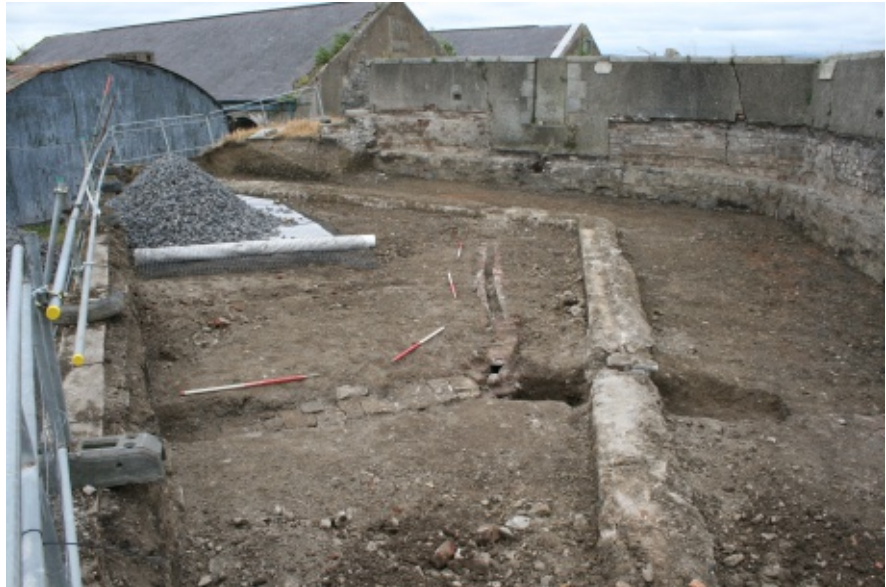
Overview of gun emplacement drainage, facing south

The drains themselves were lined with brick and measured 0.11m-0.14m. The brick was bonded by a distinctive pink lime mortar, and they were cut through the original rampart retaining wall, and also cut through the later rampart fill (C9). The two gun platform drains converged into a single larger drain which was capped with sandstone slabs, and ran into the later rampart retaining wall, which appeared to be broadly contemporary. The discovery of these drains is significant, because they demonstrate that the gun platforms belong fully to the later phase of the rampart (c. 1800) and were contemporary with the widening of the rampart.

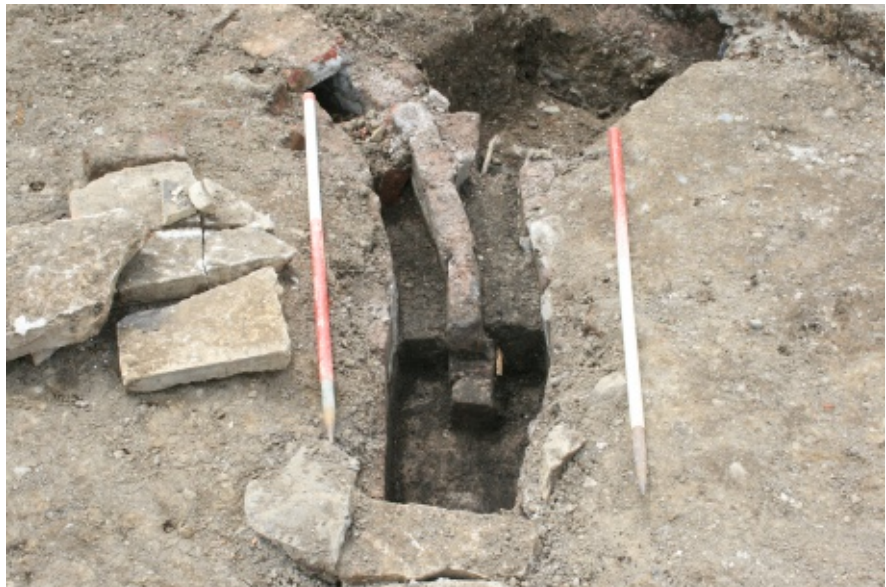
Detail of section where gun drains converge into a stone-lined drain

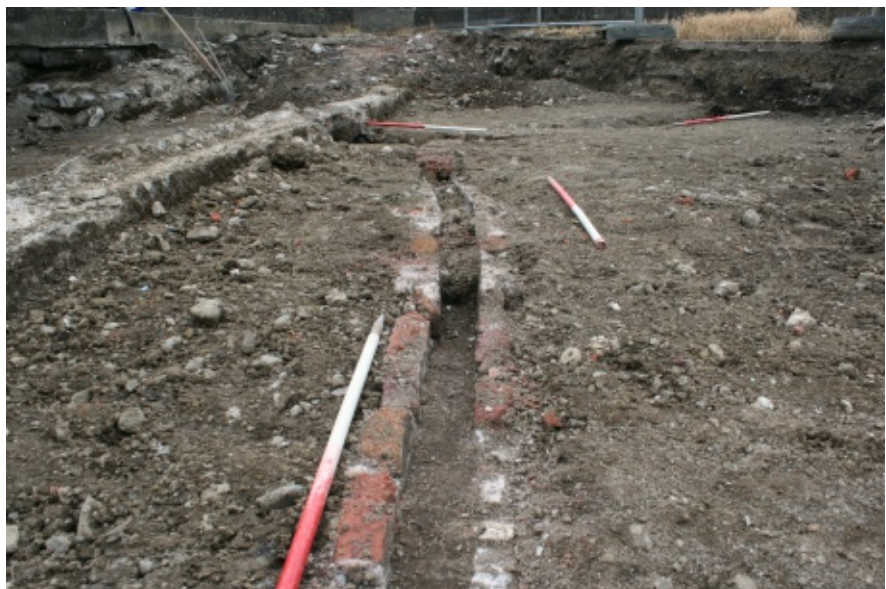
Detail of brick-lined part of drain

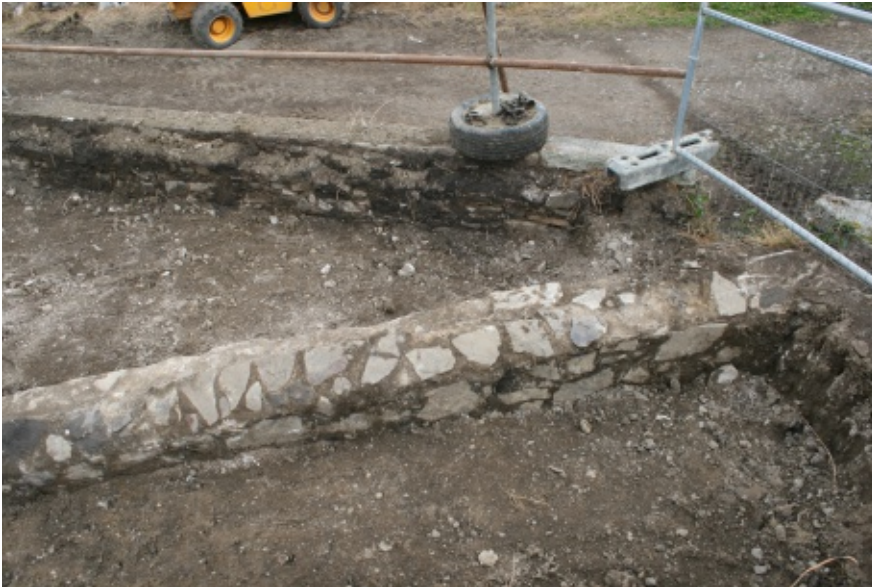
Detail of early (1736) rampart retaining wall

The early phase (c. 1738) of the internal rampart wall was identified during soil removal. Construction was of limestone with a lime mortar bonding, and was identical to the later wall (c. 1801) except for an angled capping of small stones on the interior side of the (missing) capping. This is not present in the later wall (which has a thick coat of crude lime mortar in the same location) but is present in the rampart wall to the southwest of the bastion, suggesting that the latter wall can also be dated to c. 1738. The original rampart measured c. 3.5m wide, which is the current width outside the demi-bastions. The capstones of the early phase wall had been removed at some stage, but the lime bedding for the capstones was present and suggested that a granite capping had been removed, and was probably reused on the later phase wall. The height of the wall was the same as the later wall in the southwest of Area C. However, whilst the later phase wall rises up to form the ramp up towards the cavalier, the early phase wall remained at the same level,

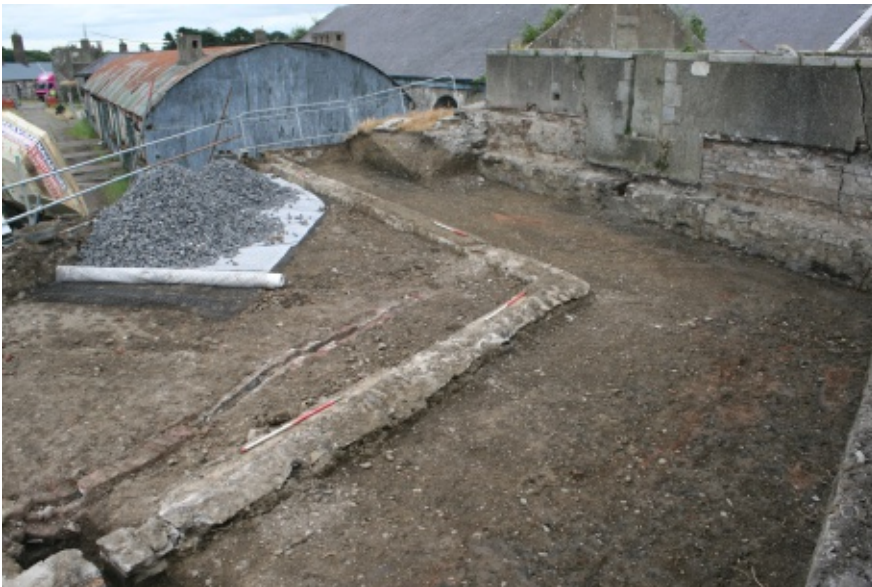
Overview of early rampart retaining wall

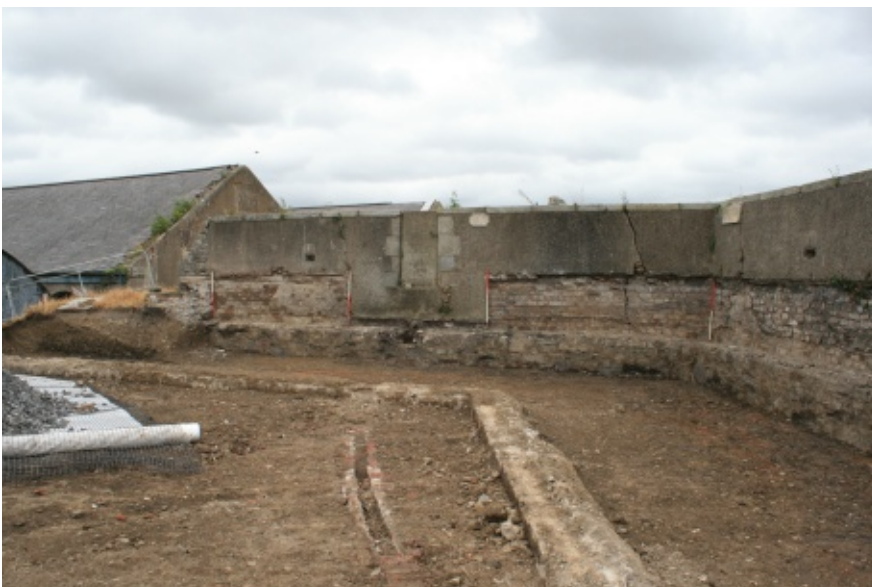
View of early brick phase of outer rampart wall

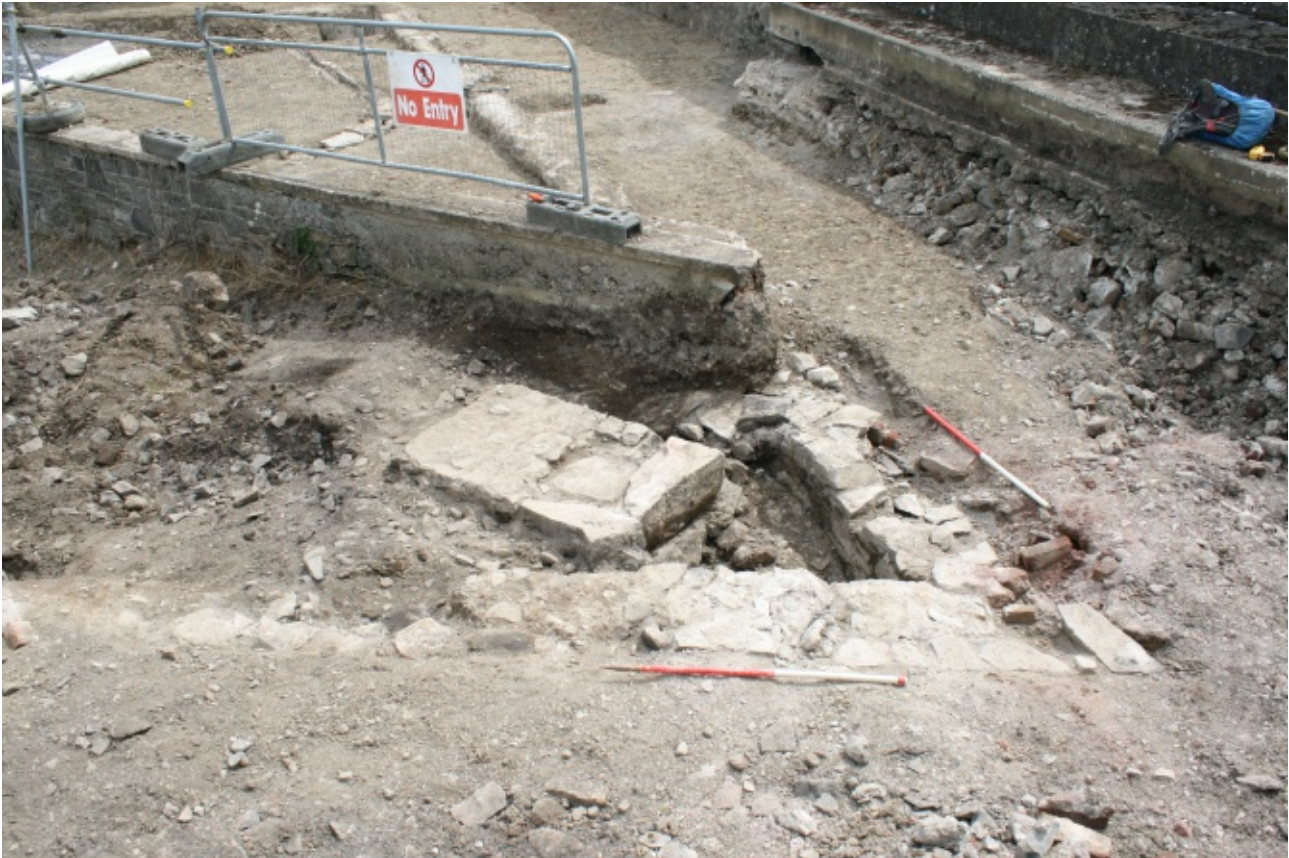
Excavation of corner of early rampart retaining wall, 1736, showing rectangular masonry footing for cavalier steps, c. 1801.

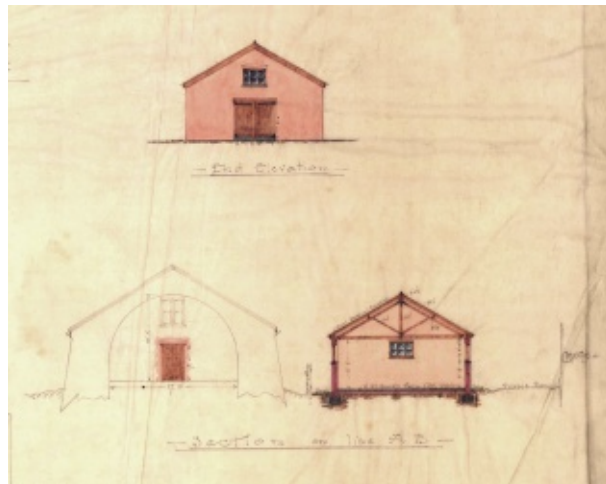
Plans for a small arms and ammunition store, 1904, in same location as existing Building B

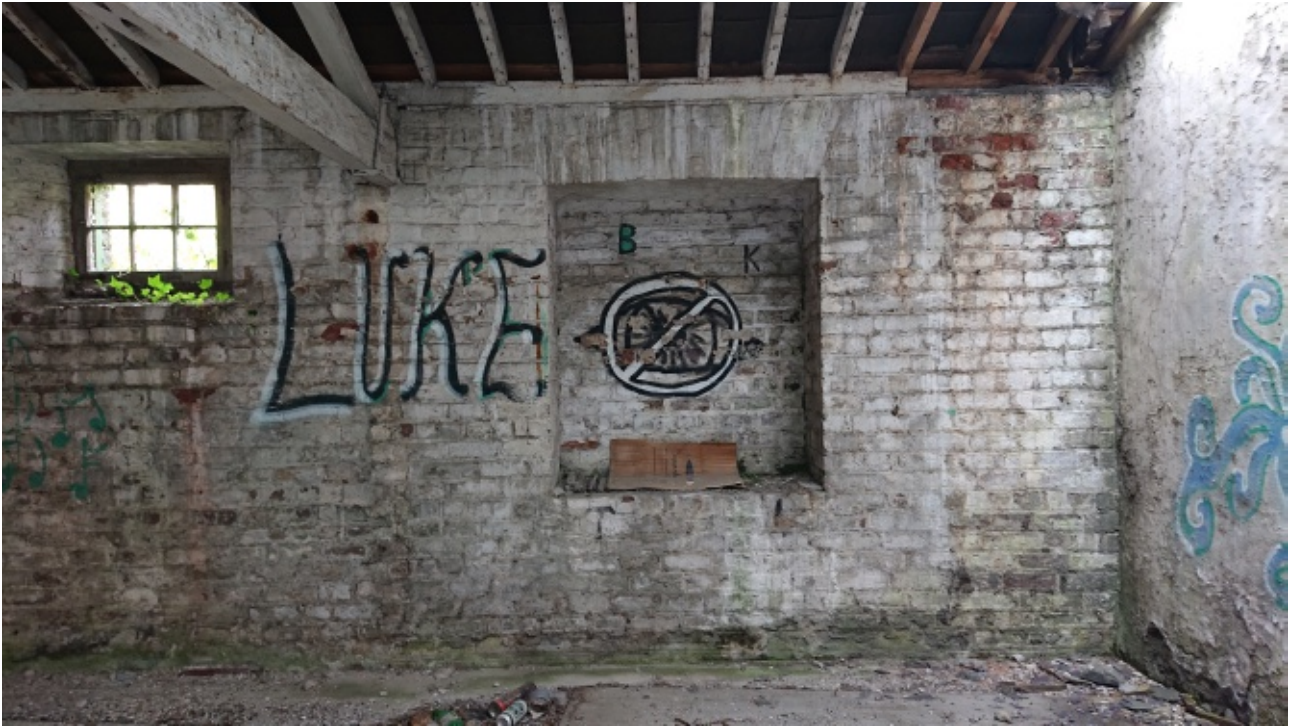
Building C, western side, showing remains of wooden partition of fireworks c. 1901 store to left of image, removed in the 1940s. Note also letters B and K in the niche.

Building C is in fact two separate buildings. The eastern half was erected between 1793 and 1806, and the western extension was added between 1806 and 1861 and connected with the earlier part after 1944. The western extension was originally a store with an internal division in

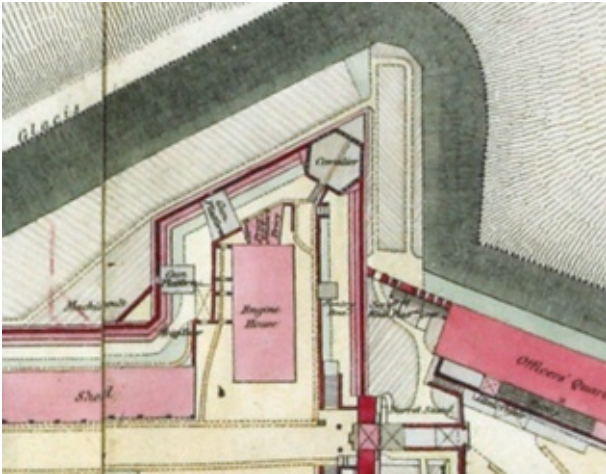
Building D shown on 1861 plan, showing absence of gun emplacement to west

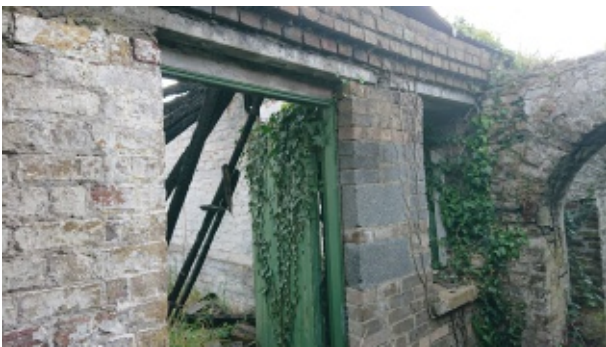
Building D showing reinforcement of doorways, possibly related to additional security and repair following 1916

The western wall entrances to the northern stores have been rebuilt and strengthened with metal sheeting on the doors and concrete lintels. Window bars also have been inserted at the rear. This modification may be related to the activity in Easter 1916 if this building was damaged in the raid, or related to the 1940s Paxo Plant.

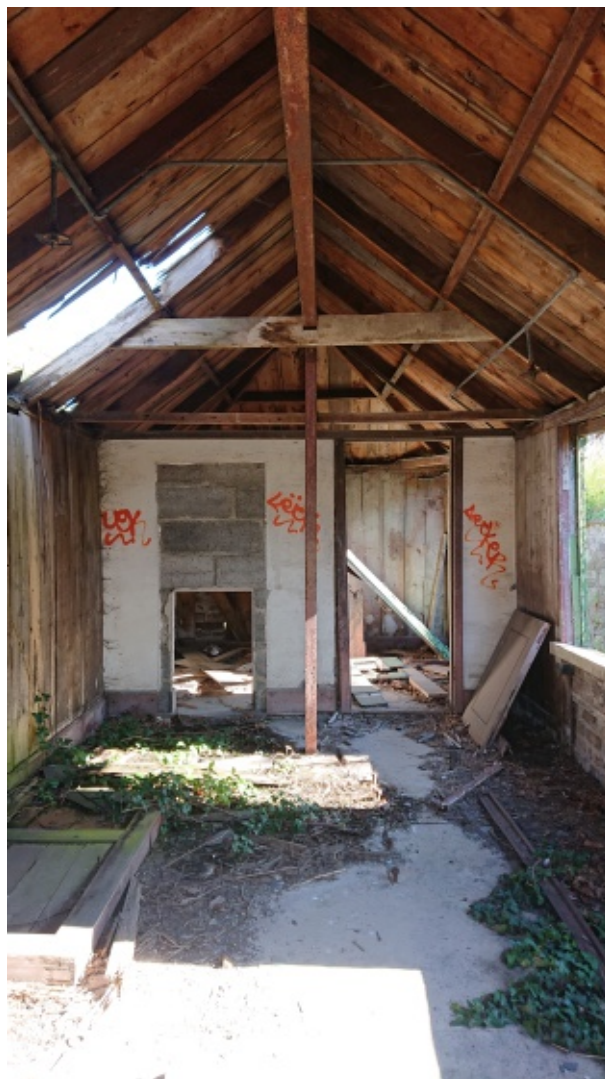
Building F interior showing steel frame, possibly c. 1940s

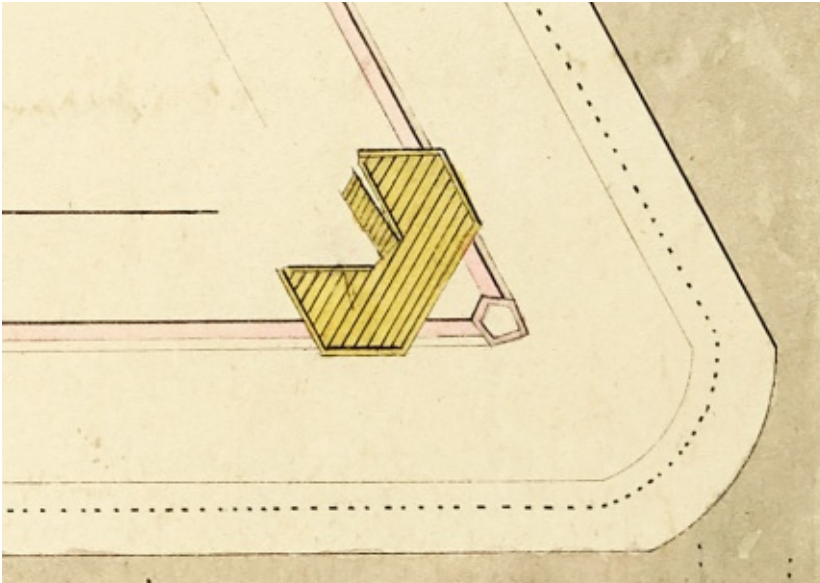
Wooden platforms on 1806 plan of 'No 3 Magazine Phenix Park' (UK National Archives MPH 1/682/2)

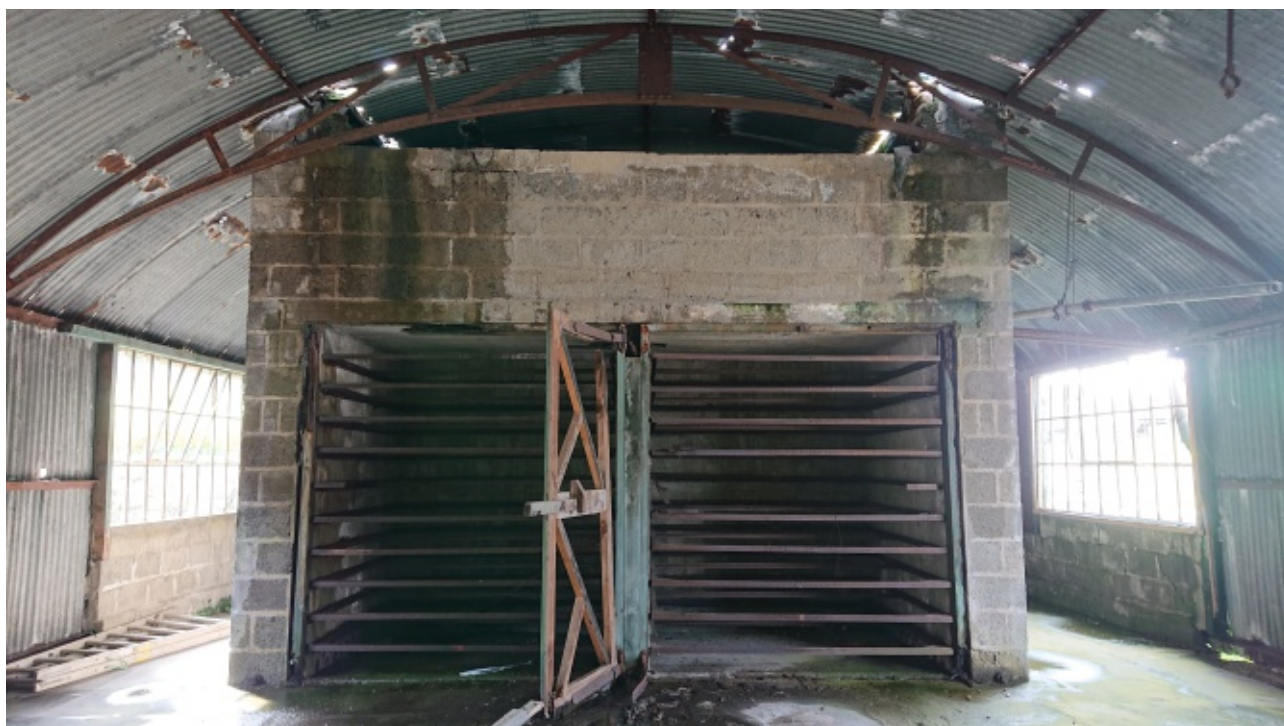
Paxo plant building B showing unidentified machinery base, possibly for a grinder. Traces of the per-1940s steel wall removed for the Paxo Plant are visible in the floor in the right foreground

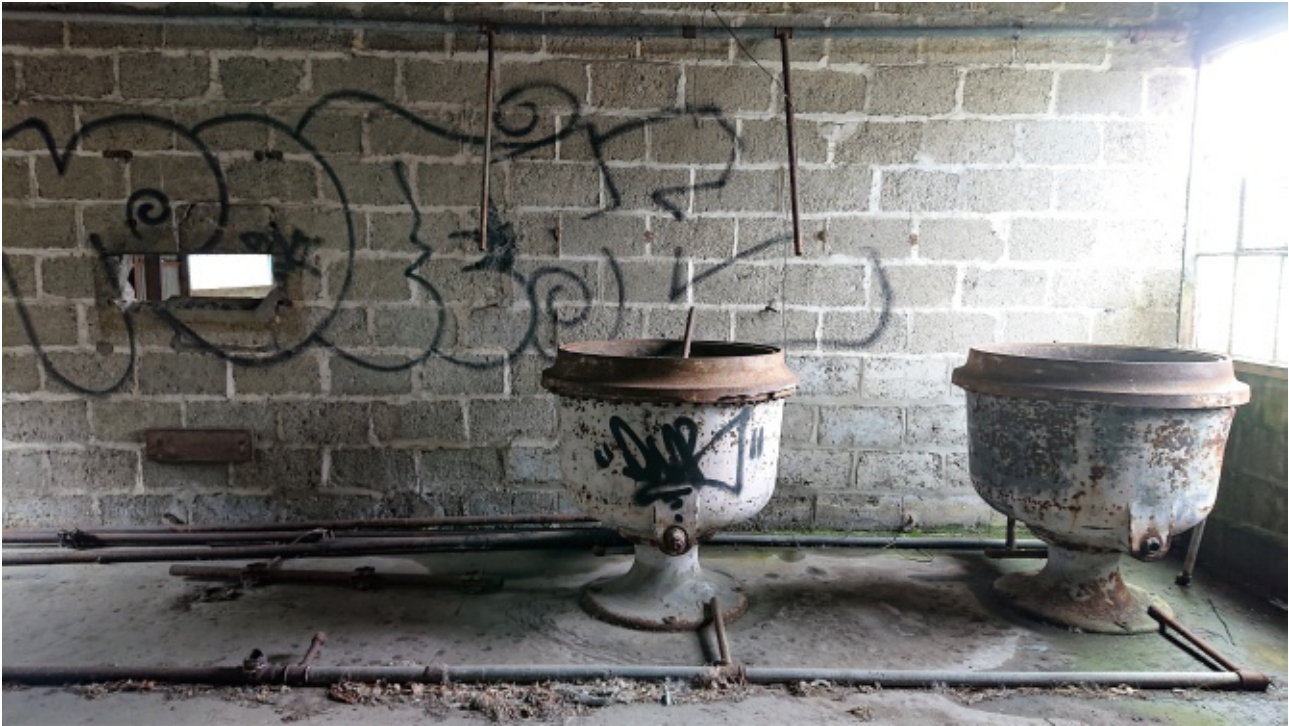
Paxo Plant plans mixers and access hatch

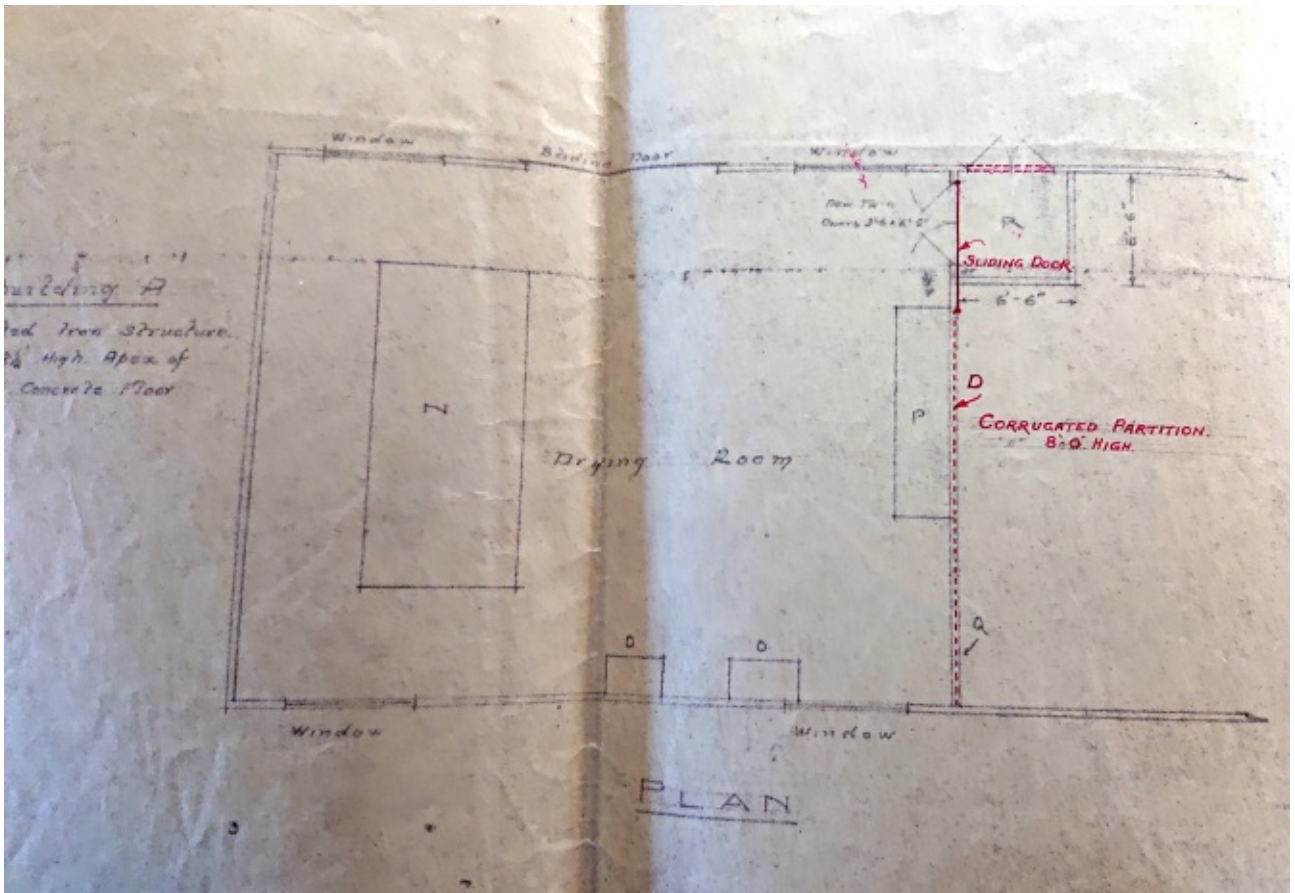
Paxo Plant modifications to Building B, here labelled as Building A

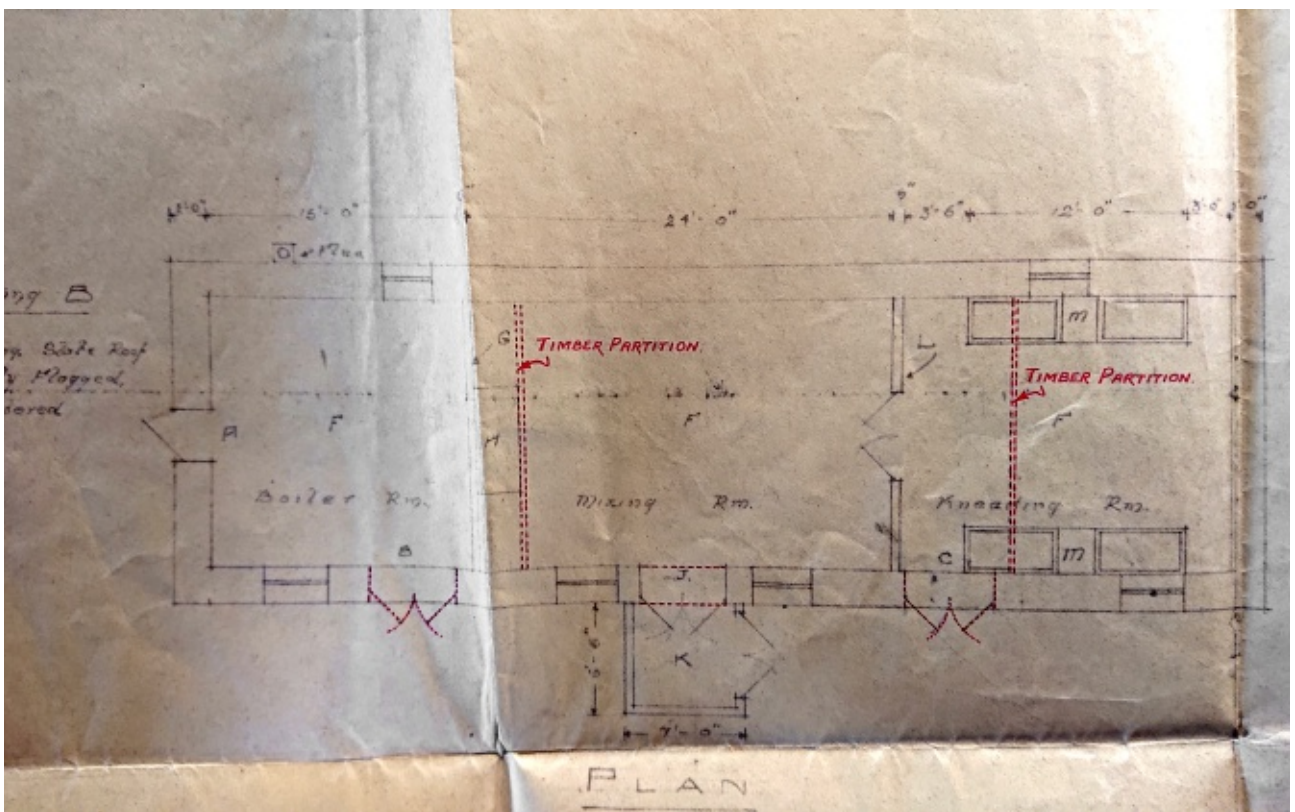
Paxo Plant modifications to Building C, here labelled as Building B

1946) and the water supply was to be extended to the boiler house. An external flue was to be erected for the boiler and installed by contract.

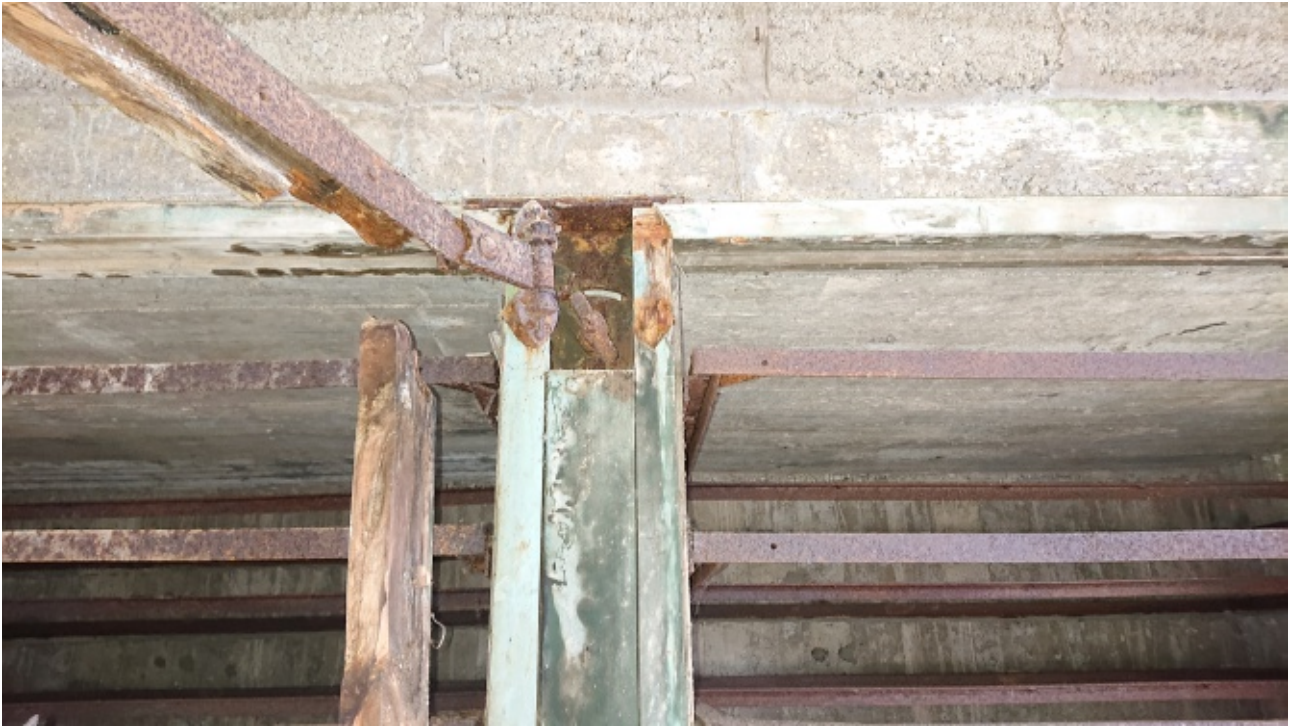
Paxo Plant detail from kiln, showing a butterfly damper and decorative hinge

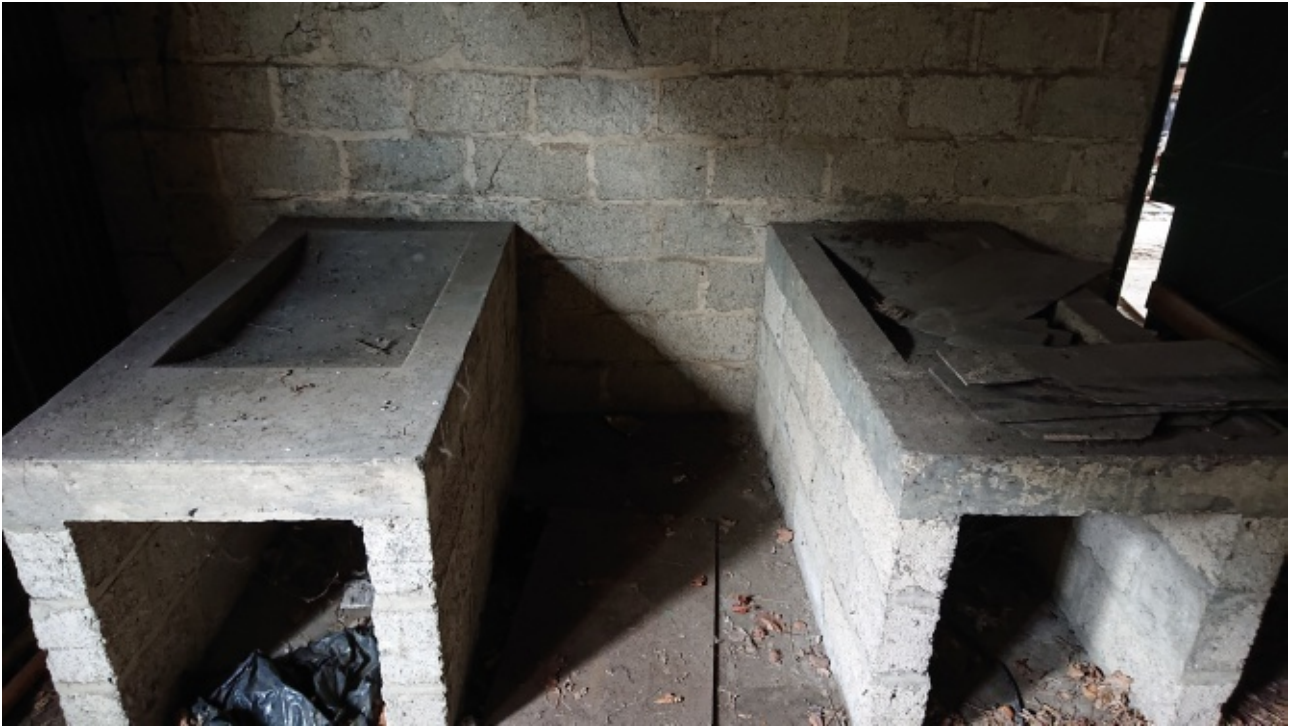
Paxo Plant kneading stations, possibly misinterpreted as being for bread-making
