# Phoenix Park Magazine Fort Testing in formal garden

Formal Gardens, Magazine Fort, Phoenix Park, Dublin 8

Office of Public Works, Jonathan Swift Street, Trim, Co. Meath

15<sup>th</sup> October 2020

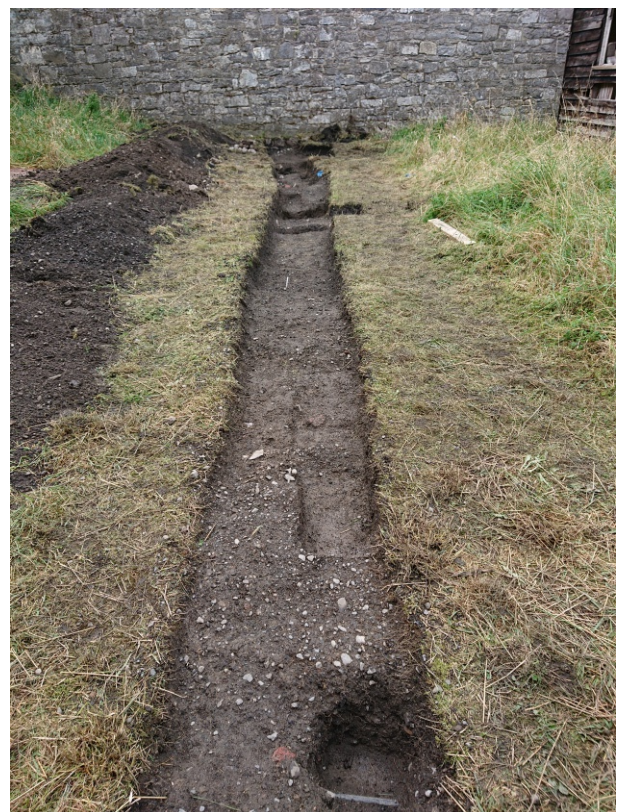
Trench 1 facing west

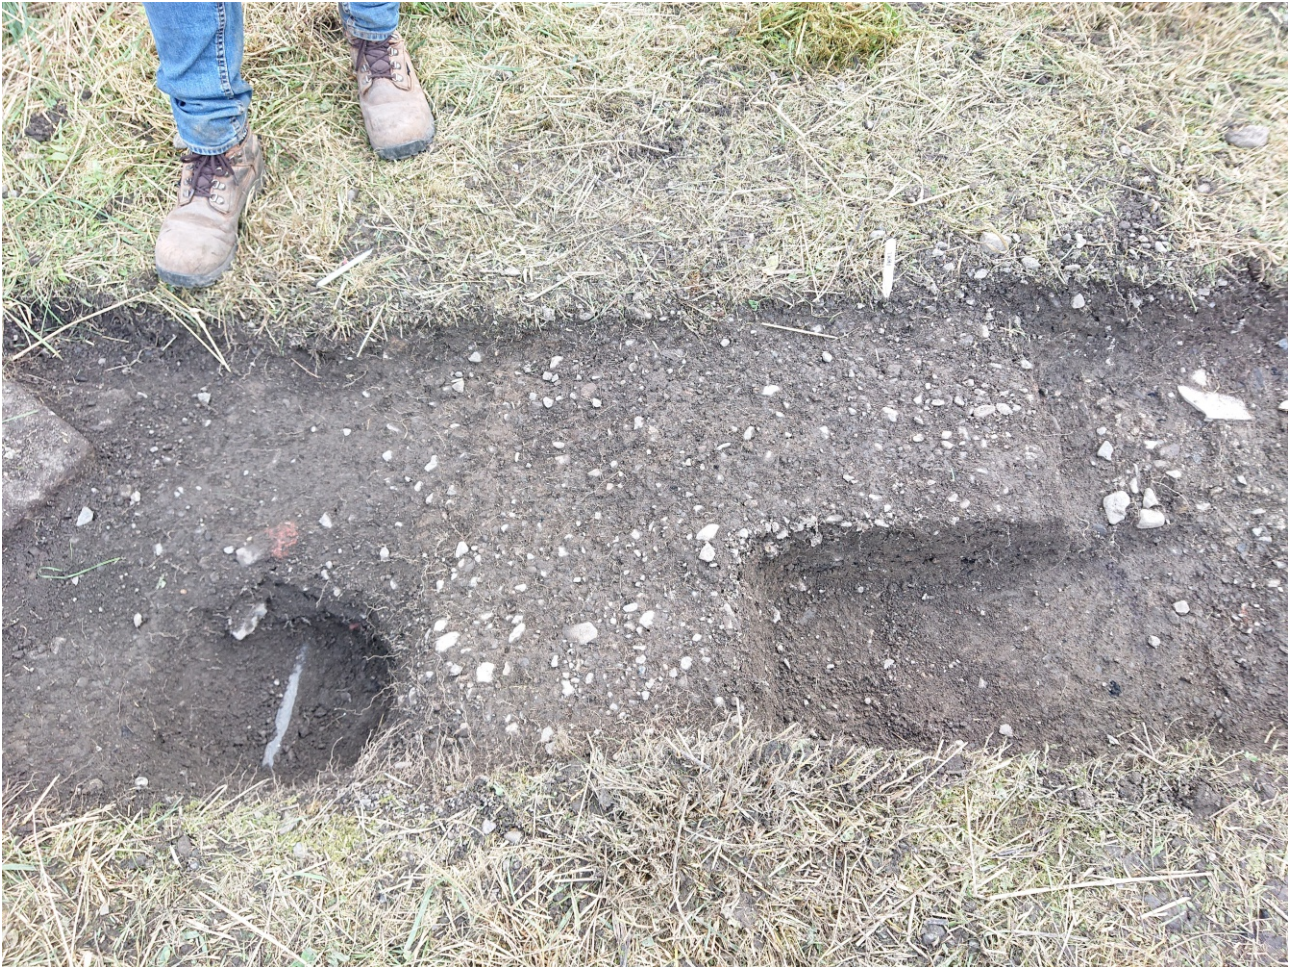
View of footpath 1 (FP1) facing south

A sondage was placed through the most damaged area of FP1 (sondage 1), which revealed an earlier footpath (C08), which had degraded eastwards into the grass or planting plot. It appears an effort was made to either stabilise it with lime or crushed limestone (C20), which today is used as a self-binding gravel. A later version of the path (C07) was laid more to the east. This later path and the bed to the east of it were cut by a ditch (C22) for a plastic pipe that runs along the eastern boundary of the garden to the water tank, where it is visible running vertically up the wall to the higher level of the ravelin.

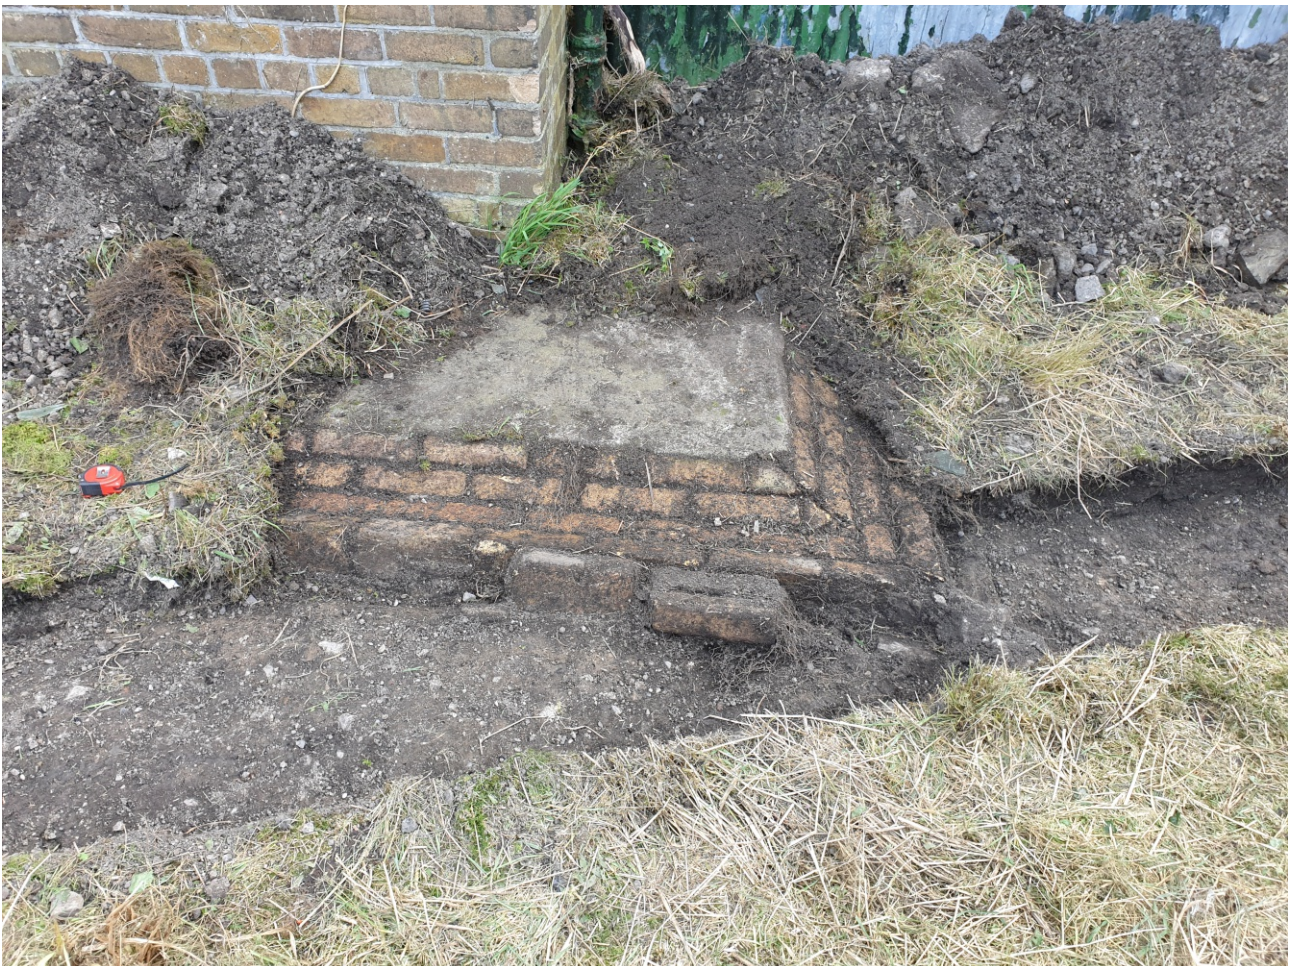
Brick surface drain around abluition room, 1901, in test-trench 2

Below this a brick surface gutter was found surrounding the concrete plinth of Building H. The gutter measured 200mm in width and was formed from four carefully-laid rows of yellow brick. The right-angle of the drain was formed by carefully-cut bricks indicating good quality workmanship. The drain was bedded into concrete and the dense clay layer below.

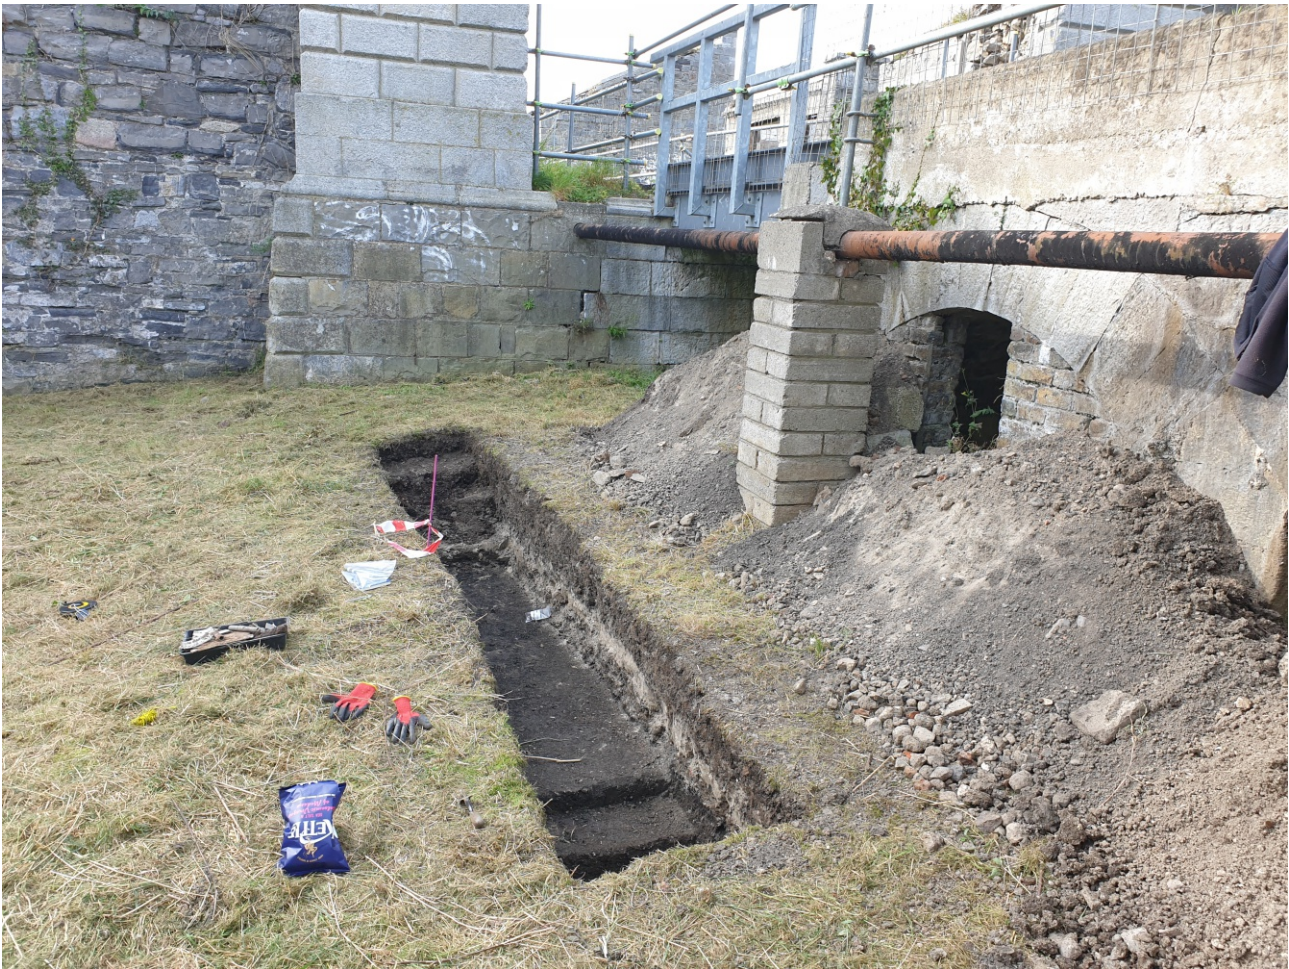
Overview of test-trench 3, facing northwest

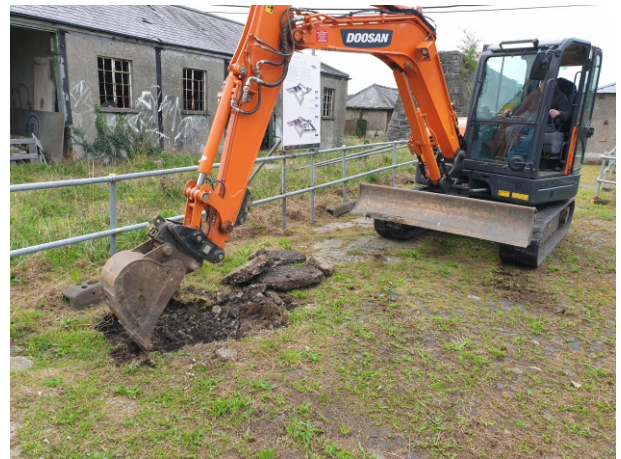
Excavation of concrete test pit 1

Located just north of the driveway through the ravelin, outside building K, abutting cobbles in the widened concrete turning area. 1m by 1m size, 120mm deep. Rough concrete slab 100mm thick. Underlying soil is a mixed greenish-brown clay with frequent inclusions of red brick demolition rubble, mortar, cinders, and small stones.
