Rathfarnham Castle Excavations 2014

LICENCE E4468

Rathfarnham Castle, Phase 6 renovation works, Rathfarnham Road, Dublin 14

Office of Public Works, 52 St. Stephen's Green Dublin 2

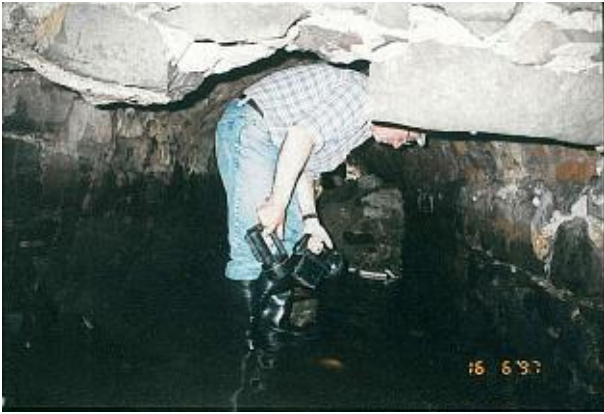
Photograph of service tunnel excavated by Judith Carroll at Rathfarnham Castle in the 1990s (courtesy of Judith Carroll). This feature was also identified during the 2014 excavations

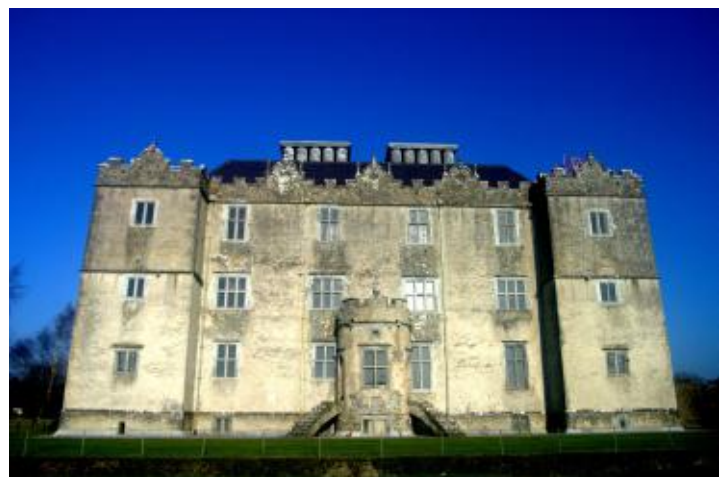
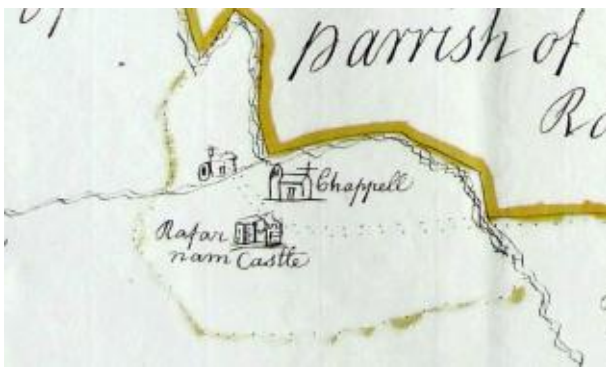
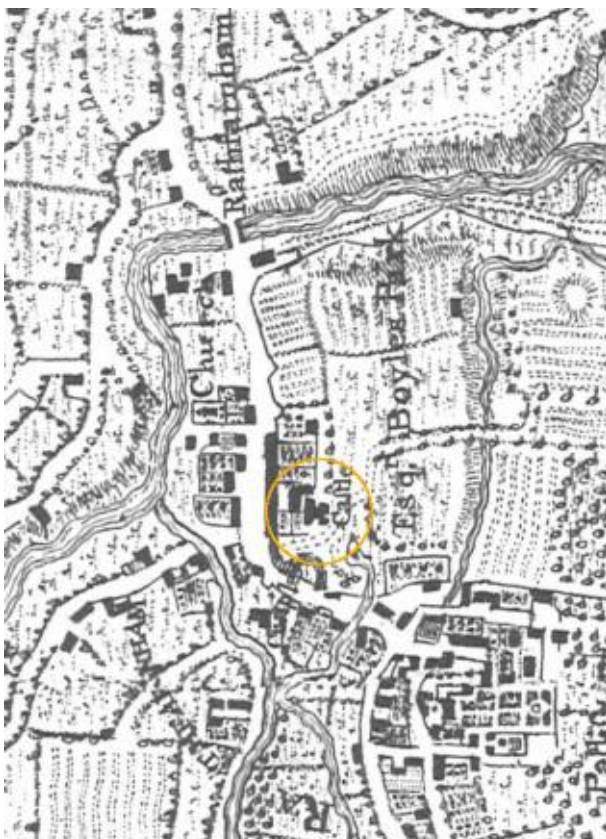
The Down Survey barony map (top) and parish map (middle) depict Rathfarnham Castle in the 1650s with crenellated towers. The church and a watermill on a small stream off the Dodder are shown nearby. Roque's map of 1760 has been rotated to show north at top. The castle is depicted with an extension centrally to the west, but the main access is from the north. An L-shaped building is shown to the northwest. A church and chapel are also marked in Rathfarnham village

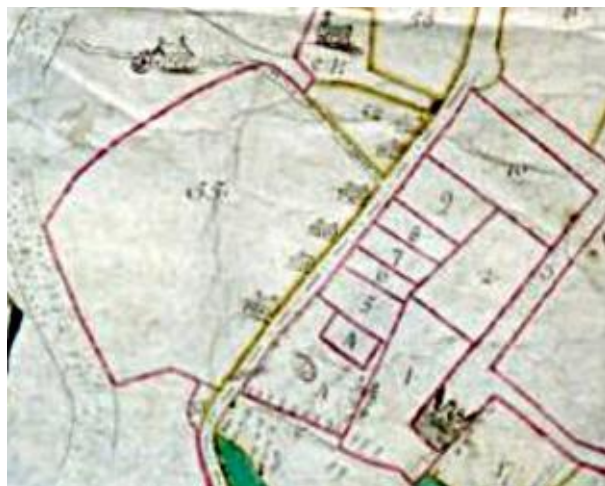
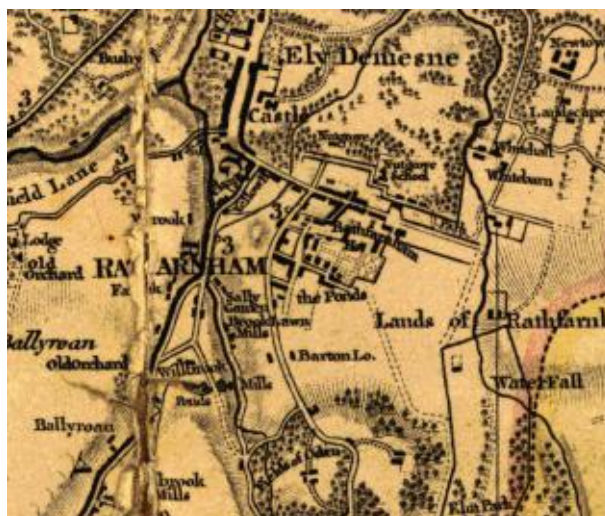
Top: extract from a map of Rathfarnham Park in the County of Dublin for the Earl of Ely, by R. Frizell, 1779 NLI Manuscript 16 G. 40 (20), showing the castle (lower right) the church and watermill (upper left)
 Middle: Taylor's map of Dublin 1816. The main access to Rathfarnham castle is still to the north but is now curves. The depiction of the castle and L-shaped building to the northwest is similar to Rocque's map of 1760
 Below: First Edition 6" map 1835-42. The kitchen wing is depicted to the southwest of the castle. The L-shaped building to the northwest is replaced by a service block

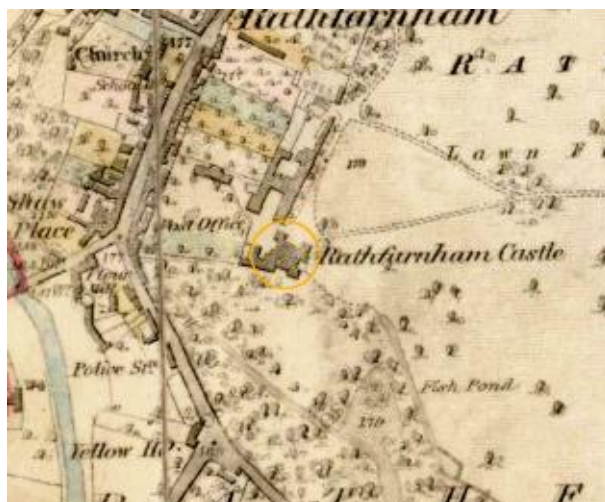
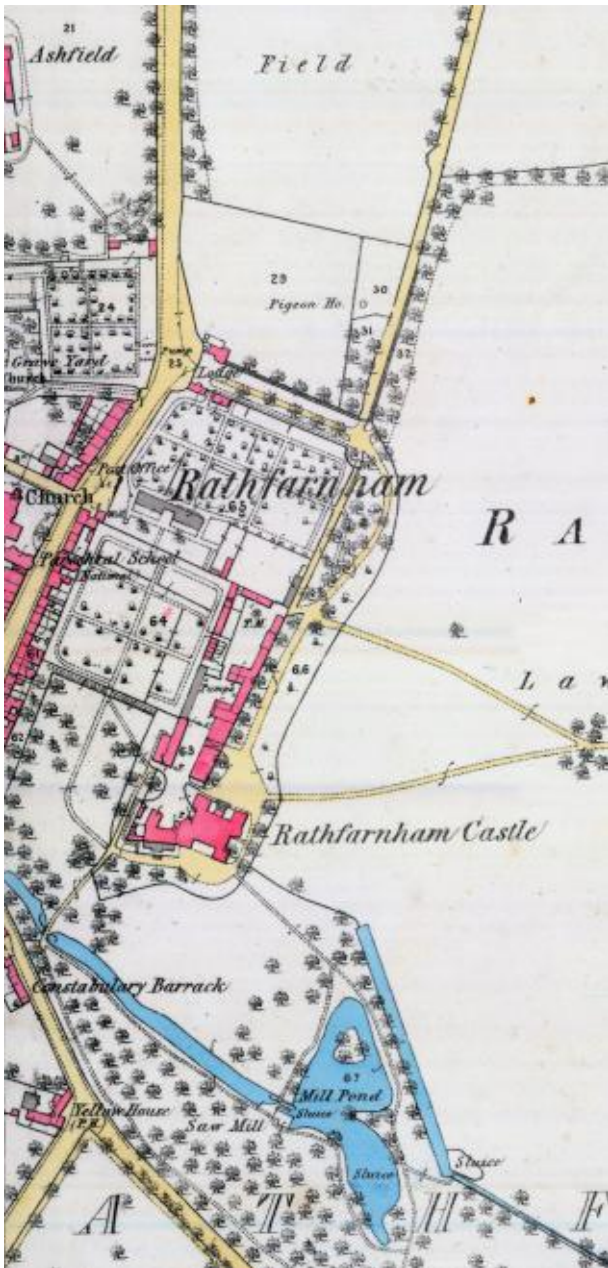
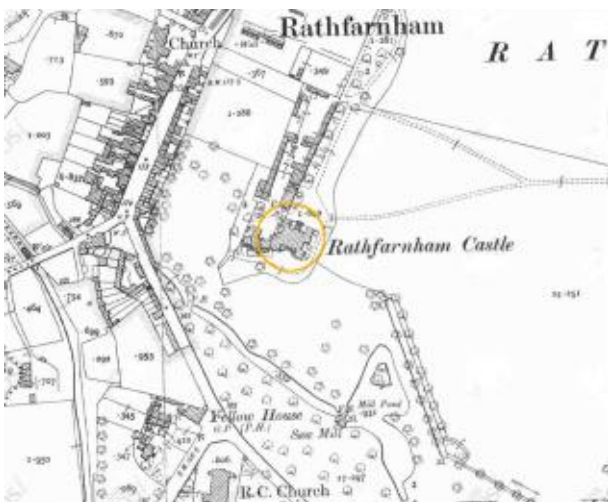
Top: Extract from 1864-65 1:2,500 Scale OS map sheets XII.6 and XII.7, courtesy of South Dublin Libraries
 Below: Extract from 1910 1:2,500 Scale OS map

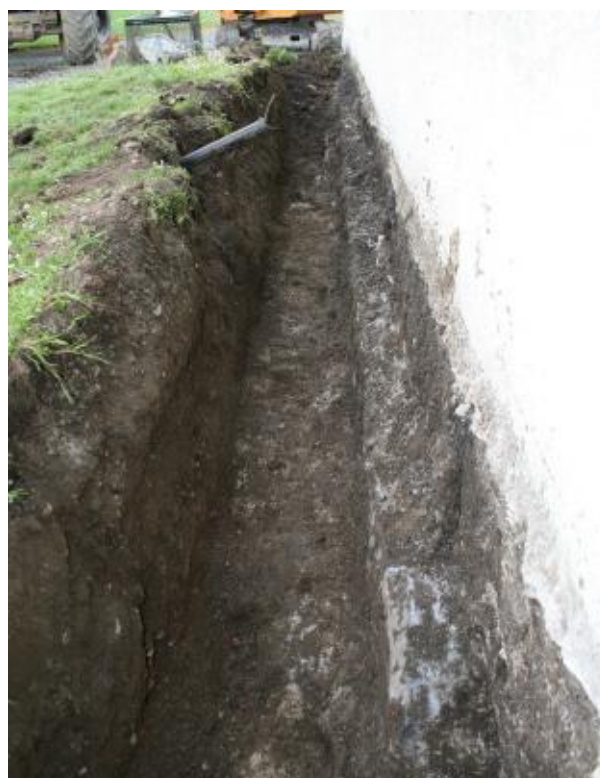
Above: foundations and ground-floor coping identified during the excavations, note how both southern flanker foundations are not squared
 Below: western foundations of the northeast flanker facing north, showing 18th century red brick cosmetic repair

The foundations of the SE, NE and NW flankers were exposed over the course of the works. The flanker towers are angled for defence and relate to the gunloops, and thus are oblique to the main block of the castle. Interestingly, the foundations were squared and aligned to the main block, unlike the flanker superstructure. The foundations extended between 200mm and 1m from the flanker superstructure in two steps. The upper spread varied in level from 100.50m OD to 99.93m OD, but the lower spread was more con-

sistent at 99.63m-99.83m. On the east façade of the SE and NE flankers lime plaster was found on the superstructure right down to the top of the upper foundation spread.

The south side of the SE and SW flankers did not have the same foundation, probably due to later disturbance which 'shaved' them back to the line of the wall. No spread at all was found on the south side of these flankers, and instead the foundations extended vertically but very roughly down to c. 98.50m OD.

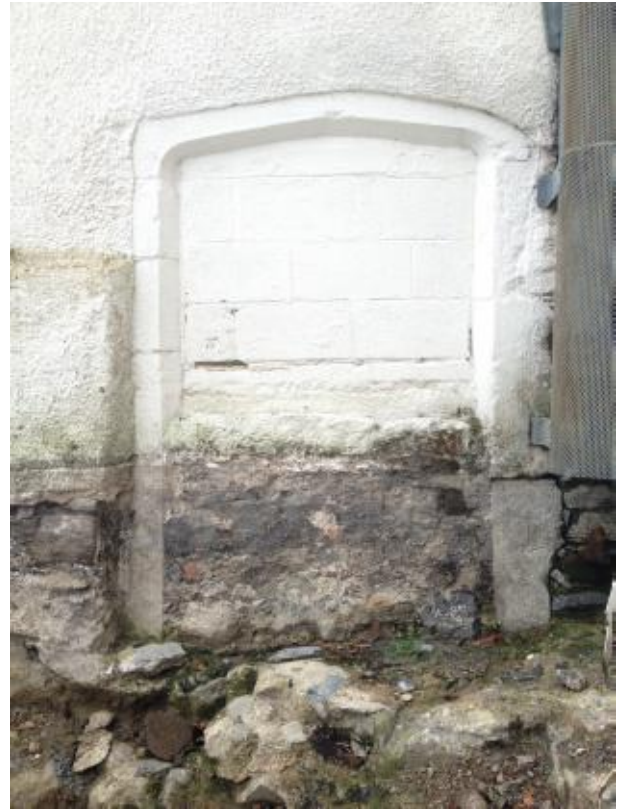
Above: 16th century doorway facing north
Below: south-facing scaled profile of southwest flanker showing 2014 ground level and results of excavations

The doorway measured 1.8m high and 1.1m wide. The dressed and pecked limestone doorway jambs all survived. Two different types of dressed stone were evident, one on each side of doorway, and the tower wall bulges out at this point, both suggestive of some level of remodelling. A large rusty iron hinge identified to the east of the doorway has been identified as holding a yett by Jane Fenlon (pers. comm. 2014), who has pointed out a parallel with Portumna Castle. A yett is a reinforced metal gate, similar to a portcullis, that swings open and closed. The hinge measured 90mm wide and 130mm tall, and was situated 120mm from the corner, 320mm from the doorway, 230mm above the later mortar surface and 310mm above the original threshold stone. A second identical iron hinge (same dimensions)

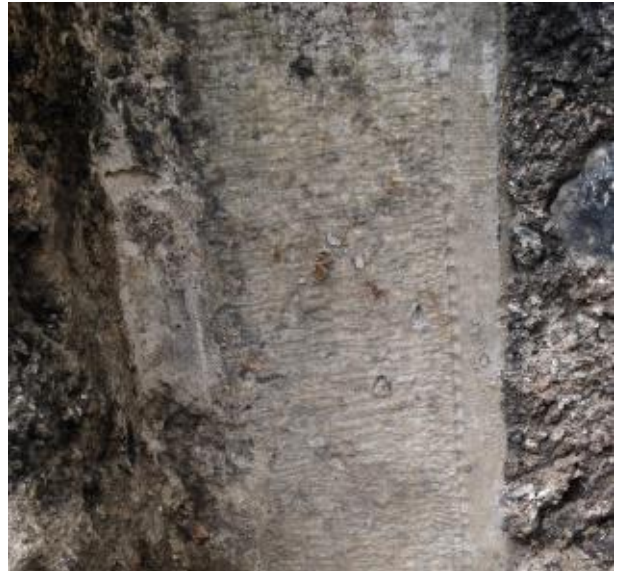
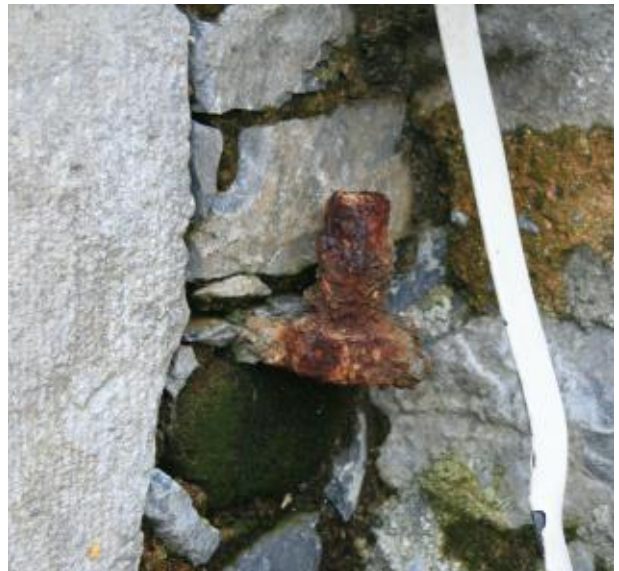
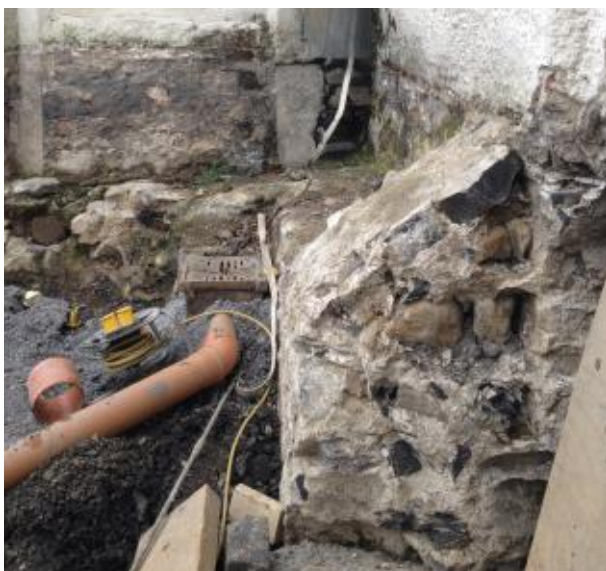
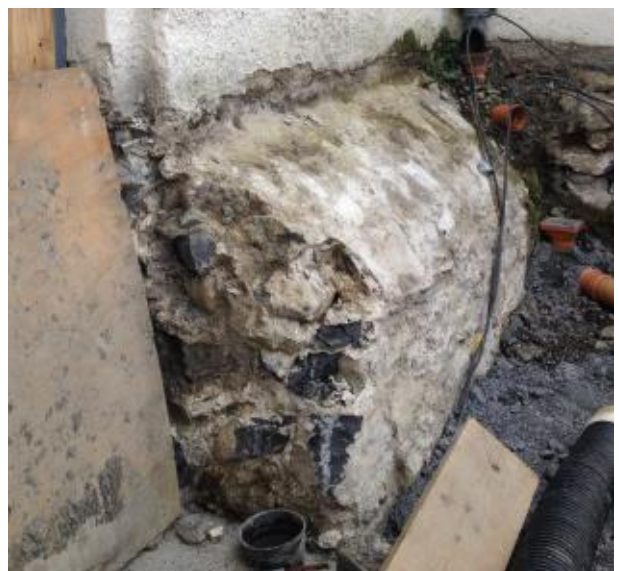
Part of the original batter of the main block was identified on the western side, near the doorway described above. This was not identified elsewhere, but may have been present at other locations around the castle. It comprised a batter 500mm thick and 600mm tall, at a 45 degree angle. The highest point is at 100.48m OD, and the lowest point of the 45 degree angle is at 99.90m OD, below which the castle wall or foundation extended straight down vertically. The 1583 ground level here to the west of the castle could not be determined (due in no small part to the 19th century cistern), but it seems probable it lay at 99.90m or lower (compared to 100.50-100.60m OD in 2014).

Above: pecking detail 16th century doorway
 Middle: iron hinge or 'yett' next to doorway
 Below left: batter or coping, facing north
 Below: batter or coping, facing southeast

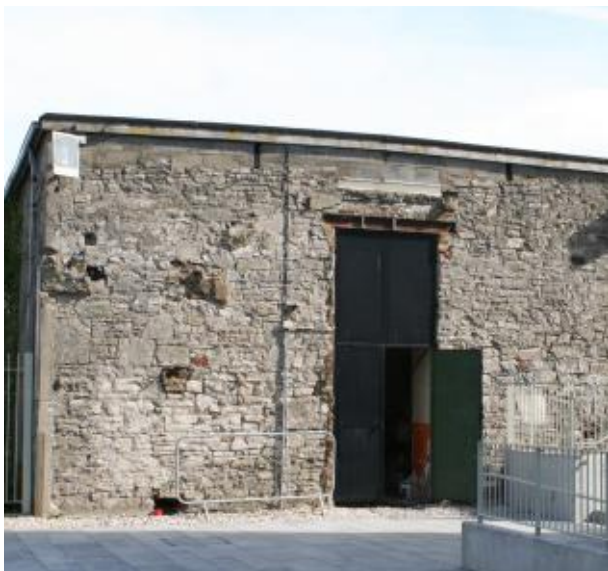
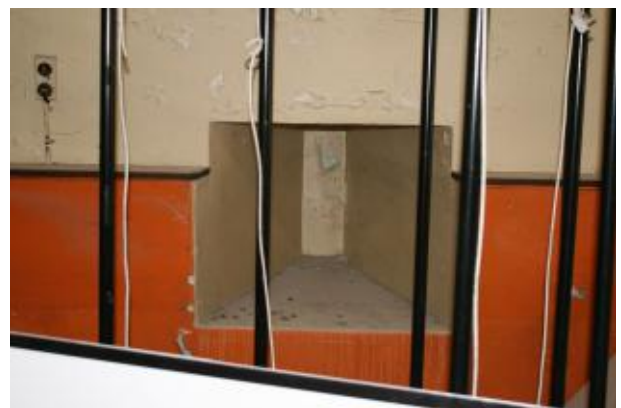
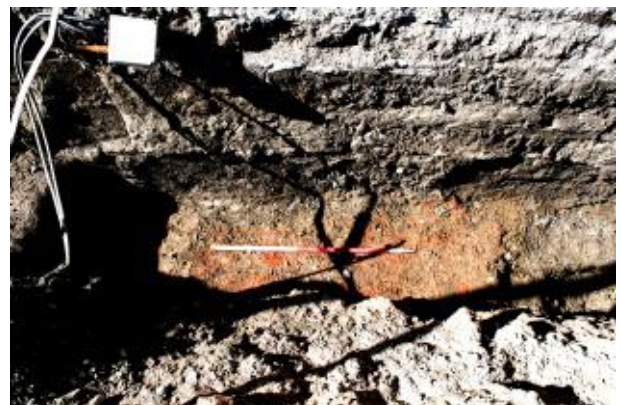
This is further supported by the finding of a substantial masonry wall abutting the NW flanker. This runs north-south 1.6m before being truncated by service c. 1990s and rests on the spread foundation of the flanker. The wall is offset 110mm east of the flanker's NW corner, but the foundation of the wall is flush with the flanker wall. The top of the wall is 400mm below ground

level while the foundation begins 1.1m below ground level (99.75m OD). The foundation extends a further 200mm to 99.58m OD and spread 150mm to the east and west. Construction is of large shaped limestone blocks identical to those of the flanker, however the foundation of this wall is very different to the flanker foundation. This wall was preserved in situ.

A possible brick kiln was identified over the northern foundations of the NW flanker along a length of some 2m east-west. The foundation spread c. 1m below the ground was covered in an olive-green sterile clay topped with packed stones

Above: wall abutting northwest flanker, facing south
 Middle: gunloop in 'Cromwell's Fort', facing east
 Bottom: brick kiln, facing south

possibly representing a temporary surface (at 99.93m OD) that extended northwards beyond the foundation spread. This was covered by a 20mm thick layer of dense brick dust and charcoal (the remains of a possible brick kiln). A thick lens of charcoal overlying this extended up the walls of the flanker 500mm, sitting directly against the masonry walls. Above this (100.43m OD) the external walls were plastered with lime. This is likely to be the remains of an 18th century brick clamp fire to manufacture low-quality bricks for use in the building.

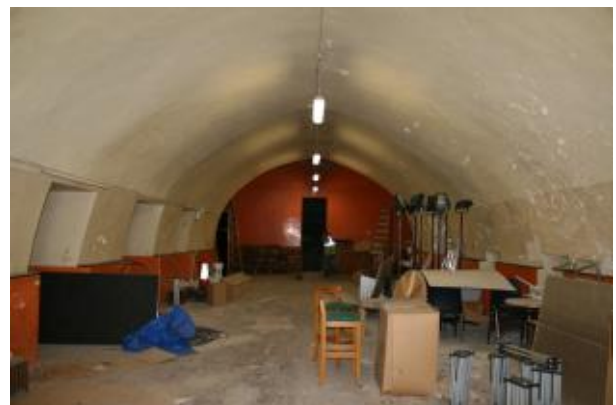
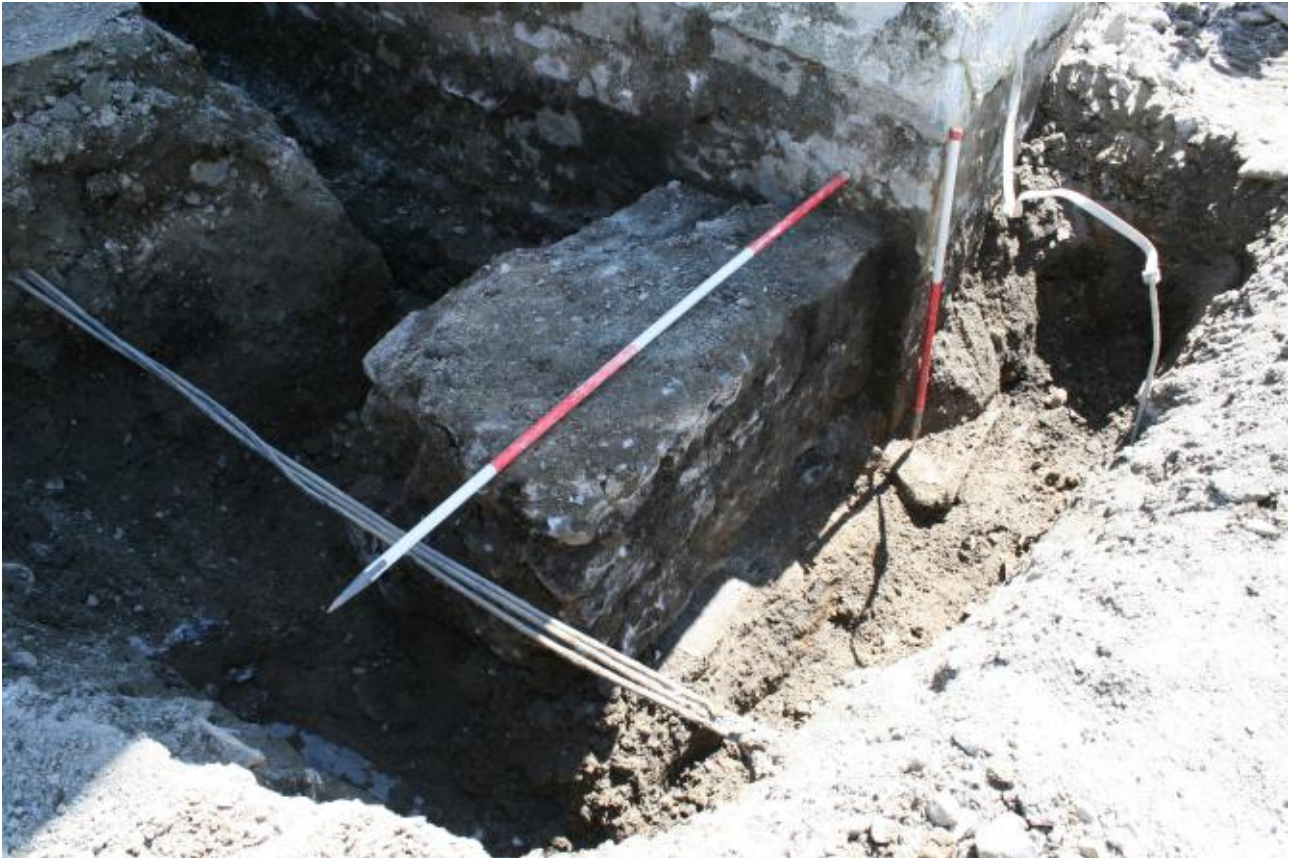
Internal inspection of this heavily modified structure identified unusually thick walls and two probable gunloops in the east wall that are very similar to the 1583 gunloops in the castle. This suggests that part of this coach-house dates to the late 16th or 17th century, and functioned as a defensive gatehouse protecting the main access from the north.

Top: location map of Cromwell's Fort
 Below: 'Cromwell's Fort' facing northwest
 Below right: interior of 'Cromwell's Fort' facing north

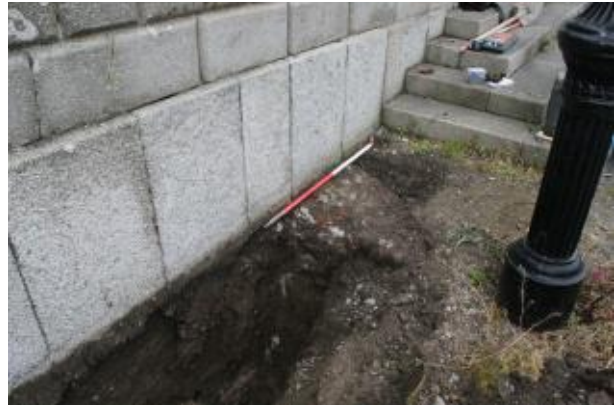
Two north-south running wall foundations were identified in front of the existing granite entrance portico. These comprised heavily damaged red brick and heavy lime mortar walls (late 18th or 19th century based on strength of mortar and bricks) at c. 100-300mm below ground level (100.43m and 100.28m OD). The western wall was situated between 3.4m and 4.95m west of the portico steps. The eastern wall was situated between 420mm and 1.24m east of the portico steps. Both ran below and were tied into the foundations of the existing granite portico. They were preserved in situ. These may be part of the 18th century entrance feature identified by Carroll in 1993 (her description is quoted in full below in the blue box), or else part of the foundations for the current granite portico.

About 5m from and directly in front of the present stepped entrance way portico was found a heavy stone construction... This seemed at first to be a wall about a metre in thickness and 11m in length. Lengthways it was roughly parallel to that of the present portico...

Above: granite portico in front of Rathfarnham Castle showing 18th century entrance feature, facing northwest
Below: location map of 18th century entrance and kiln, showing the entrance feature identified by Carroll in 1993

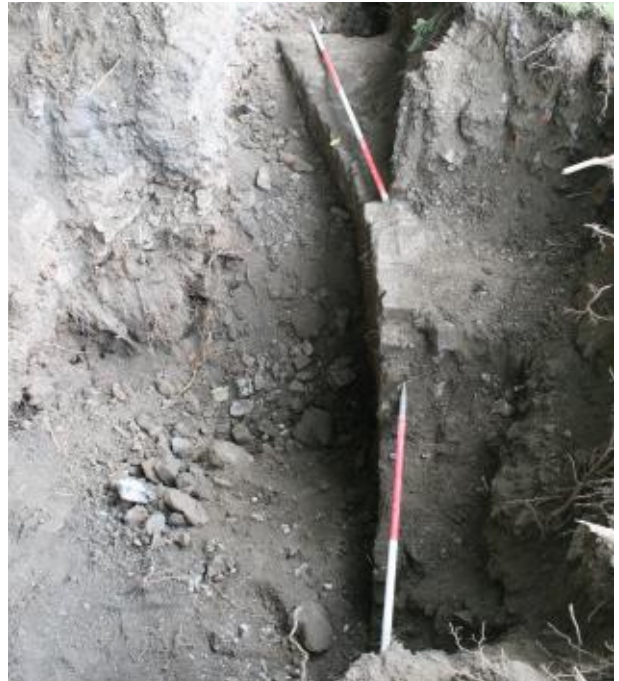
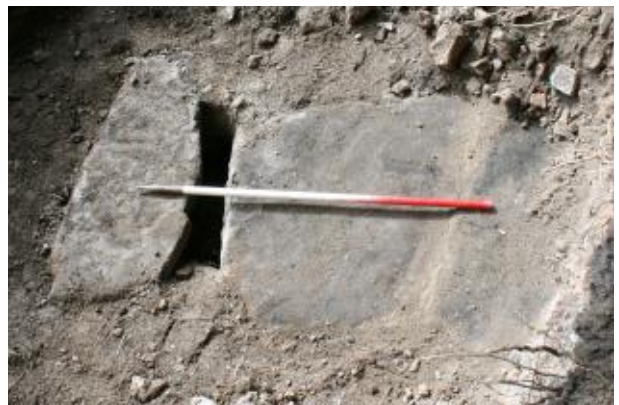
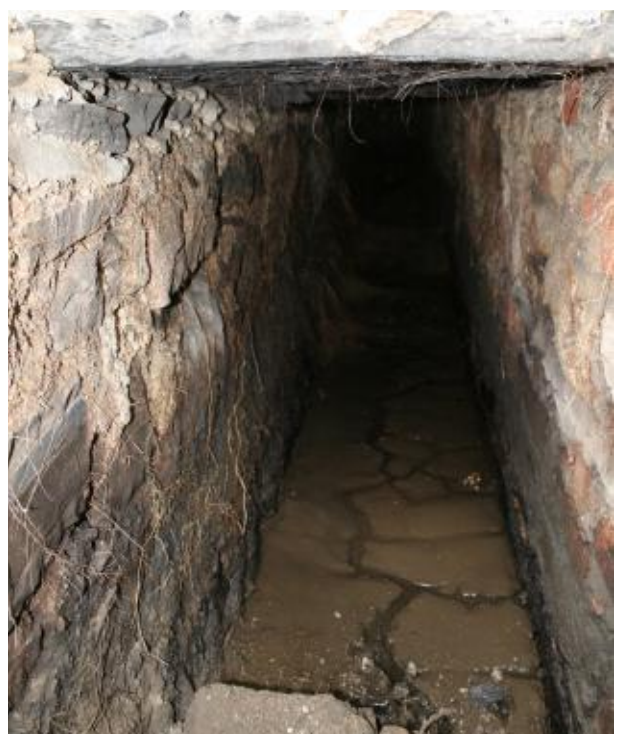
This tunnel (or tunnels) was later replaced by a large brick-lined drain that led westwards from the kitchen extension along the same line as the previous tunnel (i.e. at the same specific angle as the kitchen extension) and re-used one of the pre-existing tunnel walls. It was capped by large limestone slabs each 900mm x 800mm x 90mm at 1.1m below the ground. The construction of this drain meant that both branches of the tunnel could no longer be used. The capstones of the drain were at 1.63m below the ground and the drain measured 950mm in depth.

Above right: curving masonry tunnel wall, from above facing north. Middle: capstones of brick-lined drain, facing north. Below Right: interior of brick-lined drain, facing west, showing original tunnel wall (left) and new wall (right)

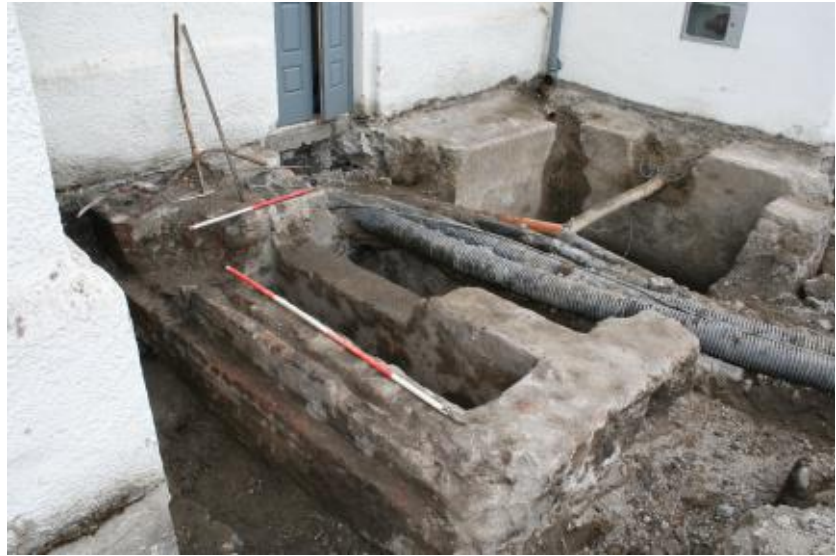
The cistern was situated 900mm west of the main block of Rathfarnham Castle, inserted in the space between the northwest flanker (850mm away) and 18th century staircase extension (650mm-680mm away). It was built directly over the foundations of the 1583 main block and flanker, and slightly damaged the coping of the main building.

The cistern comprised three chambers arranged N-S: two narrow chambers and a sub-square chamber to the south. Construction was of red brick bonded and plastered with a very hard waterproof grey cement. The two narrow chambers measured 2.35m east-west and 590mm north-south internally, and the larger chamber measured 2.6m north-south and 2.4m east-west. The dividing walls between the three chambers were 350mm thick. The cistern survived to a depth of 1.5m. The top of the cistern survived to a height of 100.23-100.33m OD. The base of the chambers was consistent at 98.86m (north chamber), 98.861m (central chamber) and 98.85m (largest southern chamber).

A series of five spaced holes, which tapered south to north from 3" (76mm) to 2", connected the bases of the northernmost two narrow cistern chambers. A sixth hole in the northernmost chamber did not come through to the central chamber, and may have returned east under the building but this could not be established.

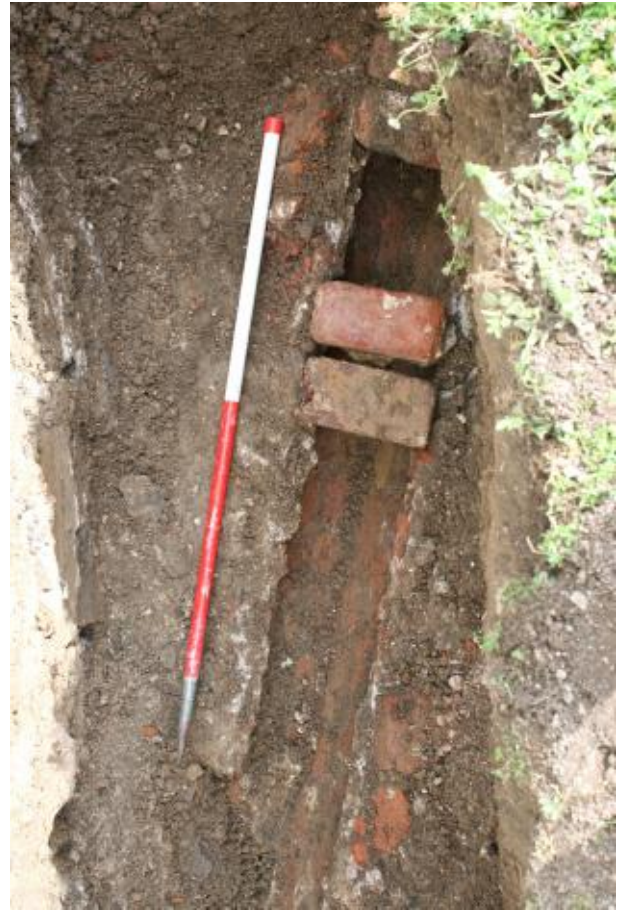
Left: tin grates from cistern
Above right: drain 2 to east of castle, facing north
Below right: location map of features east of castle

The second drain ran northeast-southwest and was truncated by the mid-18th century semi-circular extension to the east of the castle. Construction was a V-shaped brick channel made of three bricks on each side 230mm by 110mm by 50-60mm, handmade clamp fire bricks of varying colours, consistent with a pre-1750s date. The drain was capped with bricks laid side by side. It measured 200mm wide at the top and 200mm tall. This survived for at least 1.7m in length (truncated to SW) and was encountered at 1.05m below topsoil, 99.50m OD. This drain was preserved in situ.

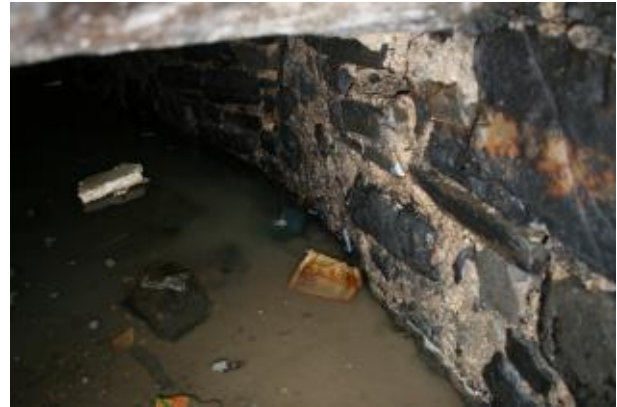
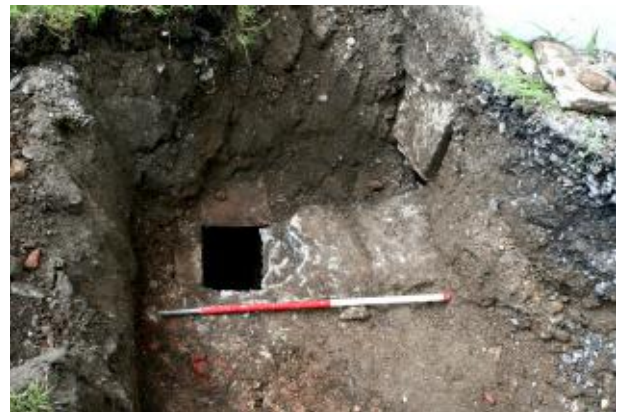
The fourth drain was the most interesting one. This was a large stone-lined drain running south-east-northwest from the northeast corner of southeast flanker. This drain truncates the foundation of the southeast flanker so it is not original to the 1583 castle, and probably dates to much later. This drain was heavily modified by the insertion of a manhole for the third drain (see above). This drain is constructed entirely of stone and measures 750mm tall and c. 850mm (min) wide, with the top of the capstones at 99.425m and the base of the drain at 98.495m OD. It ran SE-NW and had a clear kink in the northeast wall returning to the west, situated 1.1m east of the east wall of the flanker and 620mm north of the north wall of the flanker. It is possible that this drain represents part of the 'canal' marked on 18th century cartographic sources near this location. This drain was also identified by Carroll (1994, 4).

Above top: view into drain, 4 facing southeast
 Above middle: drain 4 capstones, facing south
 Below right: location map of features west of castle

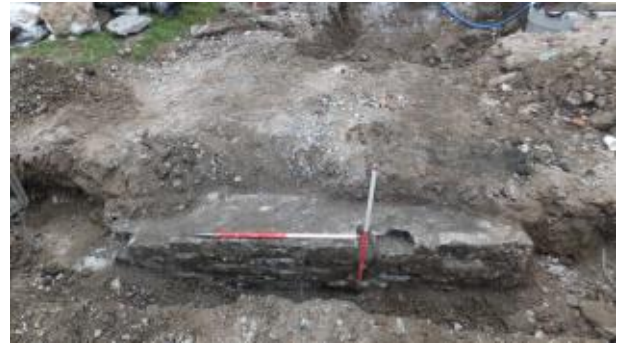
Top: masonry wall south of southwest flanker, facing nnnw
 Below: overall plan of findings outside the castle showing location of wall to south. Note how it matches the alignment of the 18th century kitchen wing extension, shown here in yellow in the lower left of the map

A corner of a masonry structure was identified 8m to the south of the southwest flanker. It survived for 3.2m in east-west and returned to the north for 7.4m towards the tower, but was badly truncated by the foundations of the Jesuit wing. It was almost exactly aligned to the 18th century

kitchen wing extension. It survived to two courses in height (520mm) and was encountered 220mm below the existing ground surface. It measured 500m in width. The foundations of the wall were not inspected. Despite the absence of red brick in its construction, its narrow width and alignment suggest is dates to the 18th century and is contemporary with the kitchen wing.

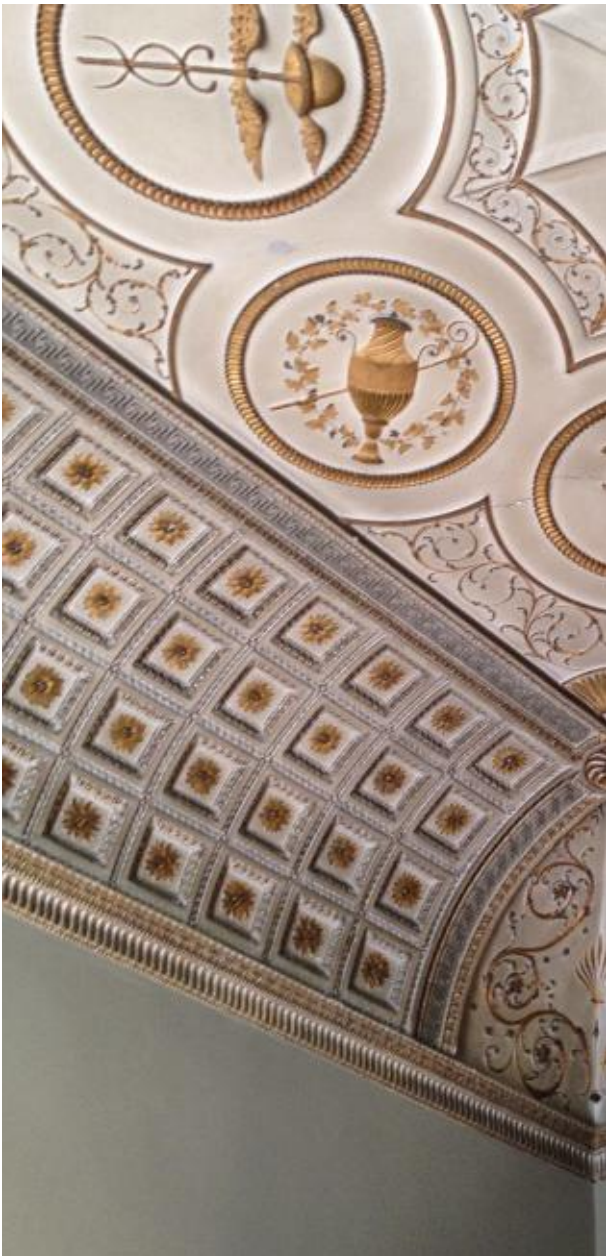
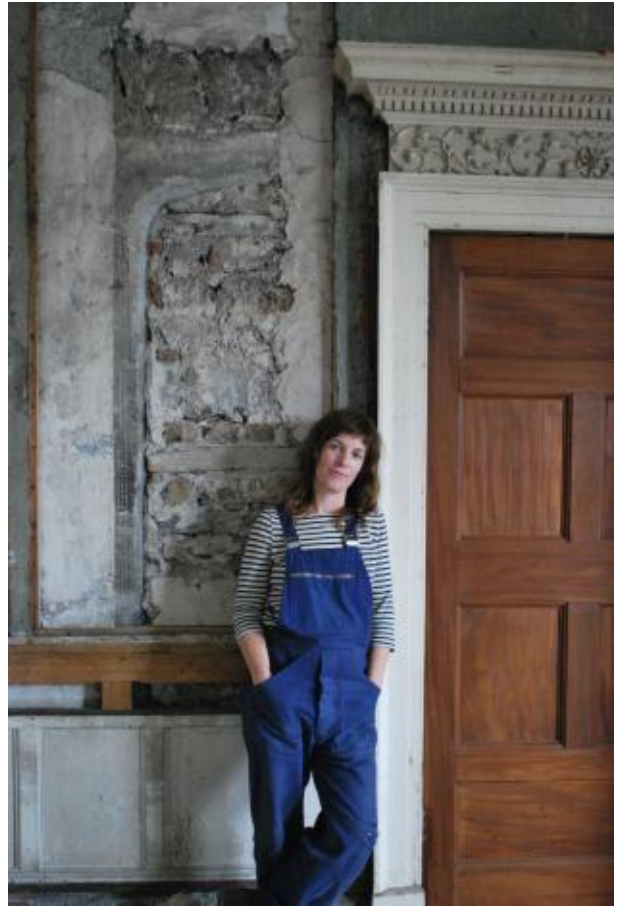
Above: archaeologist Alva Mac Gowan leans against the 16th century doorway in the main block ground floor, to the left. The 18th century doorway which replaced it is visible to the right. Facing north
Below: timber panelling in main block ground floor
Left: detail of 18th century plasterwork

The 16th century doorway provided access to the SE flanker, and had been replaced by the current doorway in the mid-18th century or earlier. The door jambs are dressed and pecked limestone just like the 1583 doorway identified in the NW flanker basement. This doorway is almost certainly original to the castle, and it confirms that the 1583 floor level of the castle is approximately

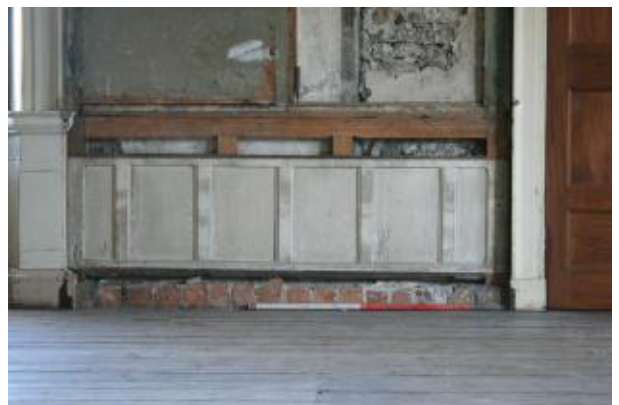
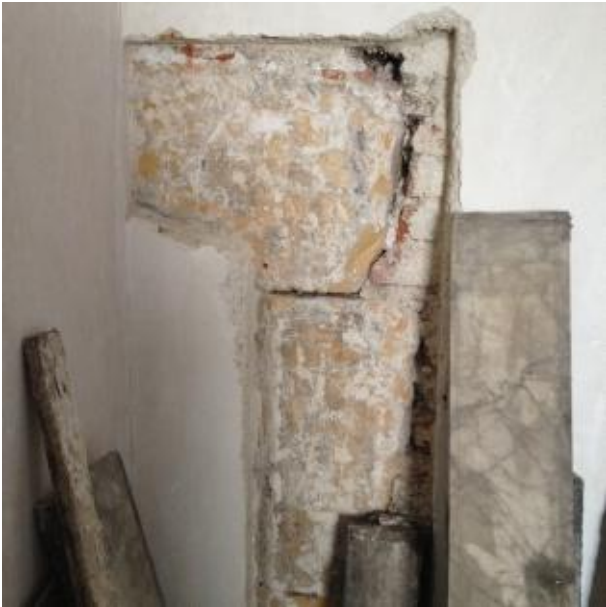
the same as the existing ground floor level. The door measures 2.25m high. Barbara Kenny (pers. comm. 2014) has pointed out that the timber panelling set directly in front of the 16th century doorway has been placed upside down and has thus been re-used from elsewhere when placed here (perhaps in the mid-18th century).

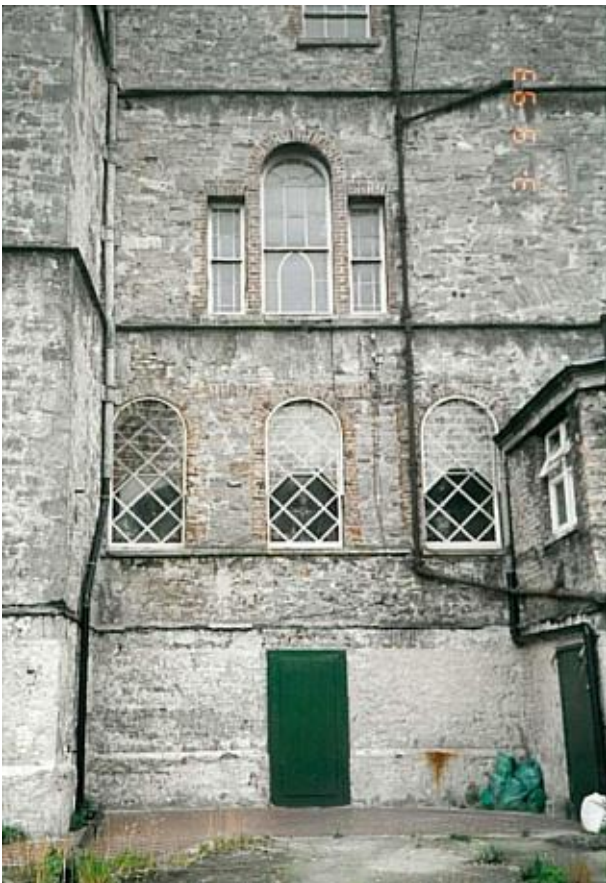
The possible 16th century fireplace is situated in the top floor of the main block, set into the south-facing side of the spine wall adjacent to the SE flanker. Only the eastern part of the fireplace frame is visible, comprising three shaped chamfered jambs of yellow sandstone that make an opening c. 1.35m in height internally. It is unclear if the fireplace is in situ, as the spine wall

Above left: 16th century fireplace in main block
 Below left: west facade of main block
 Above: window in facade of main block, facing west

around the fireplace frame has been rebuilt in red brick. The red brick is very thin, however, and could be of 17th century date. If the fireplace is in situ, the basal stone of the fireplace would suggest that the existing second (top) floor of the main block is at the same level as in 1583.

Barbara Kenny, former OPW Senior Architect at Rathfarnham Castle, provided a photograph of the west façade of the main block during OPW works on the external render in 1993. Most of the external wall is masonry. A horizontal building line runs at ground floor level but continues along the mid-18th century staircase extension so is not original. Three round-headed windows on the ground floor and the round-headed window and two smaller flanking windows on the first floor are lined with brick. Brick arches are visible between the ground floor round-headed windows, probably to support the existing window arches. A large masonry arch is visible centrally in the western façade, located between the first and second floors. This may represent an original feature of the castle.

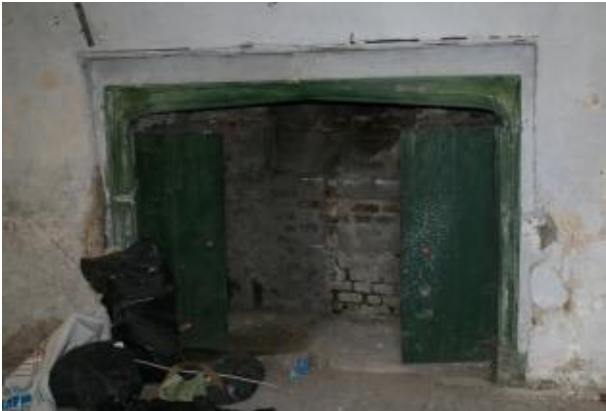
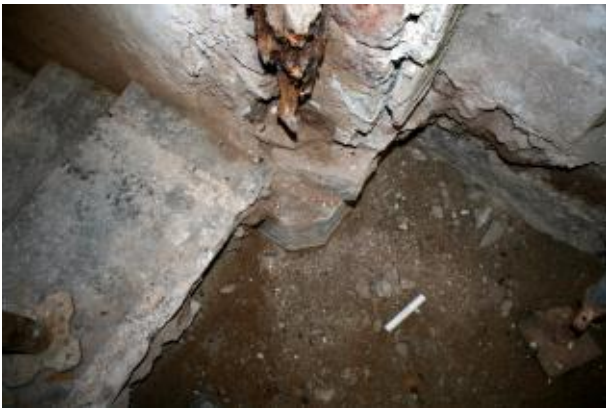
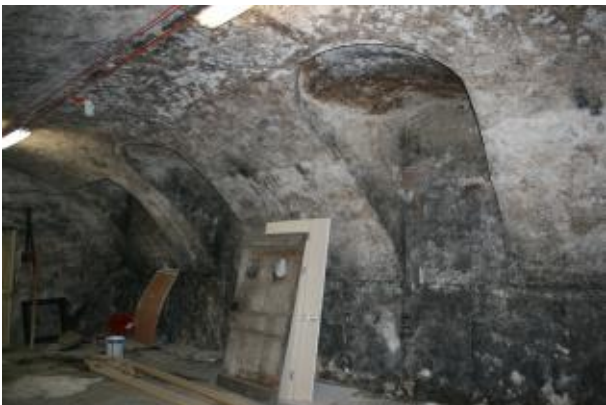
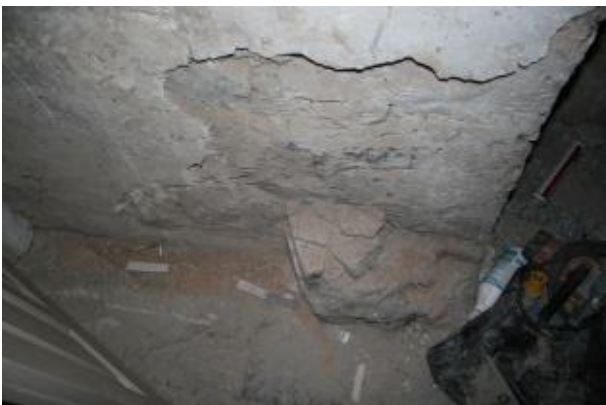
The most significant implication of this finding relates to the basement fireplaces. The two existing fireplaces in the long southern room cannot be original. The central medieval-style fireplace with pecked limestone jambs is almost certainly an 18th century insertion, either newly-carved in a medieval style or else re-used from elsewhere. The style of carving on the frame is very different from the other 1583 fireplace and doorway jambs from Rathfarnham.

Above: 18th century fireplace
 Second from top: 1583 door jamb found below paved floor
 Third from top: blocked former opening in northern basement
 Bottom: possible step of former stone staircase

tending past a later N-S dividing wall in the east. These are spaced evenly on either side of the centre line of the castle and each measures 4m long and 1.2m high, and they are spaced 1.25m apart. Originally interpreted as low cupboards, they can now be re-interpreted as a pair of huge fireplaces or possibly ovens each 4m wide and 2m tall in the largest room of the basement, which probably functioned as the kitchen in 1583. This pair of fireplaces have been blocked with masonry, most likely when the floor level was raised. The raising of the basement floor level in the first half of the 18th century is therefore most likely associated with a major renovation to the basement kitchen, and its relocation from the north to the south of the castle.

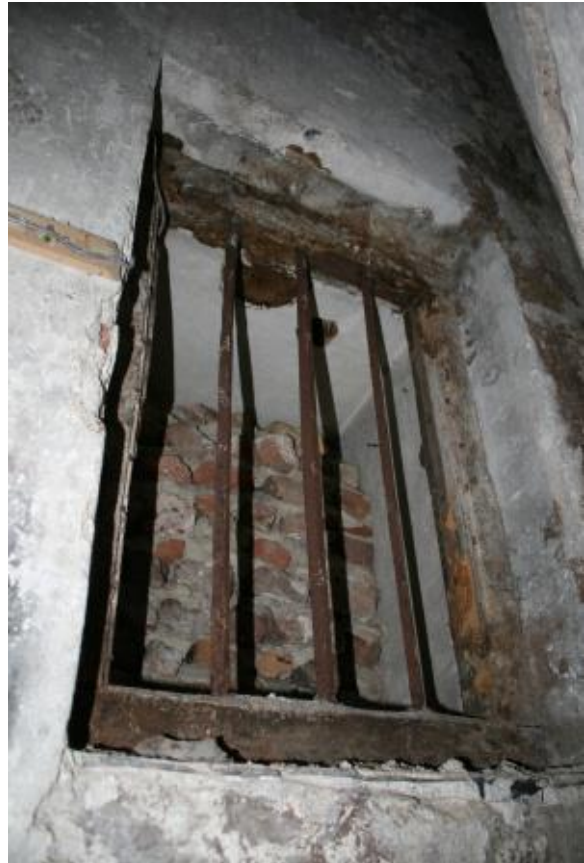
Left: stump of wall in western part of basement
Above: possible 17th century in southwest flanker, identical to the one in the main block
Bottom: removal of 18th century floor

The final finding in the basement of the main block is a timber-framed small rectangular window at ground floor or first floor height with metal bars in the southern side of the west-facing external wall of the main block. This has been covered up by the mid-18th century staircase extension, and is only visible from within the basement. A very similar window in the SW flanker tower is visible between the basement and ground floor. The flanker tower timber-framed window probably replaced a 16th century gun-loop. Both windows may be 17th century in date.

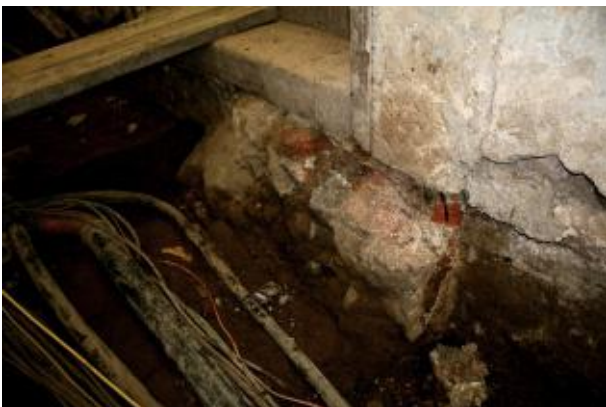
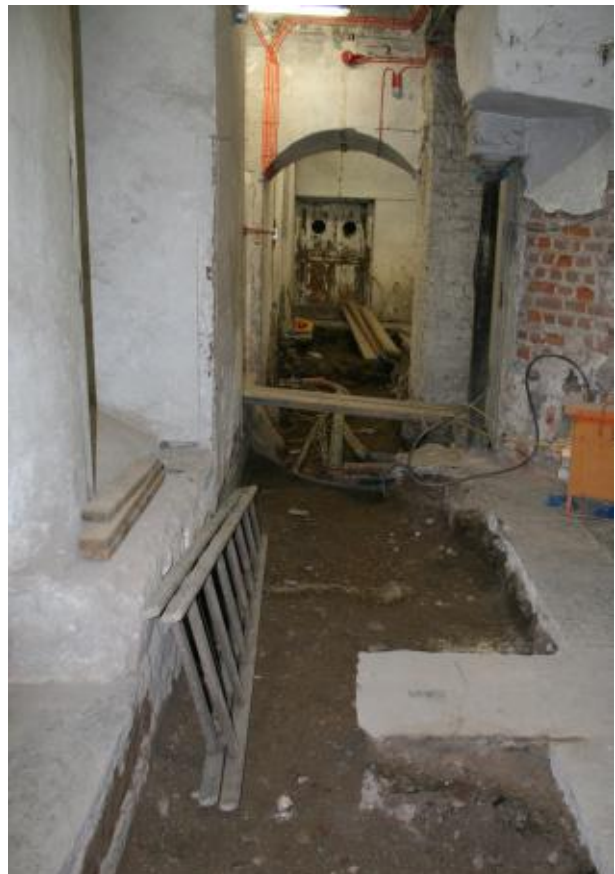
The foundations of a 1.35m thick wall was identified in the basement, running east-west and tied into the original western wall. This is an extension of the spine wall running all the way to the west wall of the castle. It is pierced by 20th century services, and was preserved in situ. It's presence demonstrates that the eastern end of the spine wall does not match the western end, suggesting only a single internal stairs at basement level.

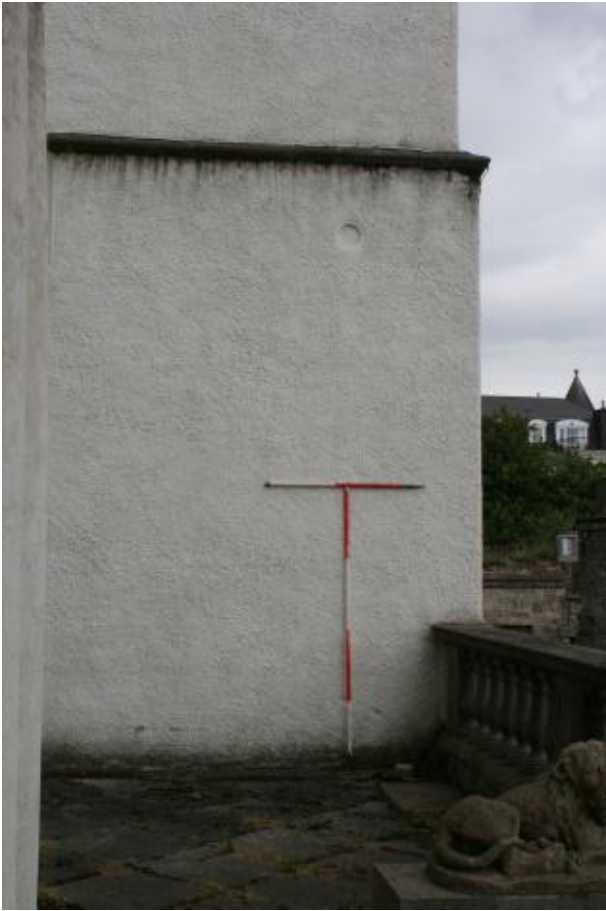
Above: external gunloop in east facade of northwest flanker, facing west
 Below: external gunloop in south facade of northwest flanker, in top of image, showing basement entrance, facing north
