Rathfarnham Castle Excavations 2014

LICENCE E4468

Rathfarnham Castle, Phase 6 renovation works, Rathfarnham Road, Dublin 14

Office of Public Works, 52 St. Stephen's Green Dublin 2

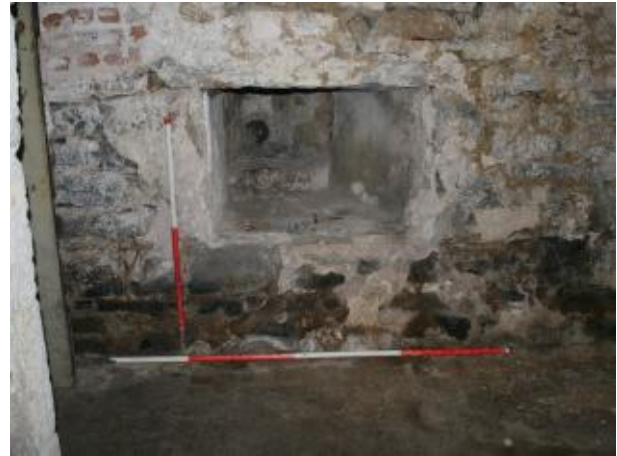
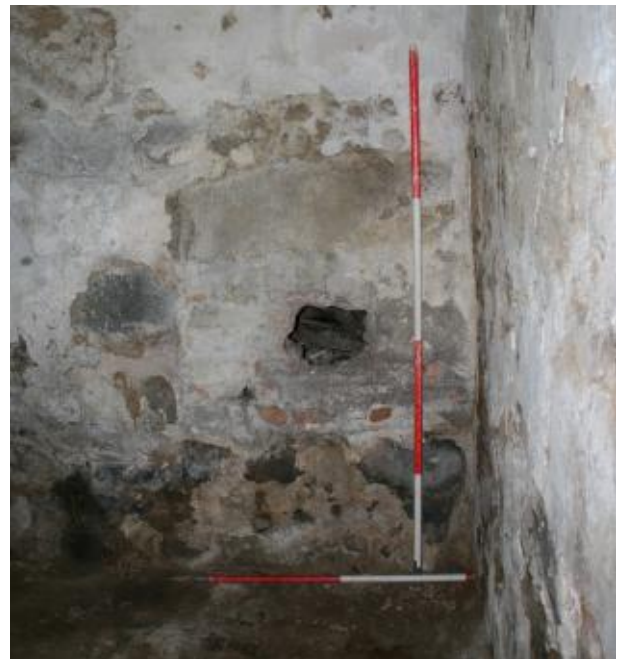
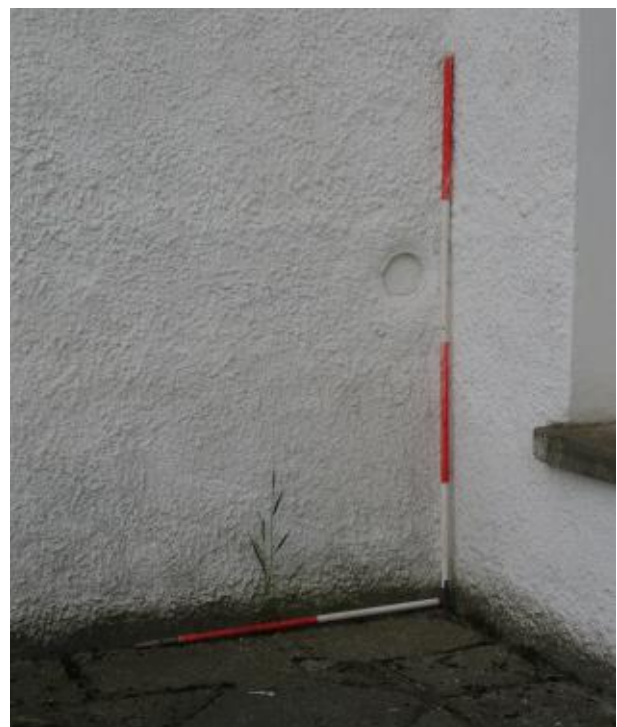
Top: northeast flanker internal gunloop 1
Middle: northeast flanker internal gunloop 2
Bottom: northeast flanker external gunloop

The first gunloop is located in the southern part of the western wall. It measures 1m (plaster to plaster) or 1.12m (stone to stone) wide, and 700mm (stone to stone) tall, splaying inwardly to the right to 200mm wide and 400mm-plus tall. It is 1.66m deep and ends in a central circular aperture 6" in diameter. It appears to have been blocked 880mm into the wall and then heavily plastered internally. The base of the gun loop opening is 580mm above the current floor. It is situated 300mm from the doorway. The loop is at about 100.6m OD, approximately the same level as the external foundation spread.

The second gunloop is located in the northern part of the western wall. It is blocked with hand-made red brick and heavy lime mortar. It measures between 1.07m and 1.12m wide (from the corner of the room) and 660mm high. The base of the gun loop opening is 620mm above the current floor. A hole in the blocking suggests it reaches 1.40m deep. It is situated 2.5m from the first gunloop and is at about 100.6m OD.

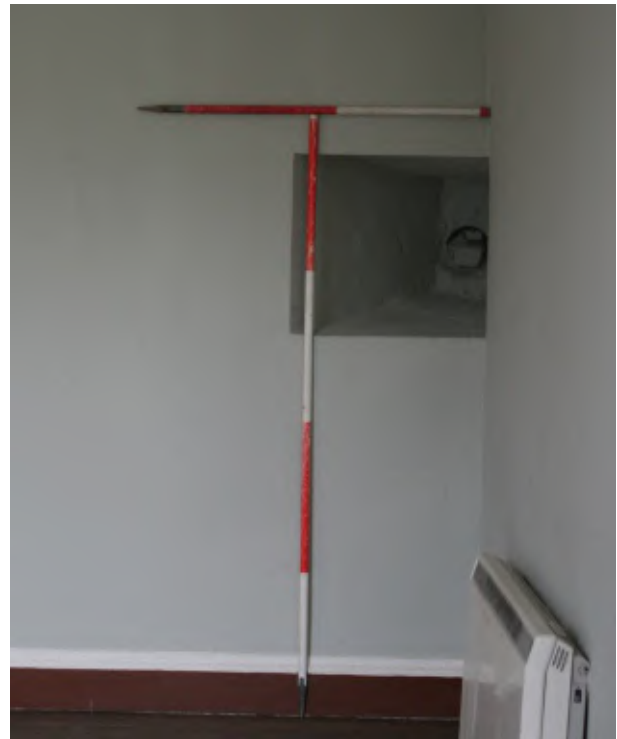
Above: gunloop in 'Pistol Loop Room' on first floor of southeast flanker, facing north
Below: features identified in basement of southeast flanker

A known gunloop on the first floor was recorded. This gunloop is visible from the interior and the room is known as the 'Pistol-Loop Room'. The gunloop is located at the eastern end of the north wall, right in the corner, and points north. It measures 800mm tall and 680mm wide, splaying inwardly to the left to 190mm wide and 430mm tall. It is currently 1.27m above the floor. The circular aperture 160mm (6.5") in diameter sits centrally in the loop at a depth of 930mm. The loop is at about 109.42m OD, a level which does not match any of the loops identified in the southwest flanker or elsewhere in the castle.

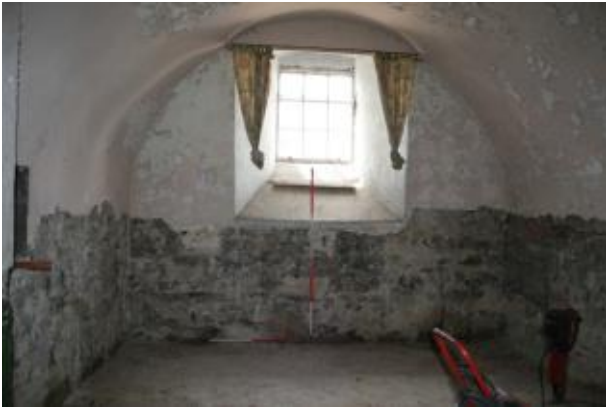
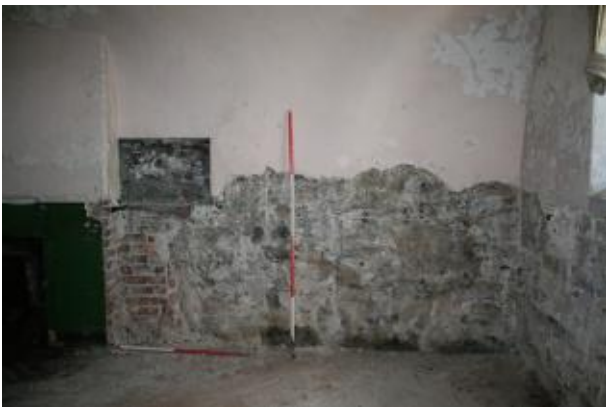
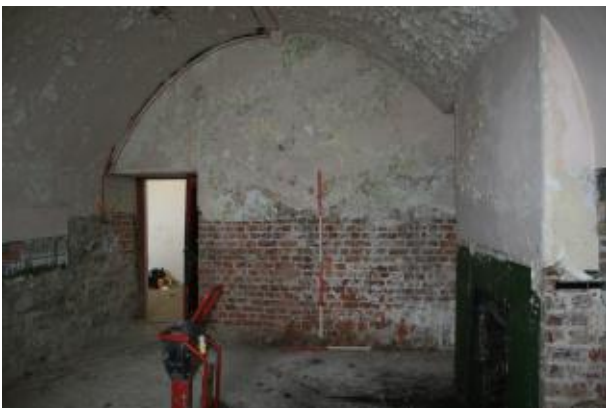
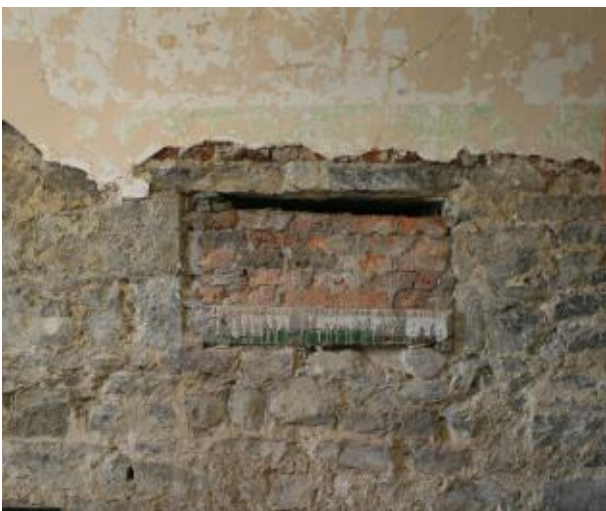
Southeast flanker prior to excavation. From top: south wall showing window and original stone vault; east wall showing original masonry to right and later brick repair/straightening to left, with modern nook and fireplace to far left; north wall showing red brick, doorway and corbel in ceiling; and blocked gunloop to north in west wall

The south wall comprises original masonry. It is pierced centrally by a window that begins 1.40m above the floor and measures 1.95m in width and splays inwards. The top of the window opening is at the same level as the ceiling of the vault, and is arched like the vault. The window embrasure at the internal wall face appears to be original, but the current size of the window in the exterior face of the flanker has probably been enlarged and 18th century brick is visible at that point.

The east wall comprises original masonry in the south, but to the north a chimney and fireplace has been constructed out of red and yellow brick and the break for this insertion is visible in the wall. A date '1960' has been carved into the fireplace. A modern shelf or small nook has been inserted just to the right of the chimney. The northern half of the masonry east wall has been rebuilt and straightened using red brick.

The north wall (and northernmost part of the east wall, north of the chimney breast) comprises bright orange-red brick bonded with lime mortar (one piece of masonry noted at 1.50m), and is probably of 18th century date. Coursing is consistent: header course, alternate, alternate-offset, alternate, stretcher course, alternate, alternate-offset, header course, etc. The square-headed doorway through to the main building is contemporary with this wall.

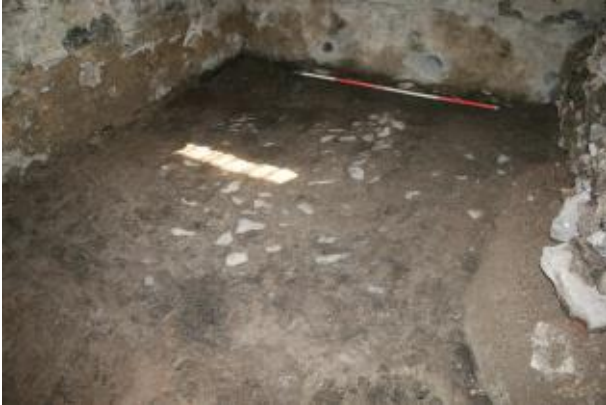
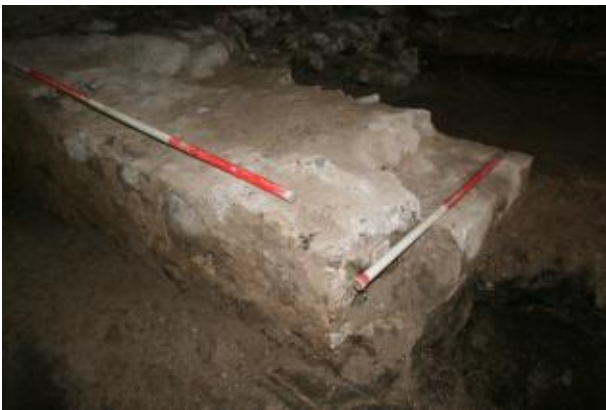
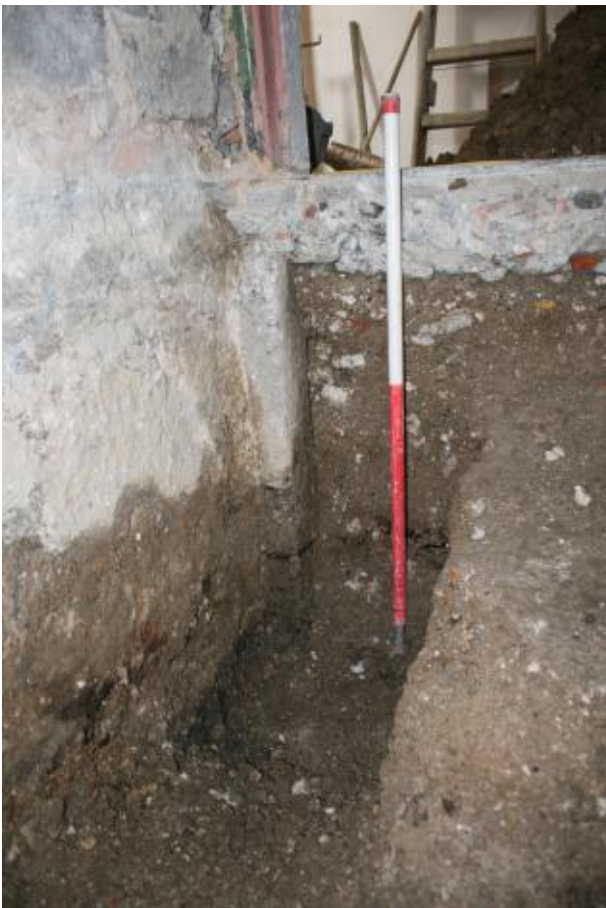
Top: 16th century cobbled or paved stone floor
 Middle: 16th century masonry block - 'oven'
 Below: 16th century doorjamb below 18th century floor

700mm below the existing floor of the flanker. This is constructed of decomposing limestone, and is very rough and not remotely flat, resembling more an external cobbled surface than a finished internal floor. The pavers/cobbles measure 100-200mm in diameter and are angular in shape with a flat polished upper surface. The floor is relatively level, but slopes noticeably down by 100mm towards the northwest, where a drain may have once been located under the floor.

The original doorway into the southeast flanker from the main block was identified. This was in the same location as the existing doorway, at the west end of the north wall. Simple chamfered doorjambes were found on either side, surviving three stones high, sitting directly on bedrock at 1.05m below the modern floor. The upper part of the doorway was demolished but one fragment (E4468:10:34) was found in the demolition rubble.

A large limestone masonry feature was identified below the modern floor, situated in the northwest corner of the flanker. This measured 2.40m north-south by 3.45m east-west and took up just under a third of the available floor space in the flanker. The feature was set into a foundation cut dug into natural subsoil and the lowest stone was at 98.85m OD. It survived to a height of up to 650mm above the 1583 floor (99.65m OD). The oven was truncated just below the level of the modern floor, so it was originally higher, most likely rising right up the ceiling. It probably supported the vaulted ceiling, as is suggested from the later posthole to the south and later alterations to the ceiling. The 1583 floor abutted the feature, which means the feature is original to the castle. Several of the stones in the centre of the feature showed signs of burning.

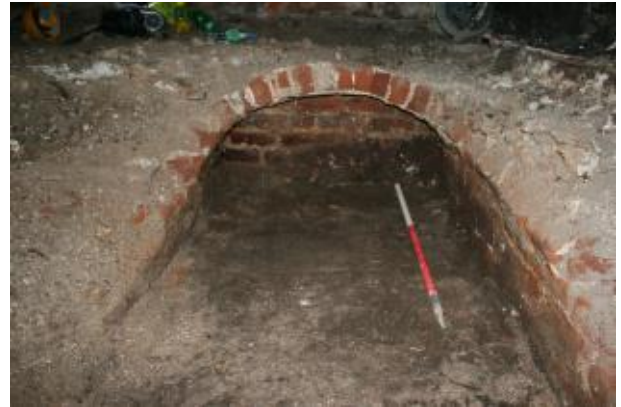
Above and below: 18th century brick-lined feature. The large paving stones at the base may belong to the 16th century oven

A small brick-lined and roofed space was identified below the modern floor at the eastern end of the flanker. The feature was lined with brick bonded with a very hard lime mortar on the north, west and east sides but no lining was found on the south side. The brick arch roof was broken. The feature was set into the truncated masonry oven, which had been broken roughly to facilitate its insertion. It predated the later fireplace and chimney flue in the west. The brick-lined space measured 1.65m N-S by 1.08m E-W and was floored with heavily polished large flat slabs (450mmx600mm) of very good quality set at the same level as the 1583 floor (750mm below 99.750OD).

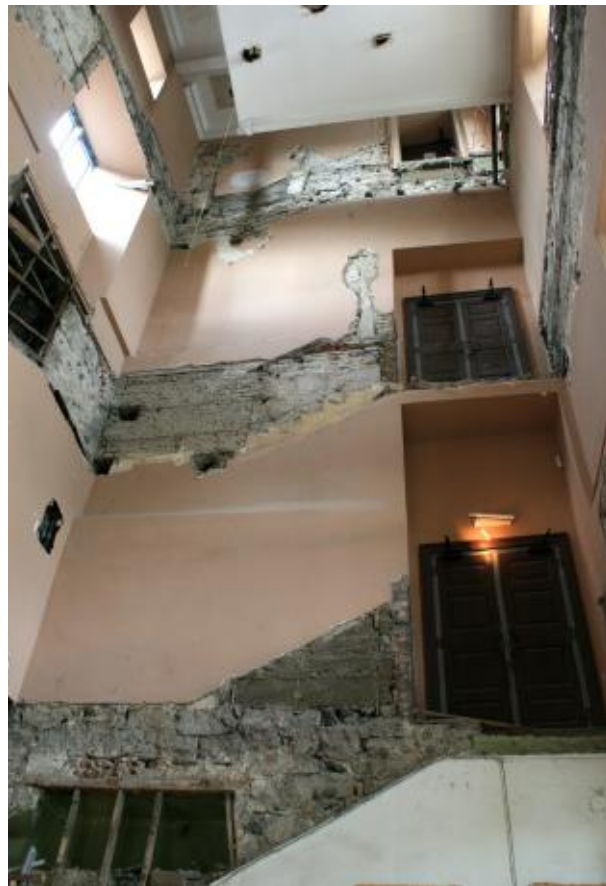
Above: view of north internal wall of flanker. The pink render is 20th century plaster, and earlier features are visible where this has been removed. The scars of the 20th century staircase are visible

Below left: external view of southwest flanker facing northeast, showing 16th century windows W10 and W12

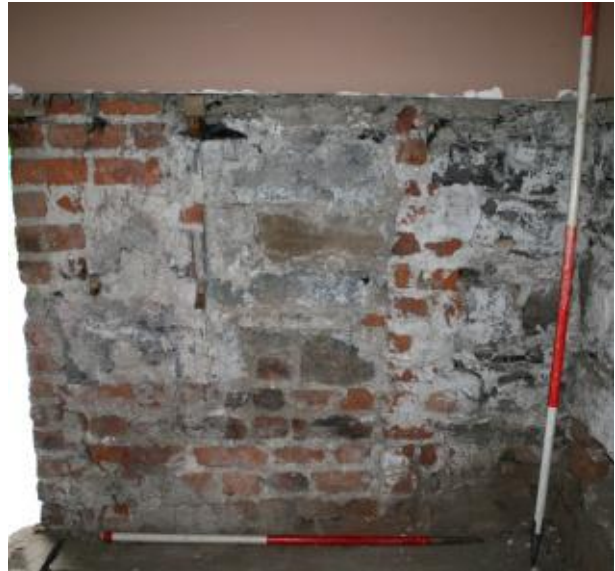
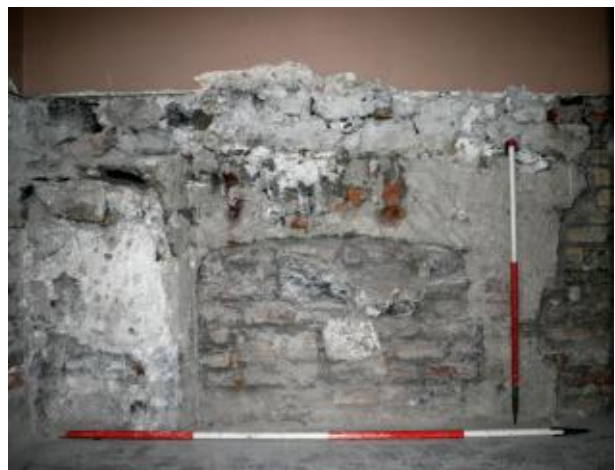
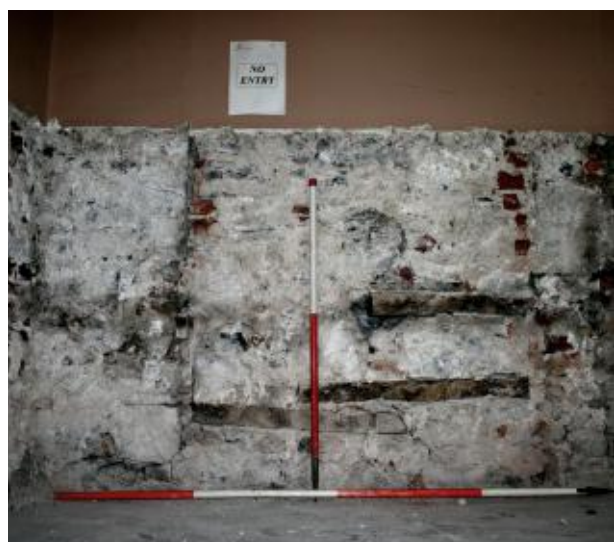
Top: S1 showing possible blocked 18th century window opening
Middle: S2 showing top of robbed-out arch for embrasure
Bottom: S5 showing lower part of blocked opening

The entire bottom southwest part of the tower has been rebuilt in the c. 18th century (S1 and W1). Construction is of handmade red brick with masonry (shaped limestone blocks max 260mm x 390mm) bonded by lime mortar. The masonry looks different in this section and along the lower western wall from elsewhere, and this may represent a later construction phase. A line of bricks (top part at c. 101.50m OD) is visible in the south, west and east walls and appears to be associated with these features. A faced line of red brick in the southern wall 700mm from the southwest corner may represent a blocked 18th century window opening. This is at the same level as the c. 1770s phase of windows in the western wall, and truncates part of the early 18th century decorative niche (see excavation below), thus is likely to have been inserted in c. 1770 during the construction of the new kitchen wing.

A break in the original masonry wall is visible in

the southwest corner of the ground floor. The original southern wall returned from the west 200mm-300mm earlier than it currently does. This break probably represents an attempt to straighten the uneven faces of the tower in the 18th, 19th or 20th centuries, changing the alignment of the southern wall by lengthening the western wall slightly. The change in wall thickness (N5), where the wall steps in by 100mm at 105.6m OD, is visible in this fragment of masonry.

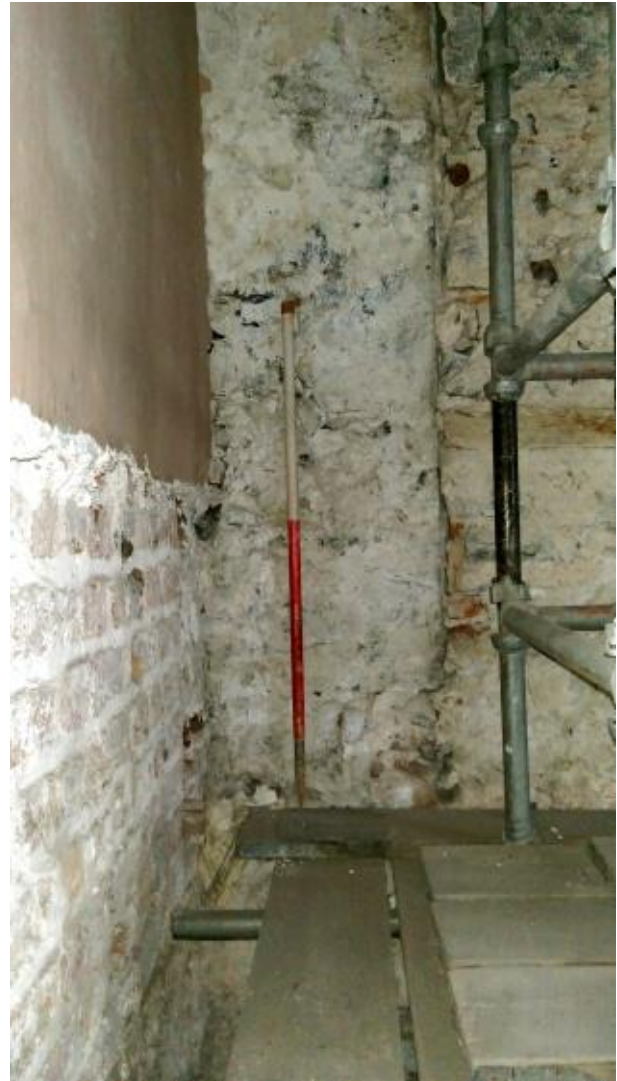
Above: S5, showing upper west jamb stones with brick blocking to right of image
Below: S7 18th century window

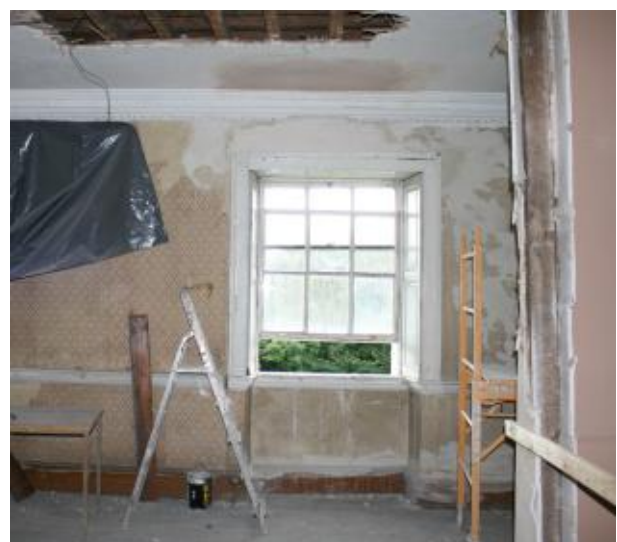
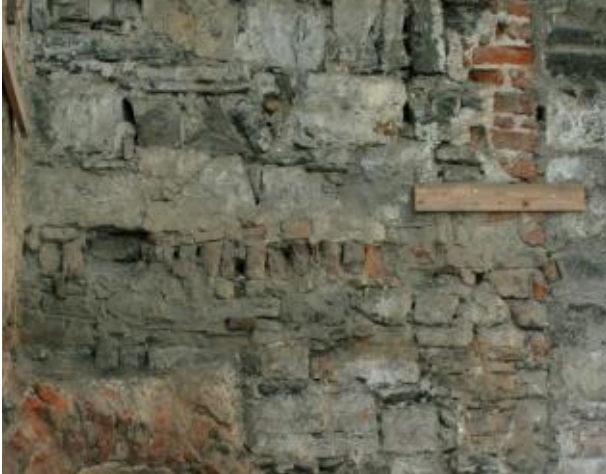
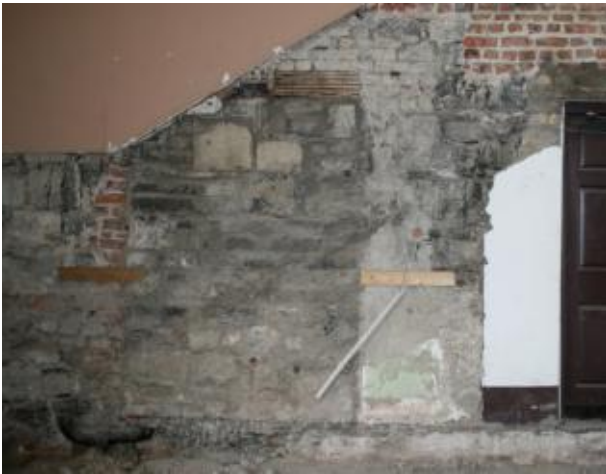
Top: W1 horizontal line of red brick in middle of image, also showing vertical line of red brick to right which is the later opening W2

Middle: W2 opening into kitchen wing defined by red brick to the left, wickerwork at the lintel, and pale plaster to right. Modern cement-bonded masonry blocked the opening

Bottom: W5 showing brick-lined opening, with arched top of opening obscured by scaffolding

Brick-lined opening 780mm-950mm wide with faces at right-angle to wall and at least 1.3m high. Brick is handmade but bonded with 20th century cement, however this may be repointing. The brick is notably different from the brick used in W8 and W5, being thinner, and a darker brown colour, and it may be late 17th century or early 18th century in date. This may represent a former access into the 18th century western kitchen extension. Blocked in the late 20th century by breezeblocks. This feature may run all the way to the ground floor where it was noted as W3.

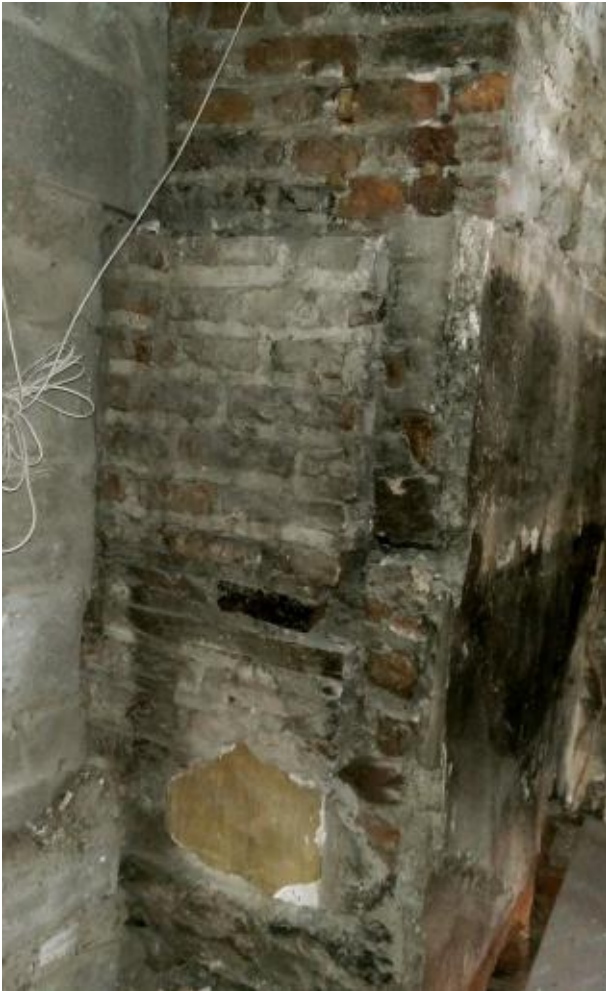
Top: W7 showing detail of brick, which is unusually long and thin

Middle: W10 showing arch of 16th century window

Bottom: W12 showing 16th century window

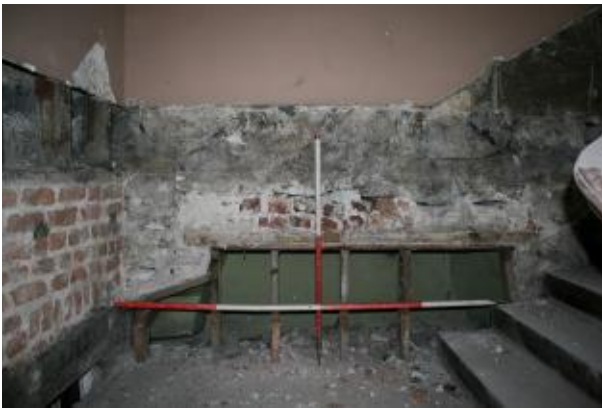
N1 blocked 18th century doorway

Top right: N1 showing 18th century doorway blocked up, from the main block, looking south
Bottom right: W2 showing possible 17th century window from the exterior of the tower
Below left: N2 showing top of masonry arched recess

Blocked 18th century doorway at basement level of tower. This doorway has brick surrounds and a straight timber lintel. It measures 1.13m wide and 2m high, with the top of the doorway at 101.75m OD. It replaced the original 16th century stone-lined and round-headed doorway in the same location, which was exposed in the excavation. The 18th century doorway was blocked when the floor level of the SW flanker was raised and a new doorway inserted to the kitchen extension, probably around the time of the construction of the kitchen extension in the late 18th century.

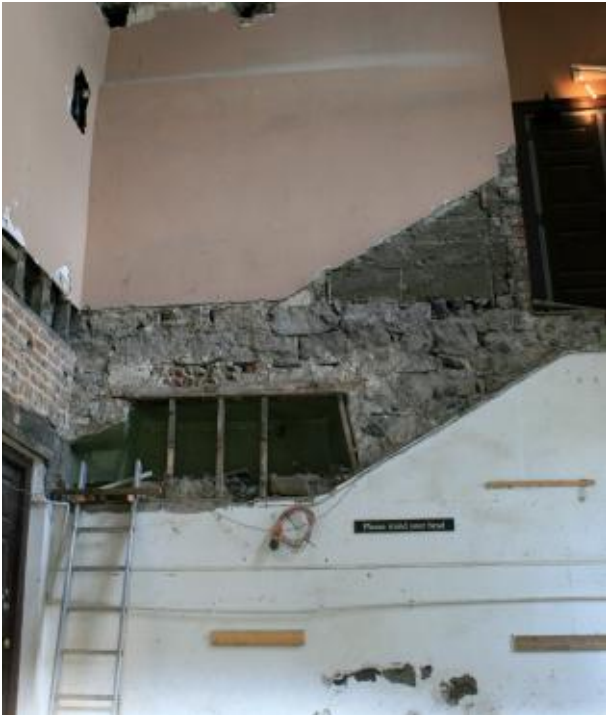
Top: N3 showing arched recess in centre left of image. N4 is visible in the upper right as a cement-blocked opening. N5 is visible as a change of thickness in the wall at the top of the image
 Middle: N6 showing modern brick blocking a cavity. E8 is visible as a change of thickness of the wall at the top of the image
 Bottom: N7 showing masonry quoin at bottom of image

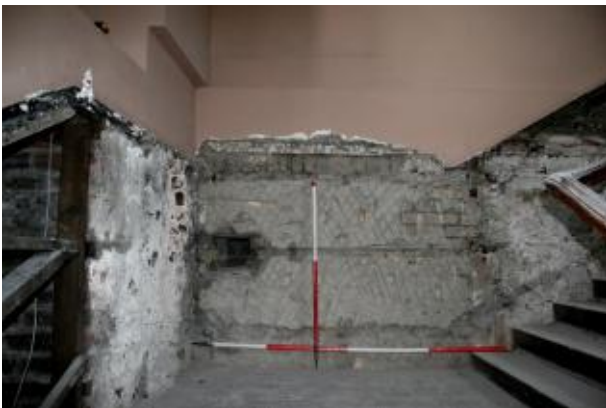
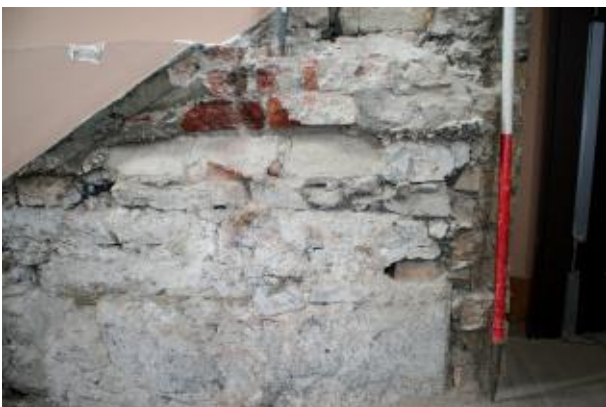
N2 basement-level window (later phase)

This window can be viewed from both the exterior and the interior of the tower. From the exterior it is concealed behind the c. 18th century circular staircase within the octagonal extension. The external side has a stone sill with levelling slates and appears to have brick surrounds for an opening 760mm wide and 1.12m tall, with the top at 103.18m OD and the base at 102.06m OD. This extends inwards for at least 1m (blocked in the 20th century) and is straight on all sides (i.e. without splaying). A timber frame fits inside this creating a single-light rectangular window 600mm wide and 900mm high with three iron bars.

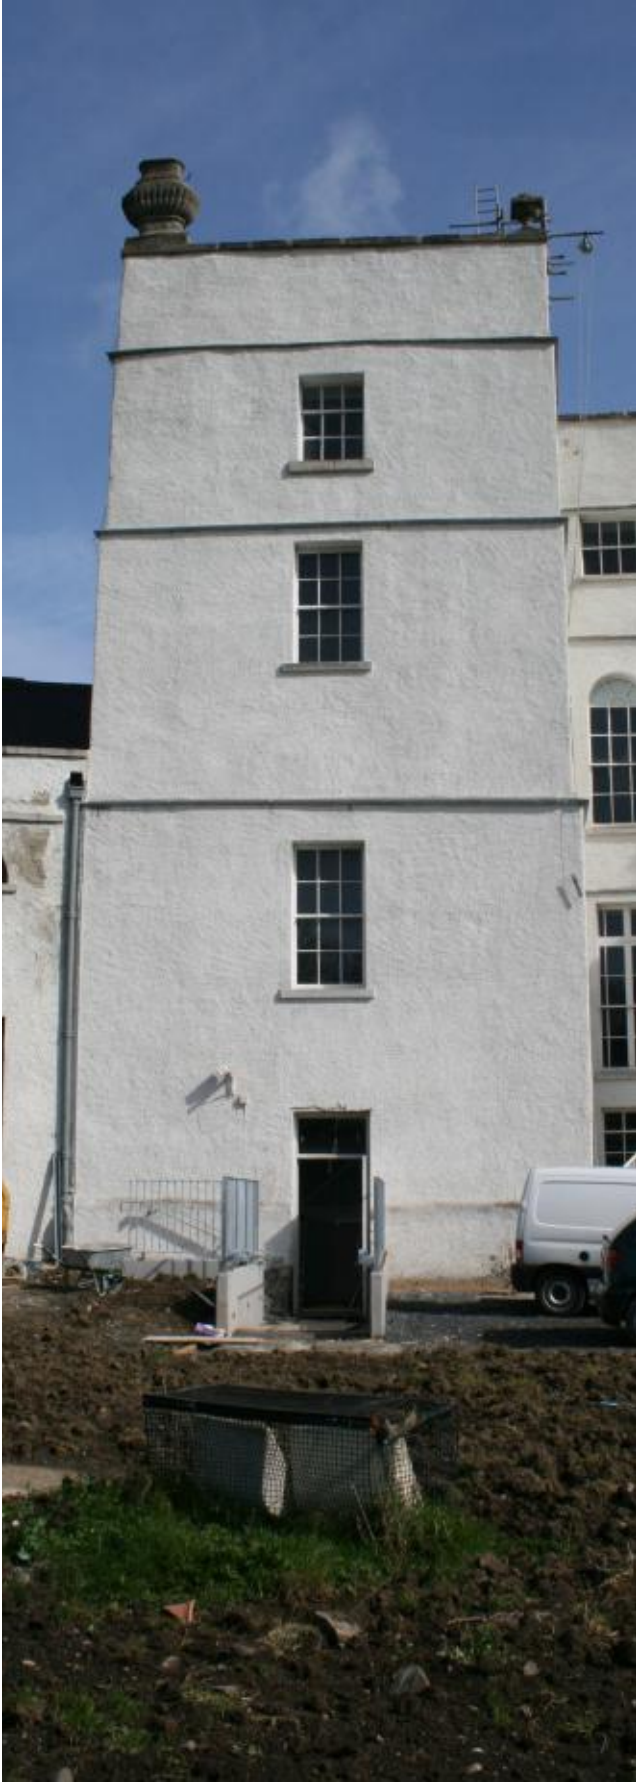
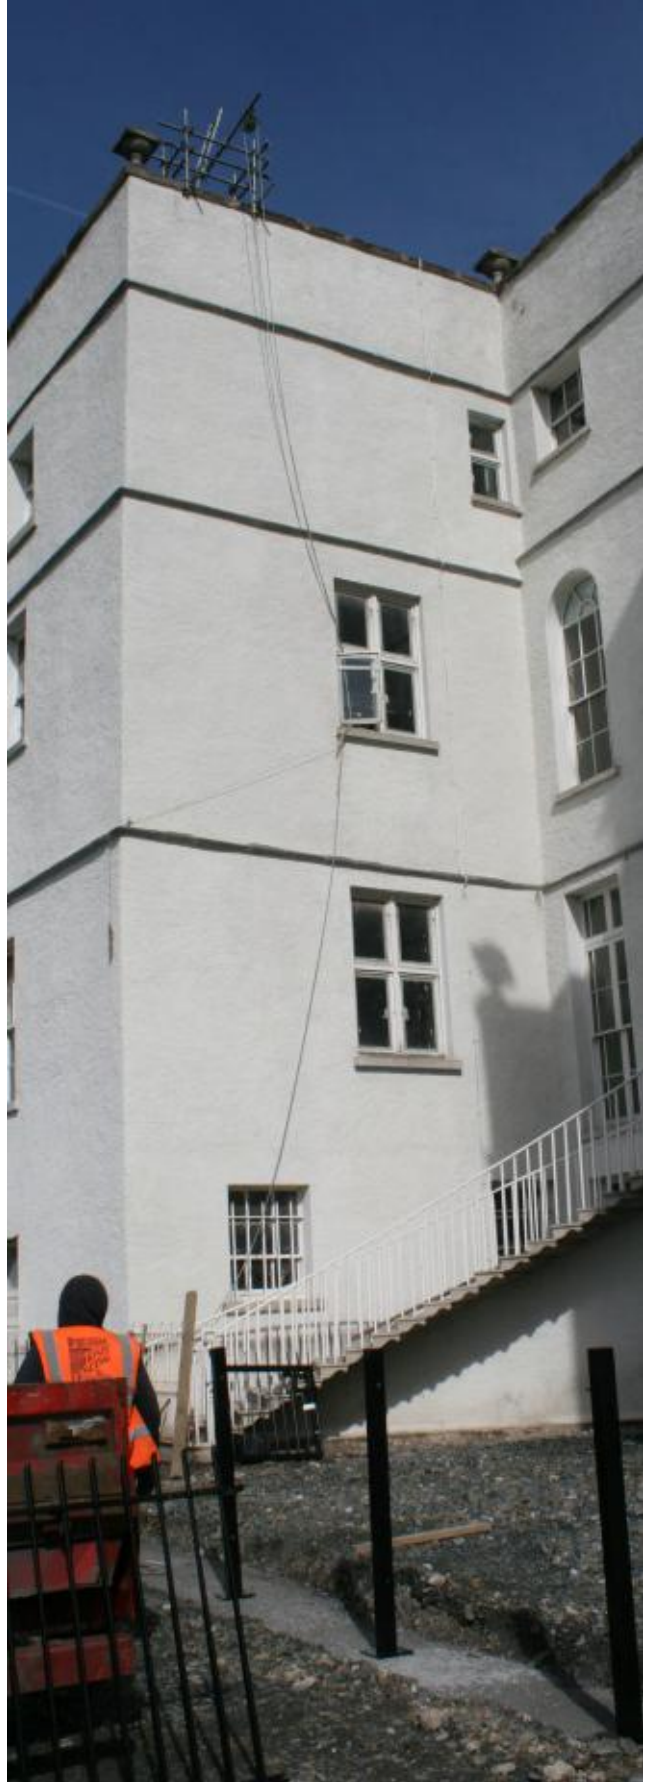
Above: southern external wall of southwest flanker (left) and eastern external wall (right)

Below: profile of northern wall

A change of wall thickness visible in the north, east and south walls at 105.6m OD, half-way between the ground floor and the first floor of the main building. In the north wall this takes the form of a sharp step inwards of 200mm to the west, fading to the east. In the east wall the sharp inwards step is 100mm just above the two gunloops E3 and E5 and is formed by a timber E6. In the south wall this sharp step inwards measures 150mm just above the arch of possible-window W2 and in the broken southwest corner S4. This level (105.6m OD) does not correspond with the external tiers or string courses. It does, however, correspond approximately with the level of two gunloops visible on the exterior of the NW flanker, suggesting a possible landing level. A scar of an old staircase providing access to the SW flanker from the main block is visible at this level.

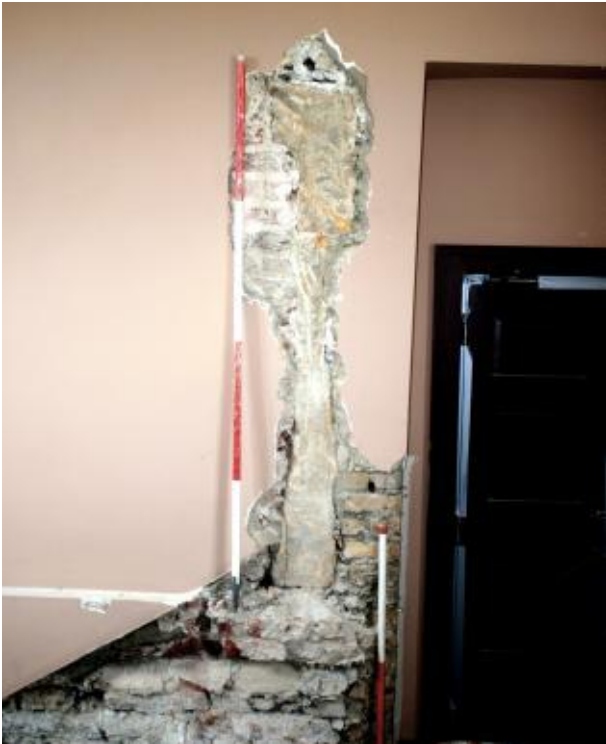
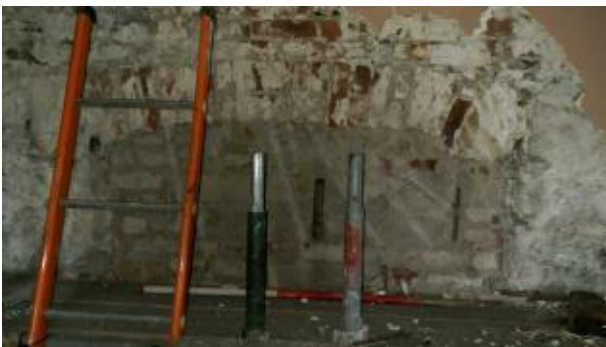
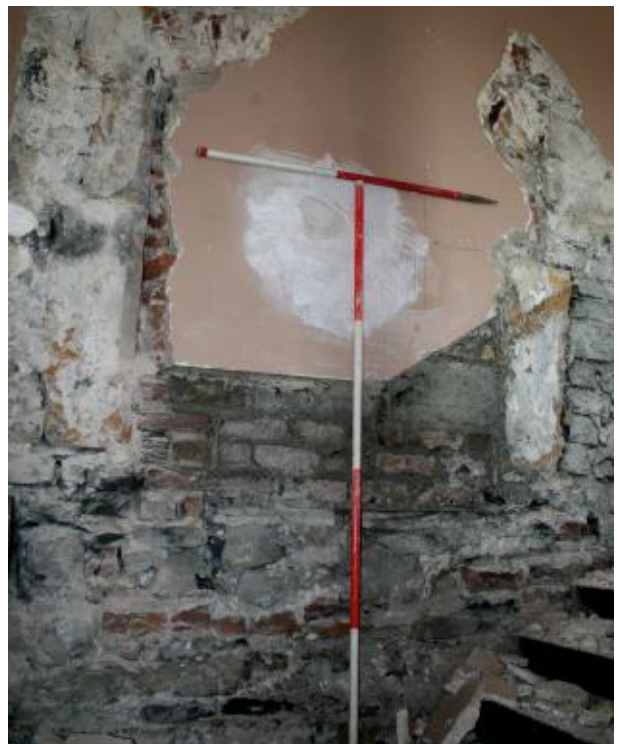
N8 sandstone fireplace

Right-hand side of a fireplace of yellow sandstone jambs (identical to N10). This measures 1.66m in height from the base, which is at 108.65m OD, the same level as the estimated 16th century and 18th century floor level E8. The right jamb is formed of three sandstone blocks (from base: 820mm x 270mm; 470mm x 170mm, 500mm x 270mm). The bottom one is chamfered from 270mm up from the base of the stone. The other stones all have plain chamfers along the inside. The upper stone forms the curved upper right side of an arch. The rest of the arch has been removed. This sandstone fireplace is sandwiched between 18th century red brick to the left and

Top left: N8 showing east jamb of yellow sandstone fireplace
 Middle left: N10 showing top of brick arch over fireplace, with yellow sandstone surviving at either end
 Bottom left: N10 showing detail of east jamb of yellow sandstone fireplace and brick repair
 Top right: N10 showing detail of west jamb of yellow sandstone fireplace with chamfer
 Bottom right: N10 showing fireplace and former floor level N9 below

modern 20th century walling to the left, so it may not be in its original location.

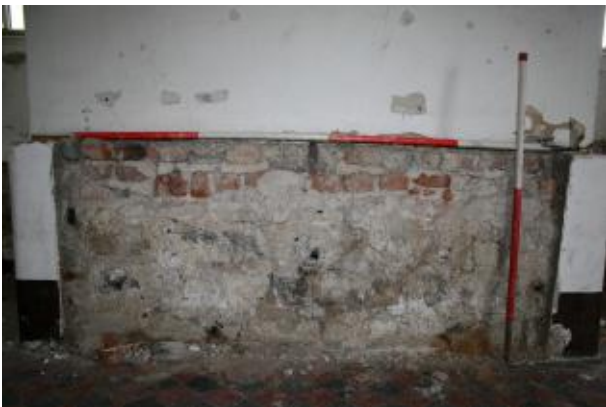
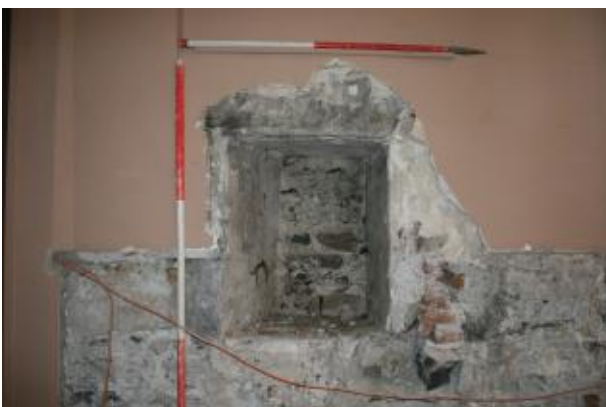
E3 ground floor gunloop

E2 represents a line of hand-made brick bonded with lime over masonry in the central part of the east wall, and in the southeast corner (south and east walls) at 101.2m OD. This is likely to mark the point above which the entire basement level vault was demolished to insert a square 18th century room with two east-facing windows and a new floor at 100.5m OD. The level of E2 corresponds approximately to the level of the springers in the other flanker basements (101.5m OD) and with the thinning of the flanker wall at the external tier (at 101.2m OD).

This gunloop measures 640mm wide and 740mm tall, and is recessed 460mm to a blocking masonry and lime wall. It is offset, with the left wall splaying inwardly and the right wall relatively straight. Large pecked limestone blocks form the sides, and the lintel is a very large shaped limestone block measuring 970mm by 250mm. The interior is plastered. The top of the gunloop is 740mm above the floor. Fragments of red brick below and to the right of the gunloop represent 18th century repair. A sandstone jamb (E4468:12:16) measuring 420mm x 105mm x 170mm with two faces polished smooth was found ex-situ within the gunloop.

Top: E1 showing shaped stones at northern side of gunloop and brick blocking
 Middle: E2 showing line of red brick at springer level sitting on the 16th century masonry tower wall
 Bottom: E3 ground floor gunloop, directly above E2

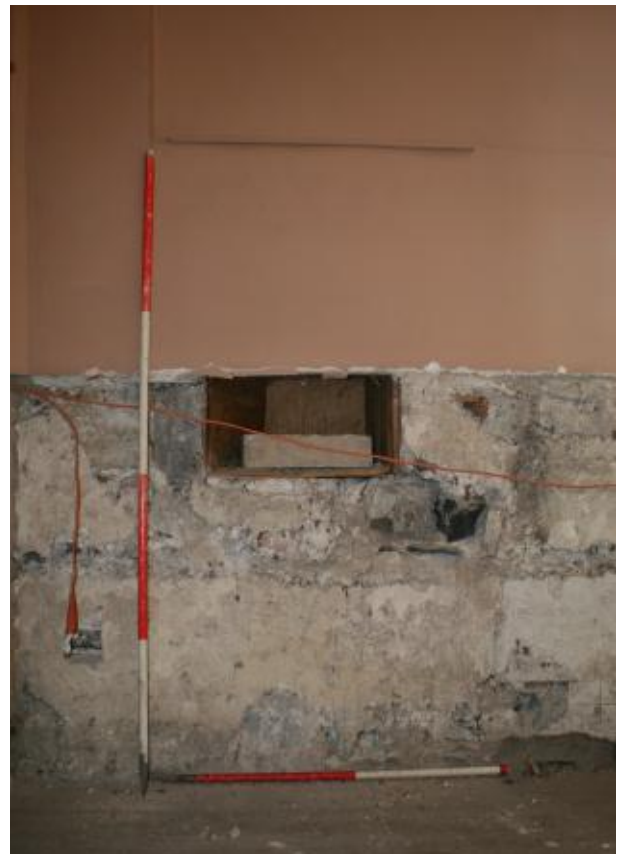
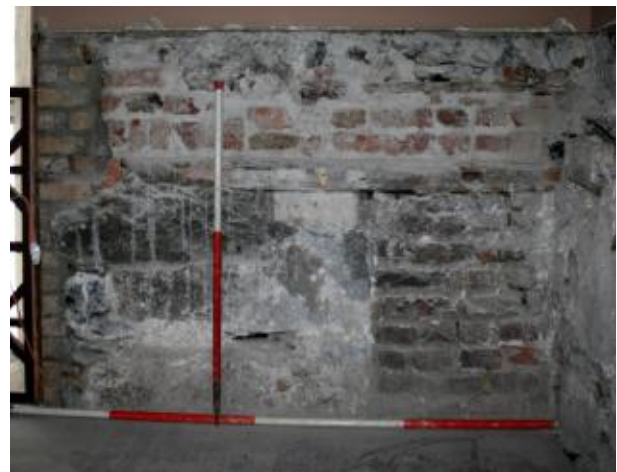
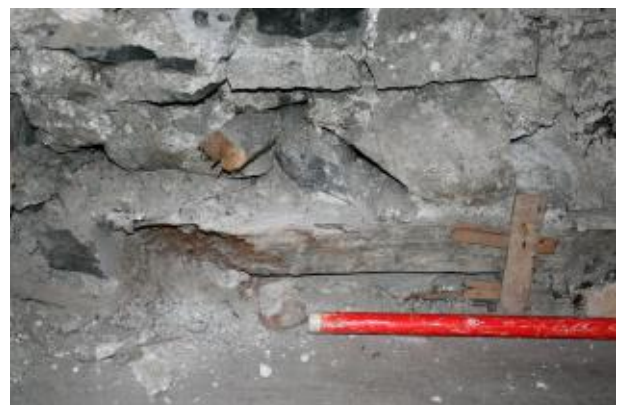
Timber joist or other construction timber, not necessarily in original location, measuring 110mm square and 1.5m in length, with three horizontal slots facing directly outwards (west) that measure 170mm x 40mm, 70mm x 40mm and 70mm x 40mm. This piece of timber appears to be old, and was probably placed here in the 18th century, since it supports (or is slotted under) a 290mm wide row of handmade red brick bonded with lime. It appears to have replaced the lintel stone of gunloop E5. This timber runs along N5 construction level at 105.6m OD.

A 280-290mm wide brick-filled gap in the masonry wall with timber inserts and some holes and modern cement in east and north walls that probably represent a former floor level. This

Top: E6 reused timber in gunloop lintel, showing detail of features
 Middle: E8 showing line of red brick and cavities representing former floor level
 Bottom right: E8 in west wall showing change in wall thickness at base of window embrasure (W11)

horizontal course of brick probably represents an 18th century floor level. The base of this course is at 108.55m OD and the top is at 108.85m OD. Directly below this in the north wall is an angled thinning of the masonry wall at 108.50m, suggesting this feature is original. The floor level is also visible in the west wall in the form of a ledge in the wall at 108.85m OD. Some of the brick within this gap is very thin, perhaps indicating late 17th or early 18th century date. The very even line of the original masonry stones below and above this feature suggests that the floor level was part of the original construction in 1583. A scar of an old staircase providing access to the SW flanker from the main block is visible at this level.

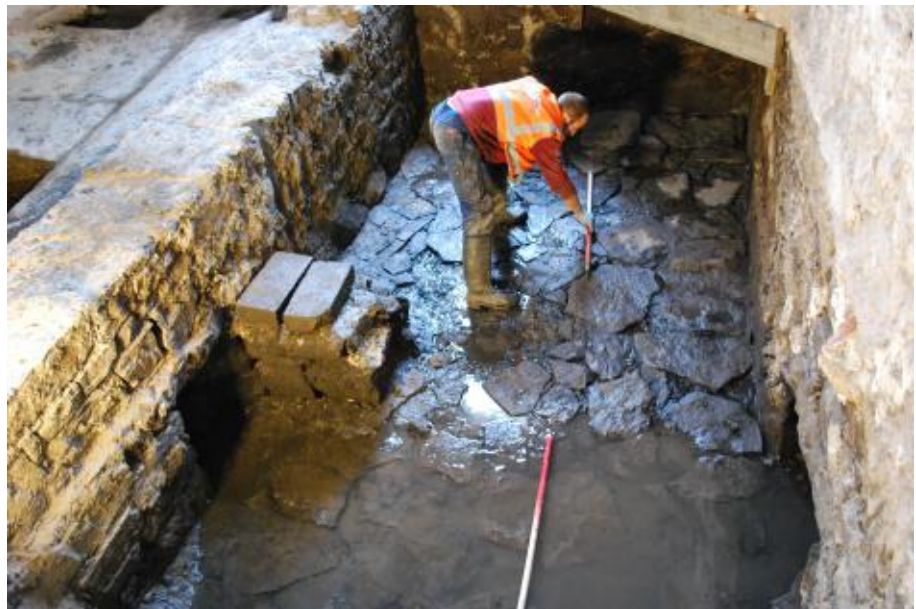
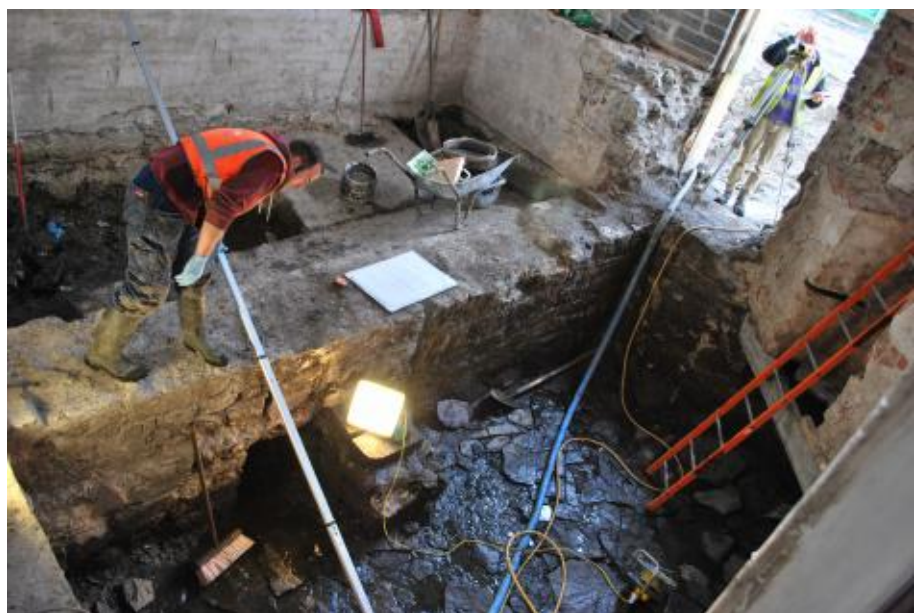
The 16th century form of the tower basement can be reconstructed based on the results of the excavation. Internally, the form is almost square in plan, measuring 6m north-south by 5.1m east-west. It is aligned to the main block, though the south and west walls are 2-3 degrees off. The eastern external wall is aligned to the internal wall and was a regularly 1.4m thick. The original northern wall is mostly gone but was also regular, 1.2m thick perhaps, and pierced with a recess and a doorway into the main block. The western and southern walls have salient angles up to 6 degrees off the main block, and thus vary in thickness from just under 1m in the southeast corner to 1.8m in thickness in the southwest corner. This variance is caused by the *trace italienne* fortification style of the castle, and the angled external walls aligned with the focused firing lines of the gunloops.

Top right: simple plan of SW flanker, showing internal north-south wall through centre and washpit to left
Right middle and bottom: recording of washpit

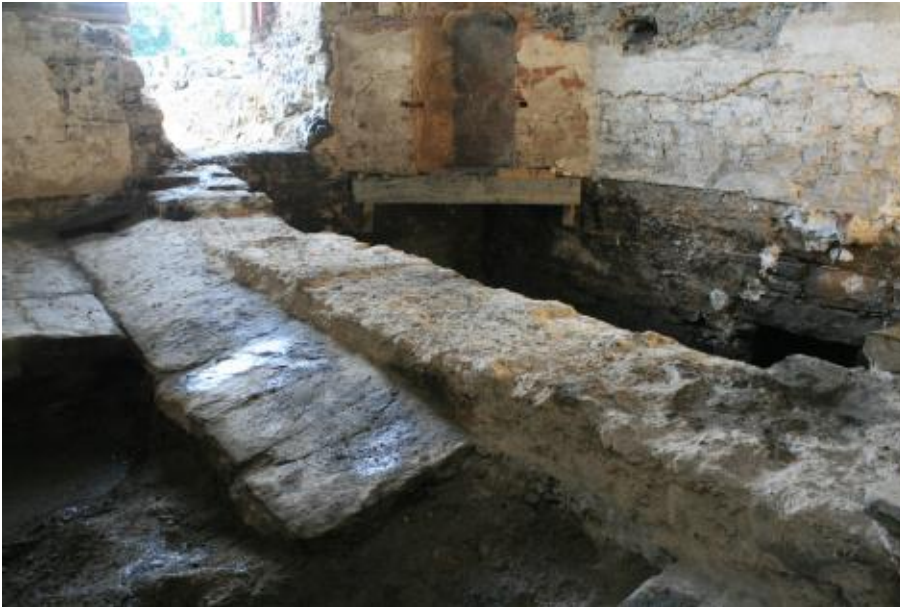
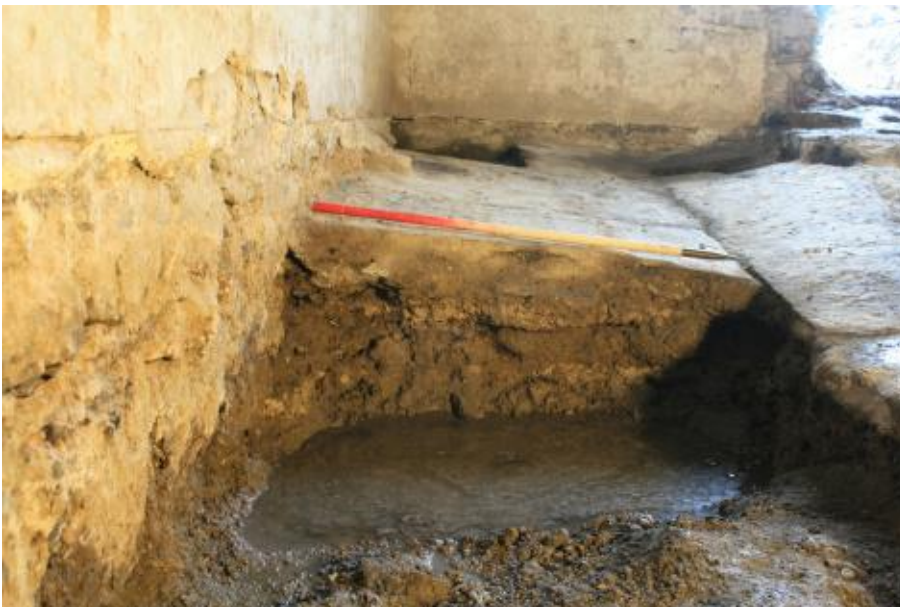
720mm in width. Construction was of limestone bonded with lime mortar. The wall was truncated in the early 18th century but probably rose up to basement ceiling level and supported a stone vaulted ceiling over the eastern side of the room (based on the springer line in the eastern wall). No evidence for a doorway or gap was found in the wall to link either side of the room, but some sort of internal doorway is very likely.

The western half of the room may also have been roofed with a stone vault, but evidence for this was less convincing. It seems just as likely that the western half of the room was unroofed at basement level and contained wooden stairs and a platform leading to a mezzanine over the washpit, and wooden stairs down into the washpit. A line of thin red bricks that appeared earlier than the typical 18th century red bricks might have supported timber beams to hold up such a platform (see

Top: dividing wall of southwest flanker running from top left to bottom right of image. Sloping 16th century paved stone floor abuts this to the left of image. Facing southwest
