Rathfarnham Castle Excavations 2014

LICENCE E4468

Rathfarnham Castle, Phase 6 renovation works, Rathfarnham Road, Dublin 14

Office of Public Works, 52 St. Stephen's Green Dublin 2

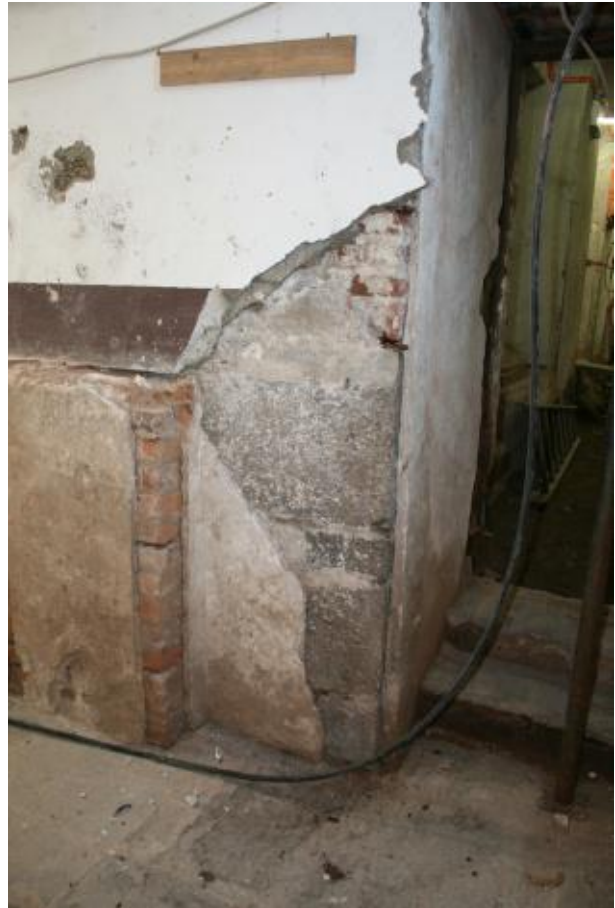
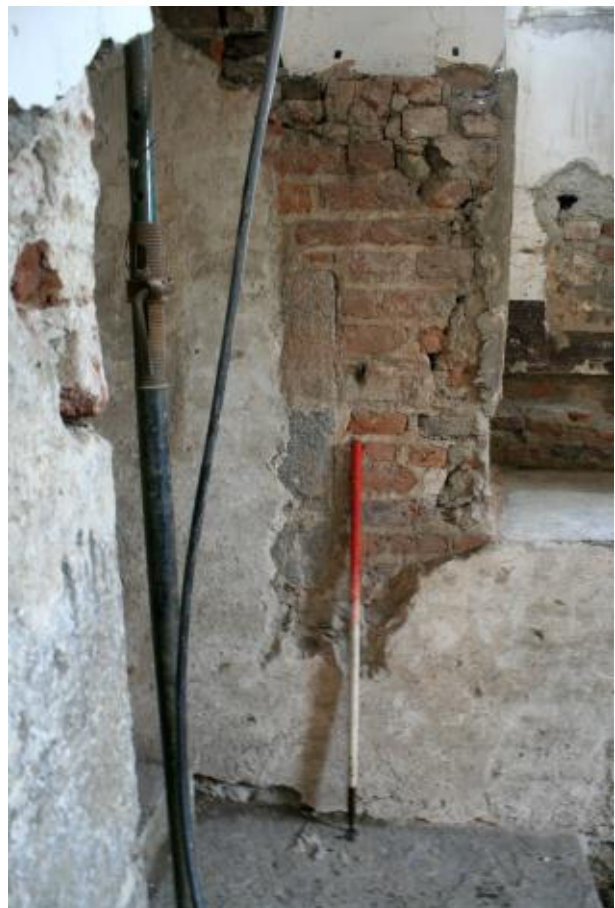
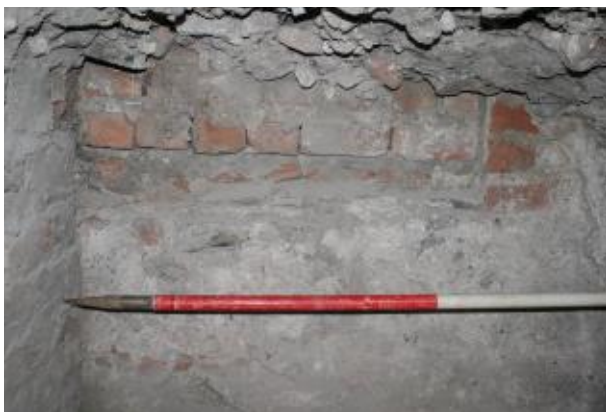
Three possible gunloops were identified in the SW flanker basement. One of these had been partially identified during the wall survey earlier, and is recorded as feature E1. It comprised three beautifully-shaped and pecked limestone jambs

Top right: 16th century door jamb. Note brick repair above stone marking former arch. Facing northeast
 Bottom right: gunloop (E1) in eastern wall, showing stone jambs to left and brick blocking to right. Facing east
 Bottom left: gunloop in northern wall, with re-worked jamb in brick to left, and brick blocking. Facing north

vertically positioned situated in the northeast corner on east wall, just at doorway, forming the northern jamb of a basement level gunloop. The base of the gunloop is 540mm below the 20th century floor (100.5m OD). The gunloop was blocked by red brick and truncated by an early 18th century window.

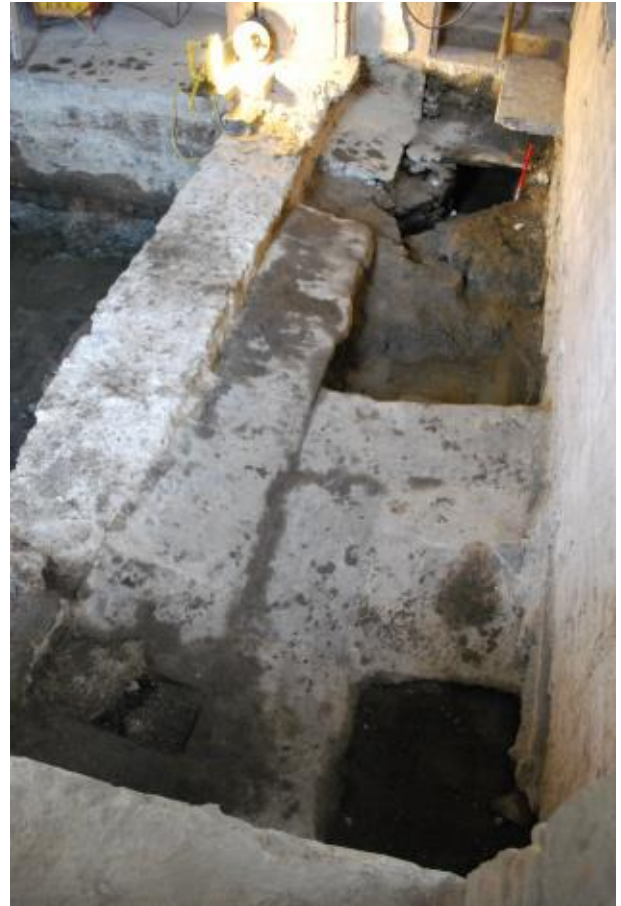
Top: 16th century paved stone floor, showing north-south dividing wall to left of image and washpit to far left. The stone in the lower right of the image was removed to lay a new floor in the early 18th century. The large pit in the back right is an early 18th century sondage to locate the drain, which is visible near the top of the image (the red and white ranging rod is inside the drain). Facing north

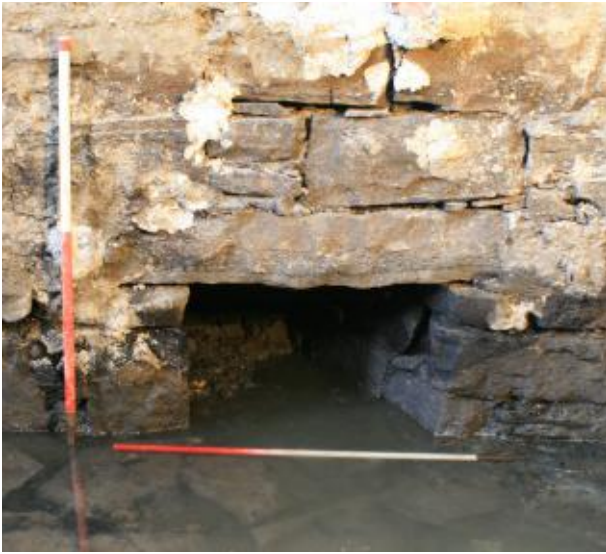
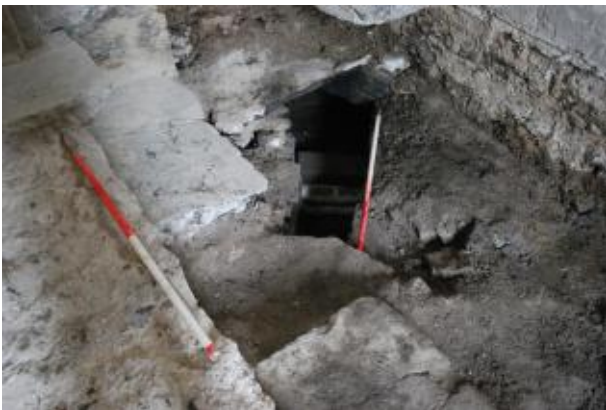
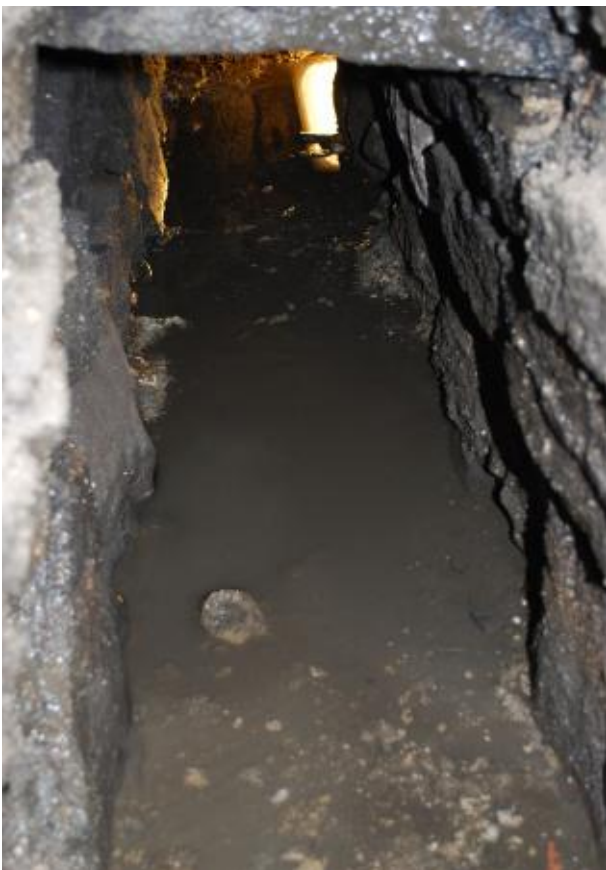
Top: exit of 16th century drain from washpit out of castle, facing west
 Middle: top of 16th century drain running under 16th century floor, facing northeast
 Bottom: view of interior of 16th century drain through central dividing wall, facing east

It is obvious from the excavation that the drain was constructed during the laying of the castle foundations, and is not a later feature despite being repaired in the 18th century.

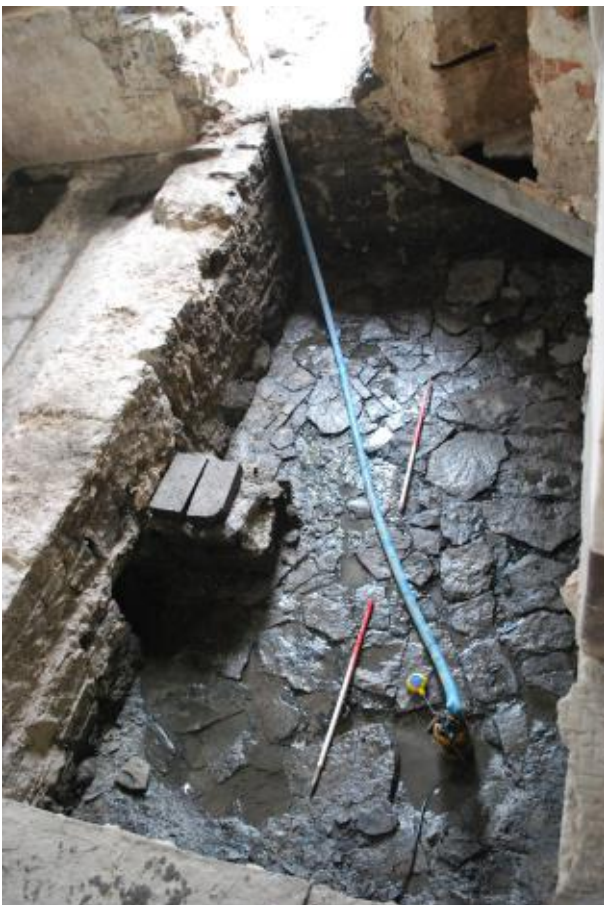
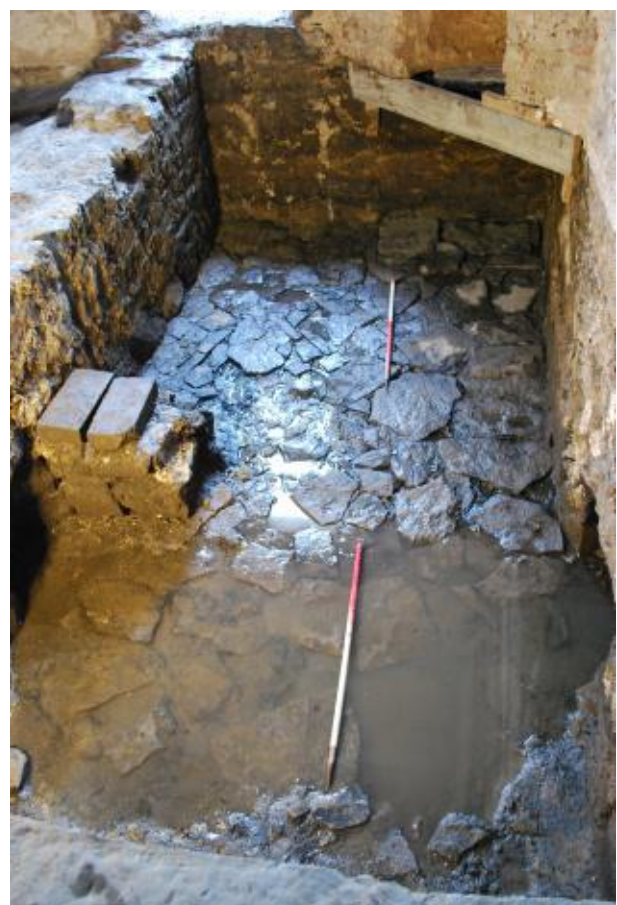
The washpit was an original feature of the castle constructed in c. 1583. There is a parallel at Trim Castle (Hayden pers. comm.) termed the 'washhouse' (see next page). The Trim 'washhouse' was a sunken stone-lined pit with a drain entrance and exit, evidence for rainwater channels to keep the drain flowing, and grills at the drain exit, all features that are also present at Rathfarnham.

Below left and right: view of washpit facing south. The paved stone floor slopes towards the bottom of the image, collecting water in an open drain that can be seen in the second image. The washpit filled with water continuously requiring a pump full time during excavation

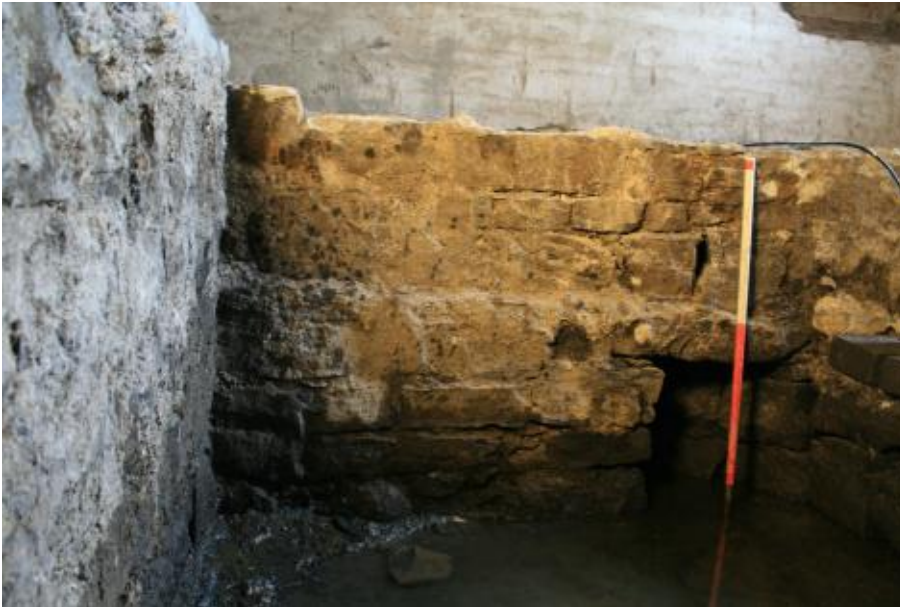
that it was mortared and that the lime washed into the clay below the stones creating the pale colour. Two ledges were noted in the washpit wall. These were 50mm-70mm wide and both ran for 1.4m and were offset from each other. On the east side the ledge was 700mm from the base of the washpit (at the top of the drain lintel), and to the north of the drain. On the west side the ledge was 500mm from the base of the washpit (at the base of the drain lintel), and on the south side of the drain. These two features may have supported a grill and/or wooden shutter at the drain exits and entrances.

Top left: ledge in the northeast corner of the washpit, facing east. A similar ledge was situated on the opposite side of the washpit, and both ledges may have supported grills or metal shutters at the drain exit and entrance

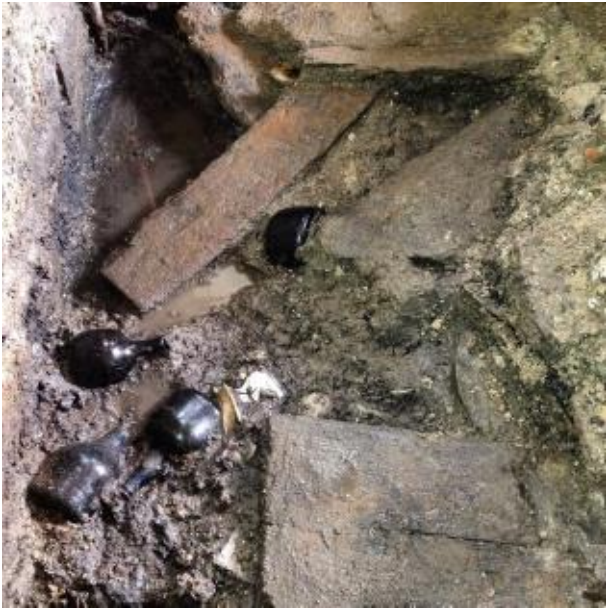
Top right: fill C7 showing timbers and intact glass bottles, facing east

their trench, they used old timbers to shore up the sides. These timbers were found still in place along the western edge of their trench (C7, Timbers 1-10). They then used large stones, probably reused from the dividing wall which was being demolished at this time, to line their trench, then red brick higher up, with an arched red-brick roof bonded with very hard lime mortar. The drain measured 490mm in width along the base and 530mm nearer the top, 1.16m in height. This created a new covered drain through the washpit, replacing the old open-air drain, and fixing the broken drainage system in the castle.

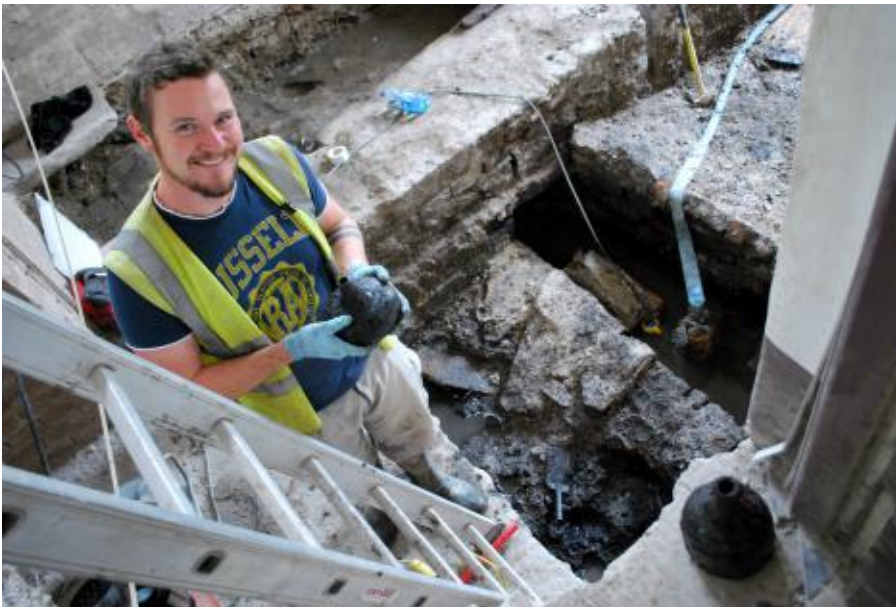
Fills of the washpit (C2, C3, C4, C6, C7 & C9)

The lower half of the washpit was filled with artefact-rich deposits. To the south the artefact-rich material had been piled up high against the south washpit wall, almost to the top. This material (C4) contained no preserved organic material, the glass and ceramics within it were not stained. It was gritty and contained purplish black cinders. Below this was a waterlogged black organic sediment (C2/C6/C7) 400-500mm thick to either side of the drain. This was extremely soft and

spongy, resembling drain fill or cess. Part of this deposit had seeped into an 18th century drain (and was excavated as C3). The final clean-back of the washpit involved checking for artefacts between the paving stones and this context was assigned a new number (C9) as it also contained material that had been inside the 18th century drain. In conclusion, however, all of the material from C3 and C9 belong to the artefact-rich deposit and only two sherds of pearlware (9:43-44) seem to date to a later phase.

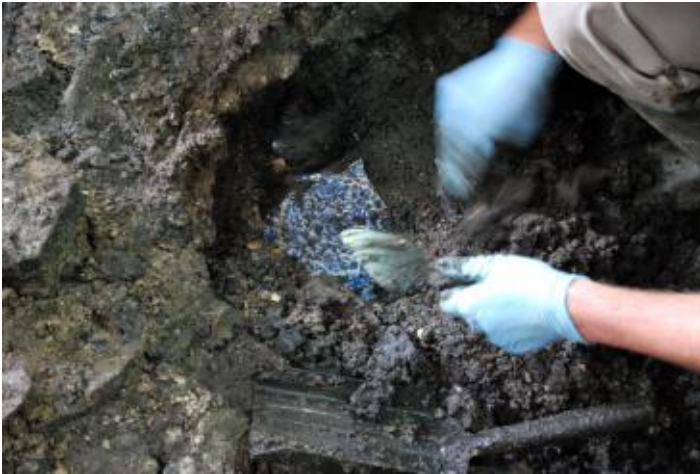
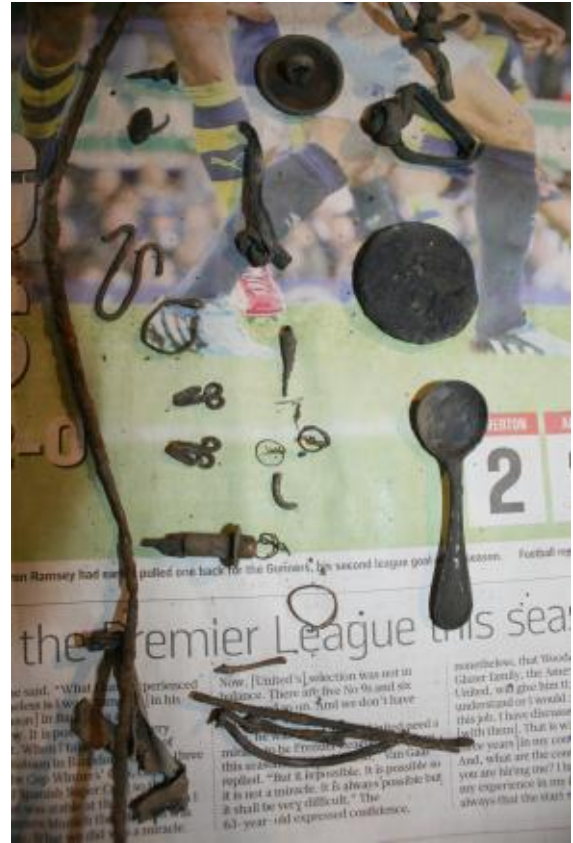
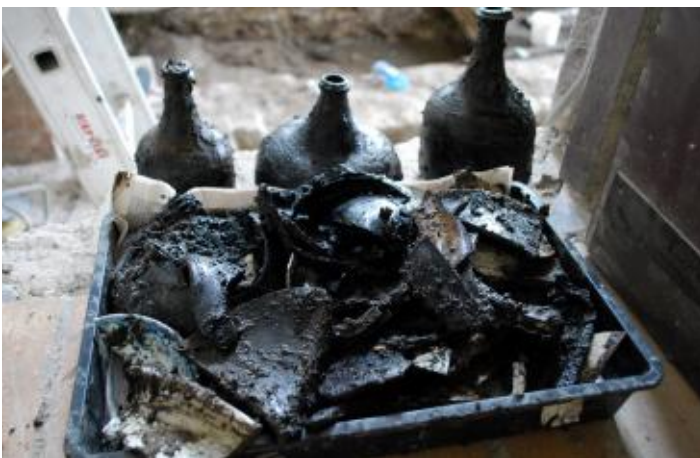
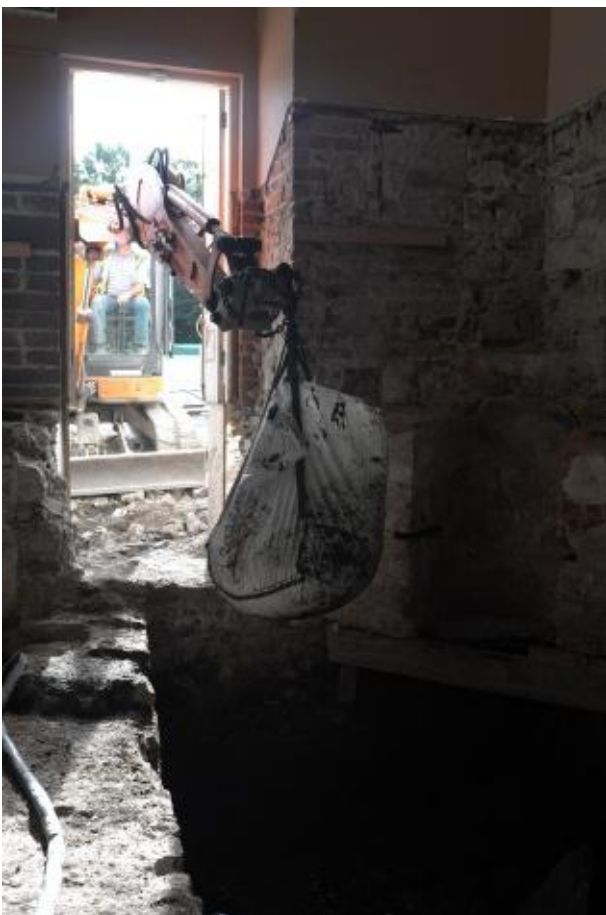
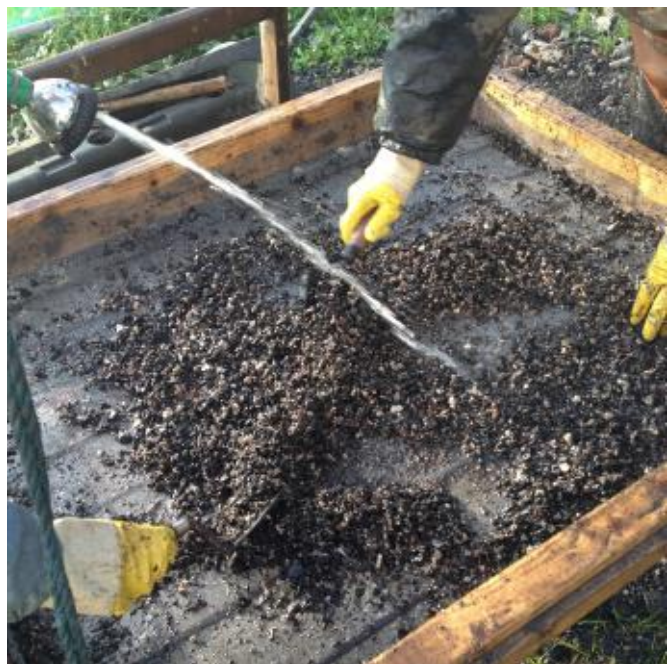
Excavation process

Top right: the archaeologists excavate the material by hand, exposing many artefacts

Top left: the artefacts are cleaned and dried in the lab as they are found

Bottom left: the rest of the material is placed in large skip bags and lifted out of the tower

Bottom right: all of the material is fine-sieved to find the small artefacts

These deposits were packed with artefacts (c. 2,000 per m³) and lesser amounts of demolition rubble to the point that excavation with metal tools such as trowels was impossible, and it had to be excavated using hands. Preservation of environmental and organic remains was exceptional. The entire deposit of c. 9m³ was hand excavated by a team of archaeologists into skip bags, then lifted by machine out

of the tower. All of the material was sieved by archaeologists through a 1.4mm mesh in November 2014, and c. 17,500 artefacts were found and catalogued. A preliminary assessment of the material suggest that most of the artefacts date to c. 1690 +/- 30 years. Some of the artefacts were complete and undamaged, for example a small lead-crystal drinking glass (E4468:4:367). This might suggest that some of the artefacts may have been placed in the stone-lined pit with some level of care and that later 18th century disturbance to

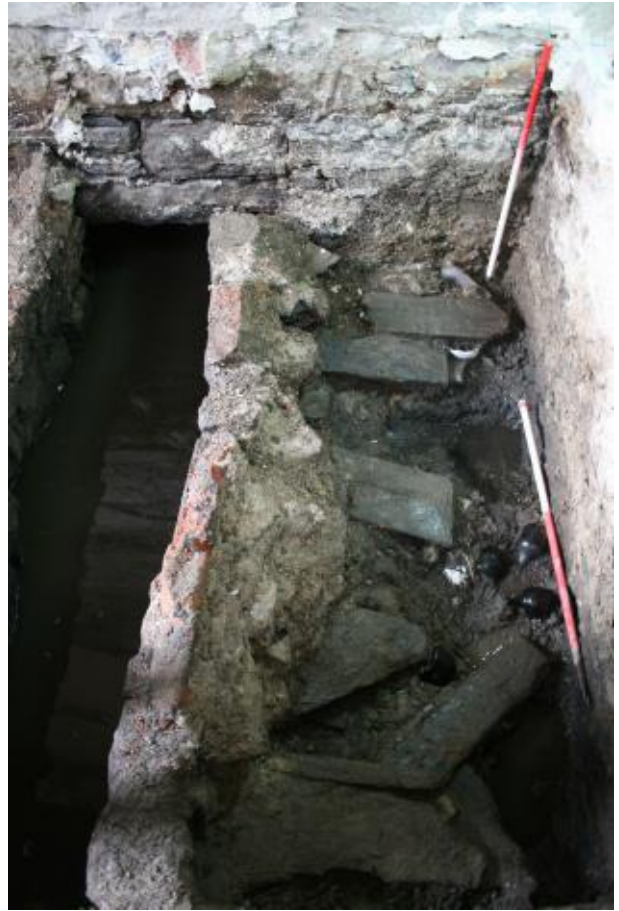
Top right: timbers used to shore up sludge in washpit during repair of drain, facing west
Bottom right: repaired brick drain, showing arch of drain having been broken through by archaeologists, facing south

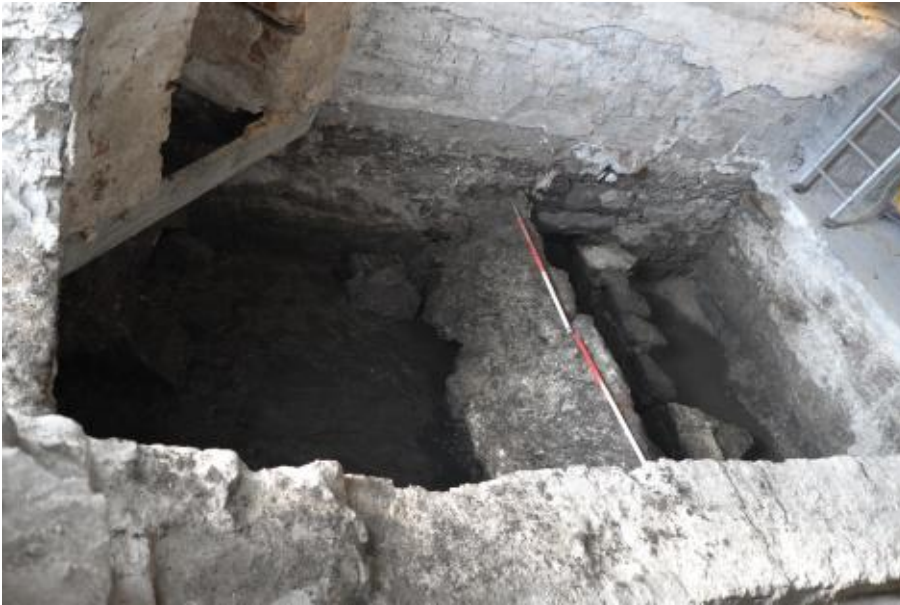
Above left: washpit showing location of repaired drain, facing northwest
Below: construction of the northern wall of drain contrasts with the southern wall of the drain, demonstrating ad-hoc construction, facing south

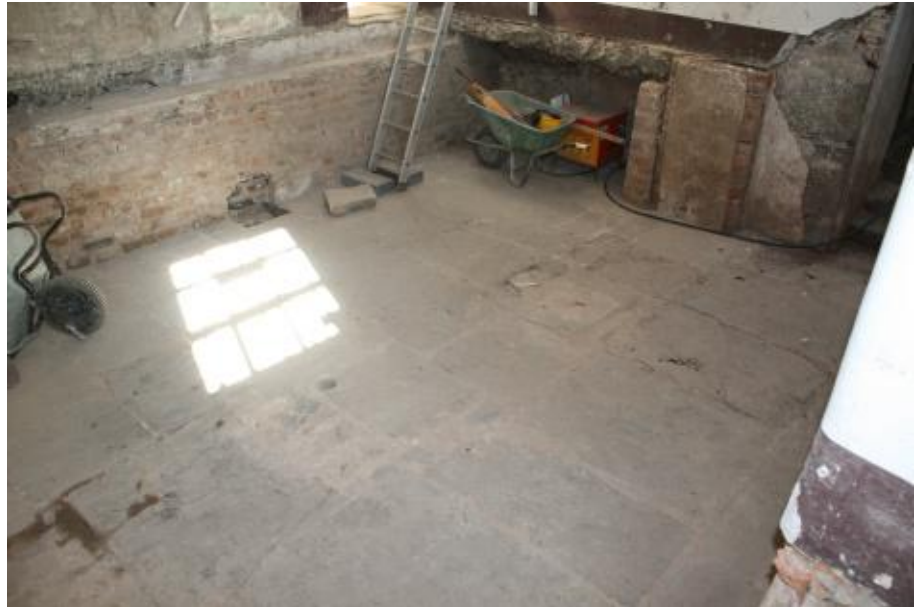
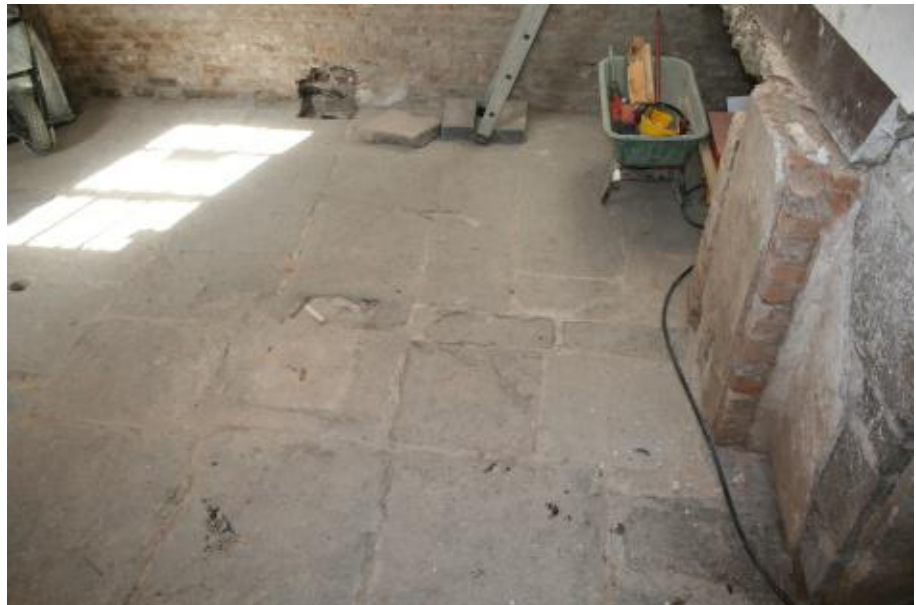
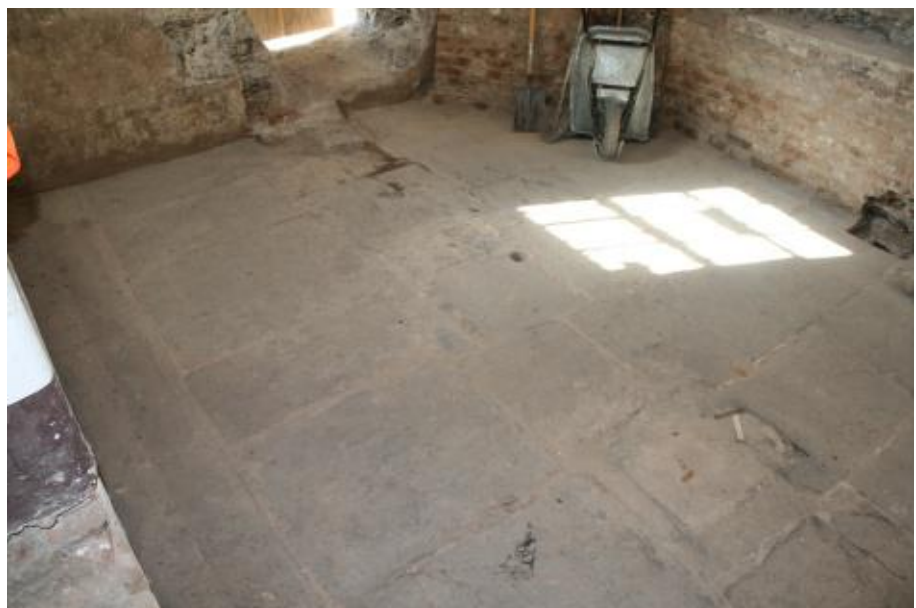
Early 18th century floor. From top: facing north, facing west and facing southwest. The drain manhole is visible in all three images (in centre back-ground in the upper two images, and in the centre right in the bottom image)

All the early features (16th century floor, washpit, artefact-rich deposit and drain) were sealed by a well-preserved beautiful limestone floor at 99.20m OD, surviving across the entire flanker tower. A small manhole in the west gave access to the drain that had been constructed inside the washpit. This floor was later replaced by a higher floor in c. 1770s, so it is likely to date to the earlier part of the 18th century. The paving stones measured up to 120mm thick and up to 1.17m by 960mm across, and were very finely bonded with extremely thin breaks. This was a very well-constructed floor, bedded on lime, and showed no evidence of red brick. The floor rose up on three steps (each 150mm high and 320-480mm wide) through the 18th century doorway up to the basement floor level in the main block of 99.75m OD.

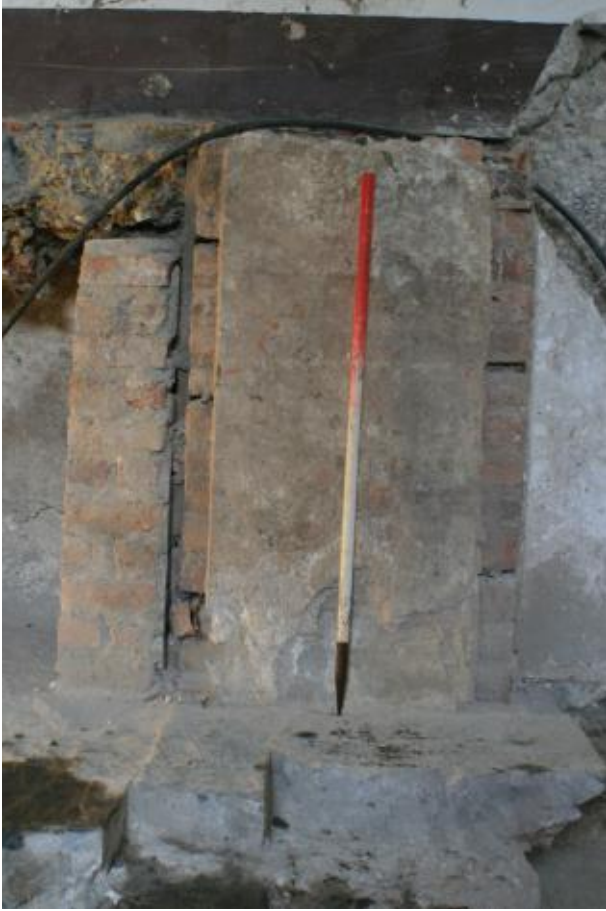
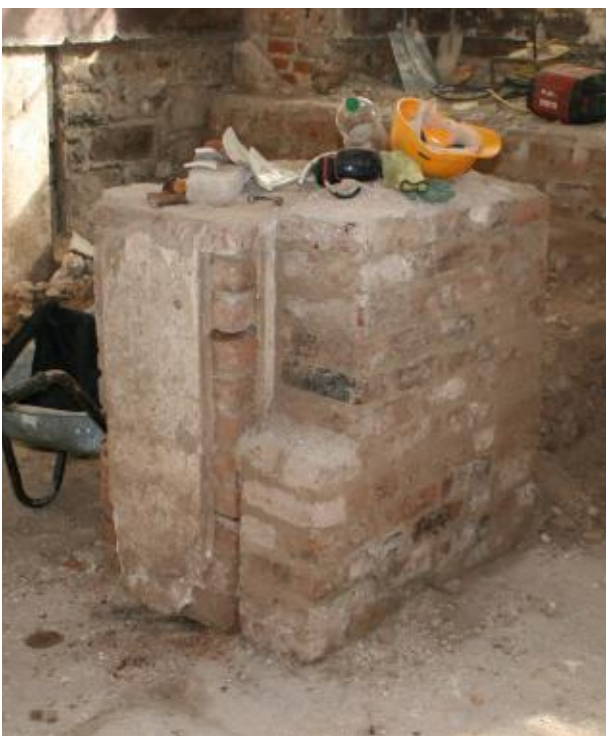
Above: northernmost structural support for ceiling, facing north. It is abutted to the left by a later floor support
 Below: second from north structural support (2) for ceiling, facing northeast. It is abutted to the right by a later floor support

A series of four structural supports were constructed directly over the truncated 16th century wall. These were in a line running north-south situated 2.43m from the western wall and 1.58m from the eastern wall. Supports 1 and 4 formed wall buttresses to the north and south extending out c. 200-300mm from the wall. Support 2 was a pillar about a third of the way along (3.7m from the south and 1.9m from the north). Support 3 was a missing pillar to provide the last evenly spaced support. These might have supported a 16th century vaulted stone ceiling after the 16th century central north-south wall was removed. The recess to the northwest was also modified at this stage, perhaps for the insertion of the '17th century window' N2 (exact phasing unclear here). These supports are likely to be early 18th century in date.

The central pillars (only the northern one survived) measured 500 x 700mm (east-west axis being wider) with a thick layer of plaster except around corners to allow for a wooden frame 100mm wide. In the main block similar corner details are used to hold bull-nosed rounded timber detailed frames. A bull-nosed masonry fragment of the same style was also identified in the overlying demolition rubble (E4468:1:46). Construction of the pillars was of handmade red brick bonded by loose lime mortar. They survived to a height of 1.02m above the 18th century floor, and were truncated in the later 18th century for a higher floor level at c. 100m OD. They are abutted by mid-18th century (Henry Loftus 1770 phase) buttresses to support the later floor level, and these later buttresses also extended all around the walls and were constructed of different brick and harder lime mortar.

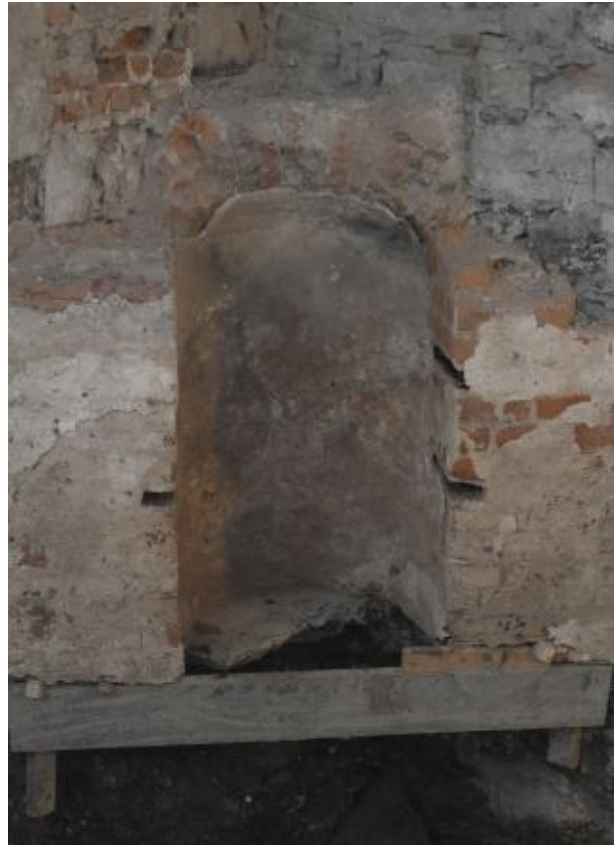
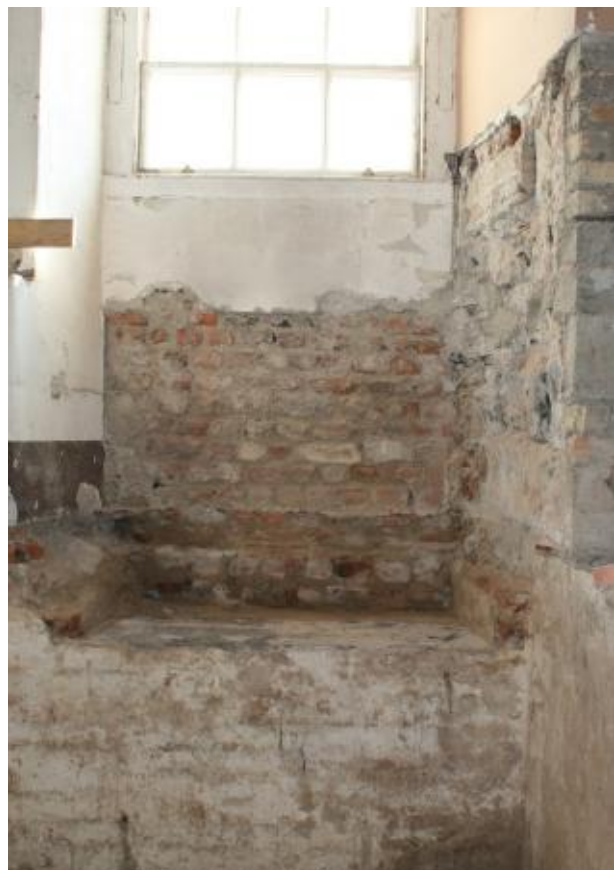
Above: decorative niche or cabinet, showing partially-replastered cavities to hold shelves. Facing southwest
Below: 18th century window showing earlier phase with limestone sill in lower part of image, facing east

This recessed feature was preserved *in situ*. It takes up the angle in the southwest corner of the flanker, comprises a domed semi-circular niche 1.4m tall, 840mm wide and 750mm deep constructed of red brick and lime mortar sitting on the early 18th century floor. Slots on either side could have supported two wooden shelves, for displaying items, but these were later heavily plastered over in a later phase to create a single rounded space, which would have been suitable for the display of a statue or similar item. Some light burning was noted in the roof of the niche but not enough to suggest any frequency of burning or use as a fireplace. The niche or cabinet was later blocked up, then sealed up by deposit C1. The uppermost part of the niche was removed in the late 18th century or later.

The two existing windows in the eastern basement wall of the SW flanker were carefully excavated and revealed four phases of construction. The first phase comprises two gunloops, one partially surviving as feature E1, and a second presumed gunloop further to the south. The second phase dates to the same period as the early 18th century limestone floor. These early 18th century windows were cut into the flanker wall, and were lower and slightly narrower than the current windows: 900mm deep openings, 1.34m wide tapering to 1.18m. They had beautiful limestone sills that exactly match the distinctive stone of the early 18th century floor. The height of this phase of window is uncertain. The windows were raised and, in the case of the northern one, slightly widened, later on when the floor was raised, prob-

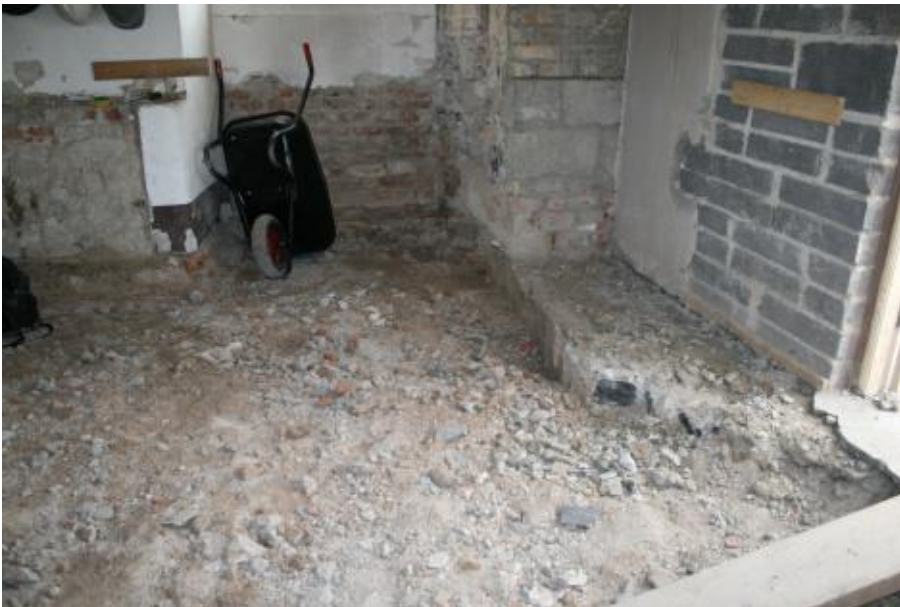
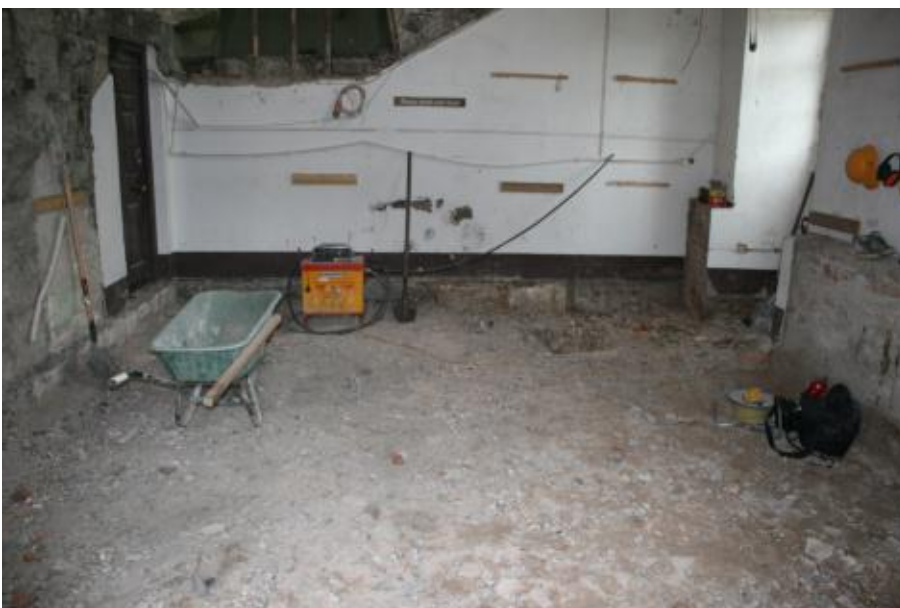
Above: excavation of uppermost layer C1, showing window in background.

Facing east

The 20th century tiled floor of the tower was at 100.5m OD. This was broken up and excavated by hand down to the top of an early 18th century floor at 99.20m OD. The material between the floors (C1) comprised mixed demolition rubble 1.3m thick. Brick supports for a floor of late 18th century date stop at 100.225m, which is just 270mm-280mm below the level of the modern floor, however no trace of this floor surface was found. The evidence for the raising of the floor in

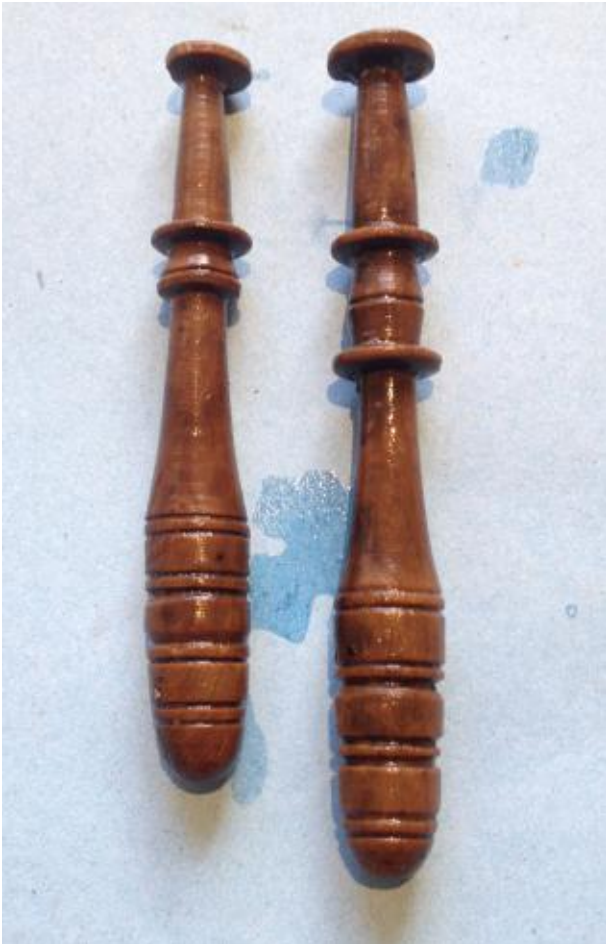
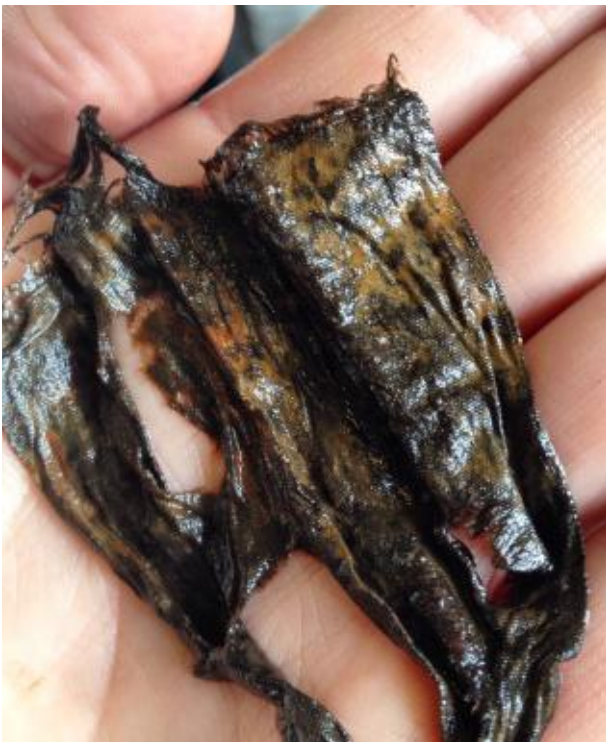
Lace bobbins

Seven 'South Bucks' style wooden lace bobbins were uncovered. The shank of the 'South Bucks' lace bobbin is decorated on its lower half with four bands of parallel lines. It narrows near the waist. It has a collar near its neck, which is preceded by a single line and tapered band. The head is flat in shape. This style of bobbin was originally made in South Buckinghamshire, hence the name. The bobbins found at Rathfarnham vary slightly in size, presumably to do with their function in the manufacture of bobbin lace.

Due to the delicate nature of lace, very little of it survives from this period. Whether it was being produced by the ladies of the house or their maids, the presence of so many brass pins and lace bobbins at Rathfarnham provides us with some of the earliest evidence of lace making in Ireland.

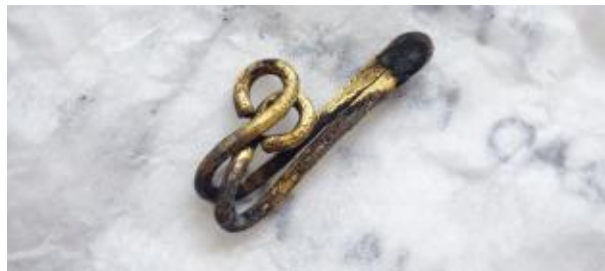
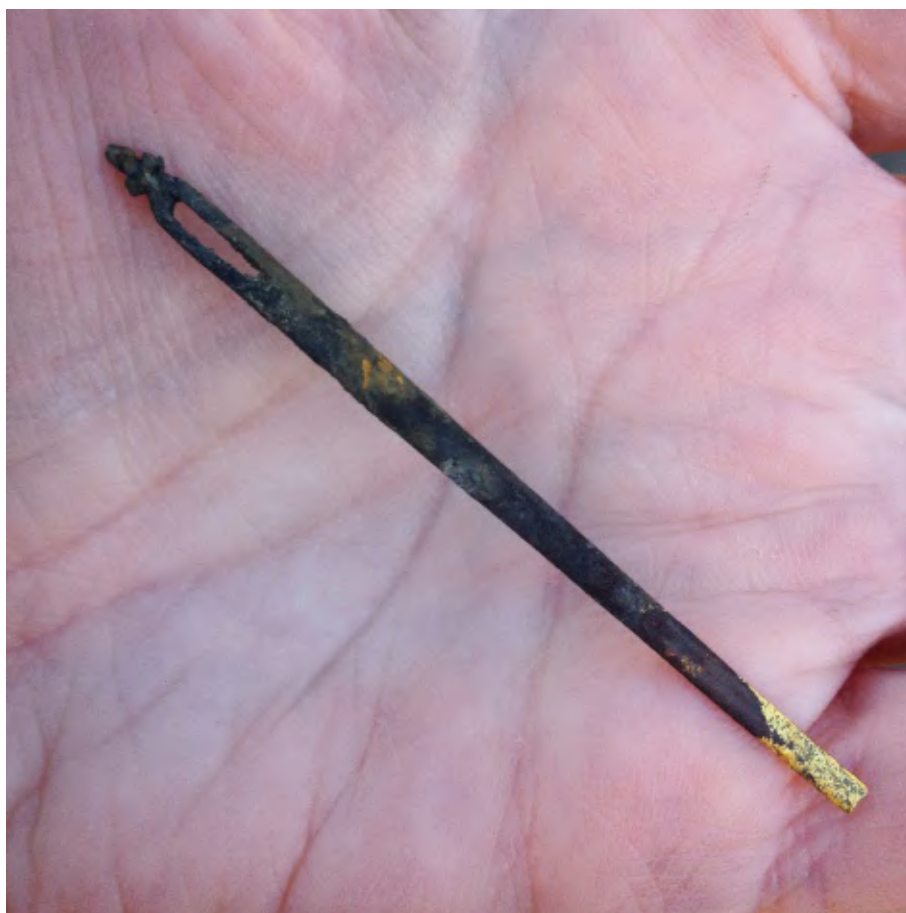
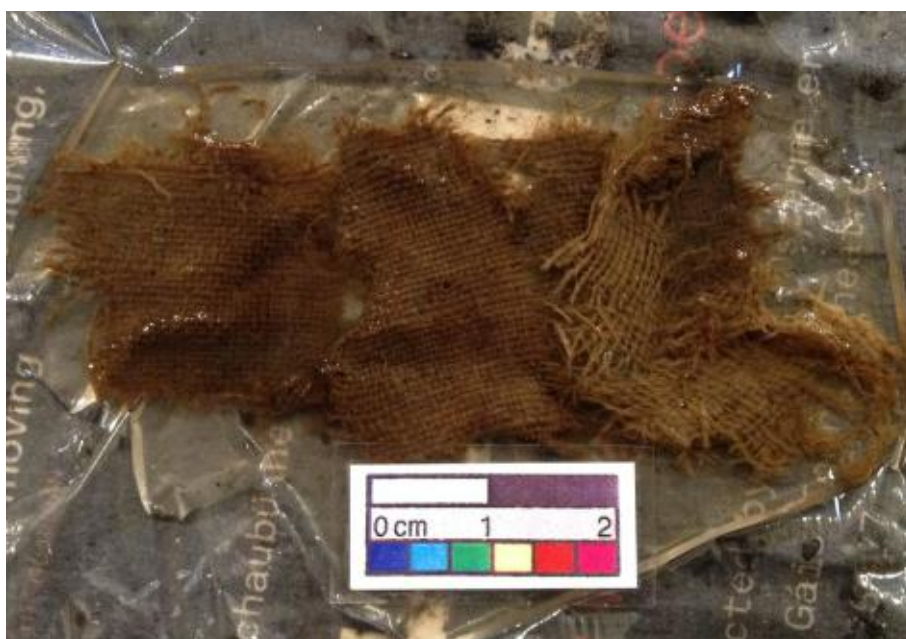
Top: dress fastener
Middle: brass bodkin 9:401
Bottom: scrap of fabric
recovered from excavation

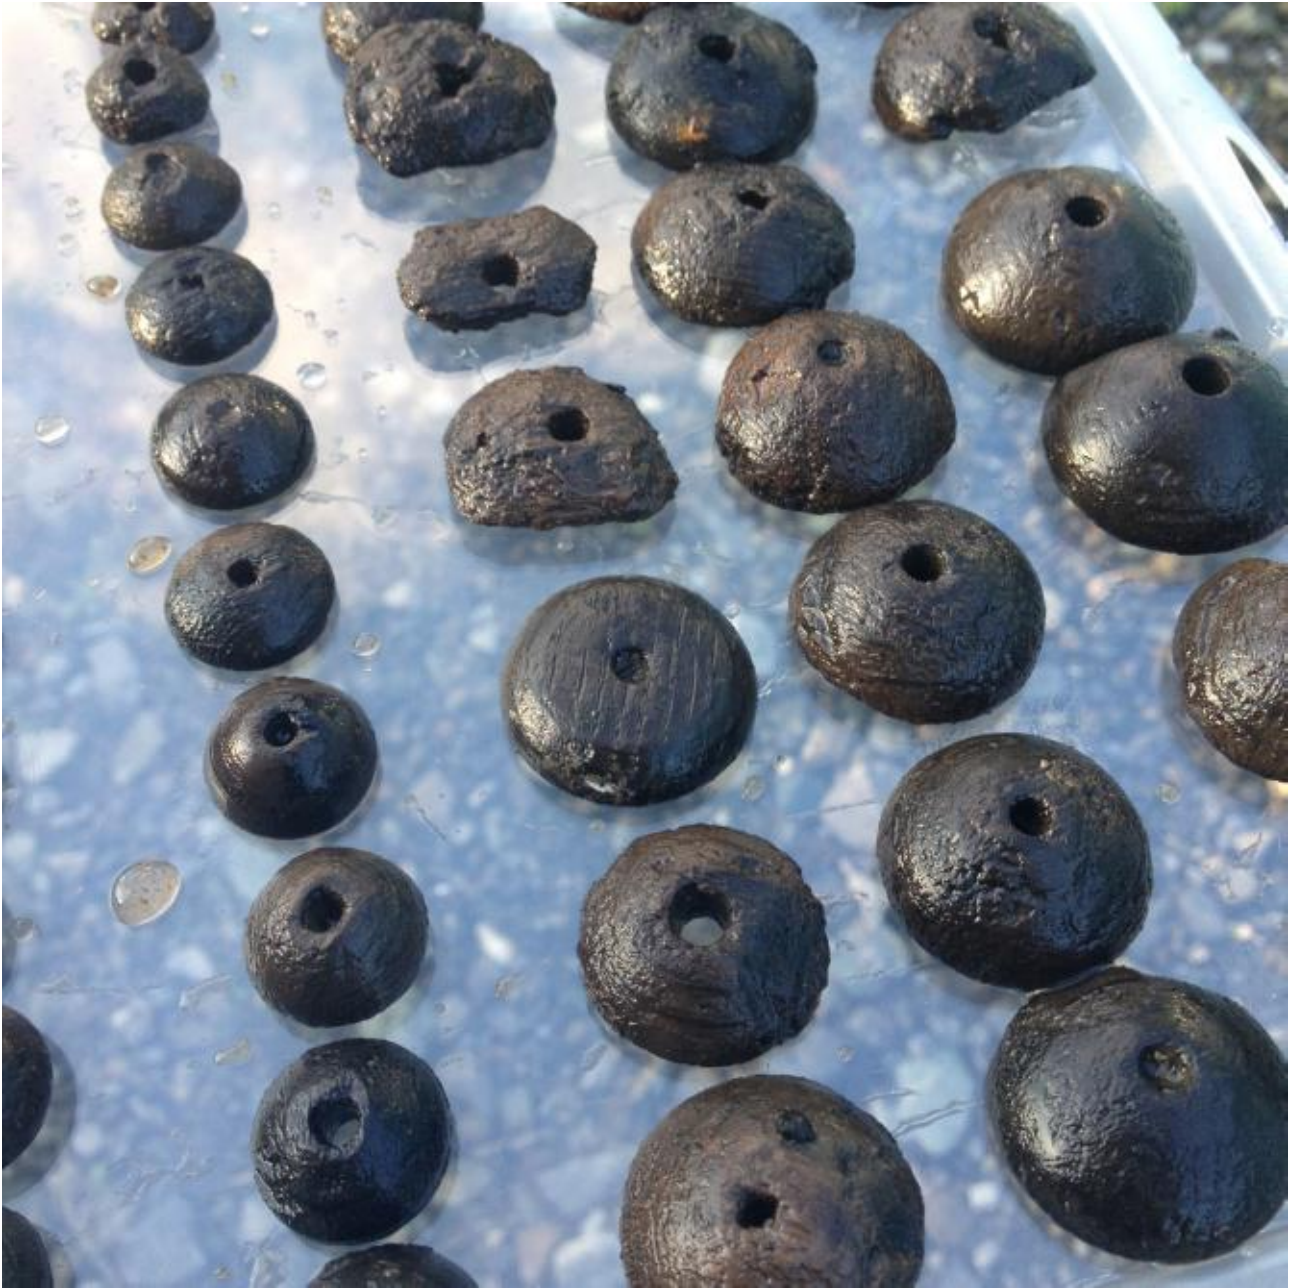
Above: array of wood buttons

The wood core buttons from Rathfarnham Castle were originally covered in a wrapping of threads. The threads would have been wrapped in patterns and woven through a central hole to form an attachment shank. The type of thread used varied from simple linen to expensive silk or gold; by the late 17th century they were becoming a symbol of status. One button (E4468:6:4705) was found with some of the original threads still attached.

Thirty eight of the wood core buttons found at Rathfarnham are large and would have adorned a coat or waistcoat, and 45 are medium and functioned as waistcoat or breeches buttons. The two smallest buttons retrieved from Rathfarnham could have been used to embellish accessories like a pair of shoes or a handkerchief, or to fasten a young boy's waistcoat. During the 17th and 18th centuries children tended to be dressed like miniature adults with the same set of clothing.
