Rathfarnham Castle Excavations 2014

LICENCE E4468

Rathfarnham Castle, Phase 6 renovation works, Rathfarnham Road, Dublin 14

Office of Public Works, 52 St. Stephen's Green Dublin 2

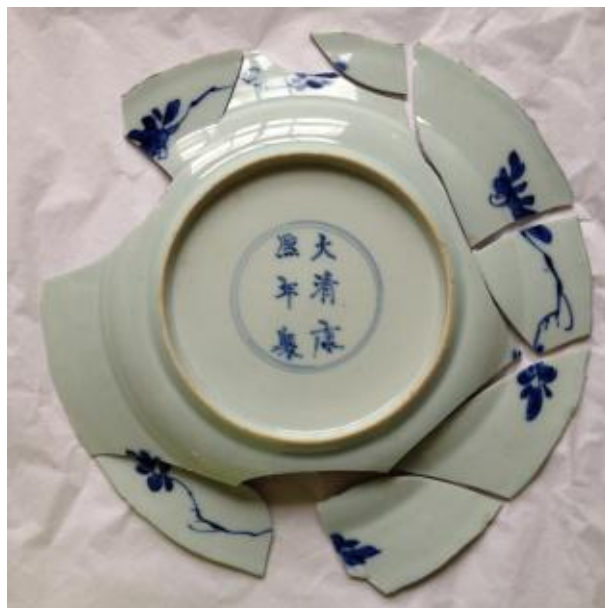
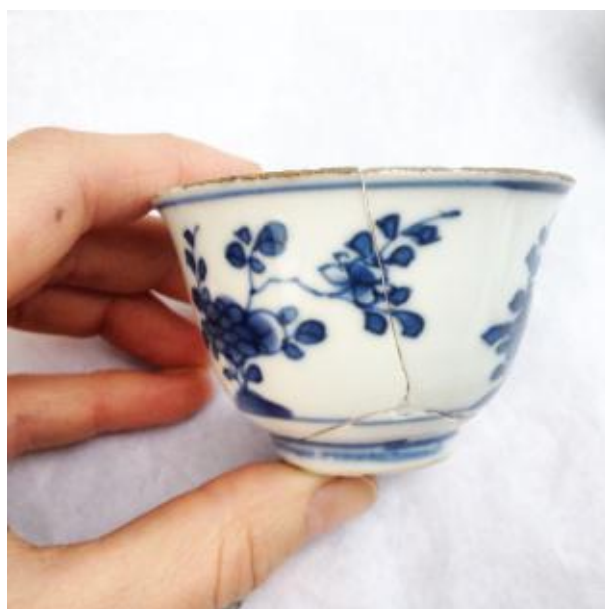
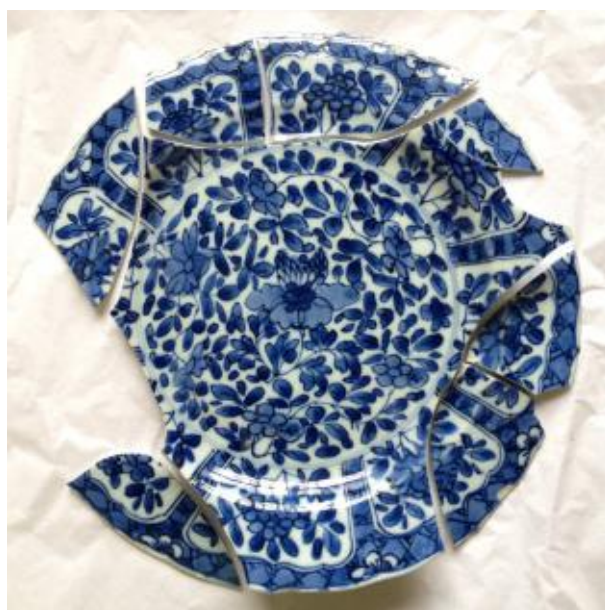
Top: Chinese porcelain plate with imperial seal
Middle: Chinese porcelain bowl
bottom: Chinese porcelain plate

The Rathfarnham ceramic tableware was generally hand-painted blue on white as was fashionable at the time. Red and gold leaf on white ('Rouge de Fer') was also represented in some of the Chinese imports. The fine tableware is either Chinese porcelain, or else Dutch or English copies. The contrast between the extremely fine porcelain and the chunkier tin-glazed European copies is interesting to see, as the assemblage dates from a time when Chinese ceramics were highly prized in Europe and European craftsmen were attempting to copy the designs themselves. Some of the Chinese porcelain plates and bowls bear makers marks, including the imperial seal of the Qim Xi dynasty (E4468:6:1355 & E4468:7:25). The Chinese porcelain assemblage at Rathfarnham is difficult to compare with other contemporary Irish assemblages, because porcelain is frequently misidentified in post-medieval Irish contexts, for the simple reason that it looks too new and modern. This reinforces the significance of the sealed deposit at Rathfarnham.

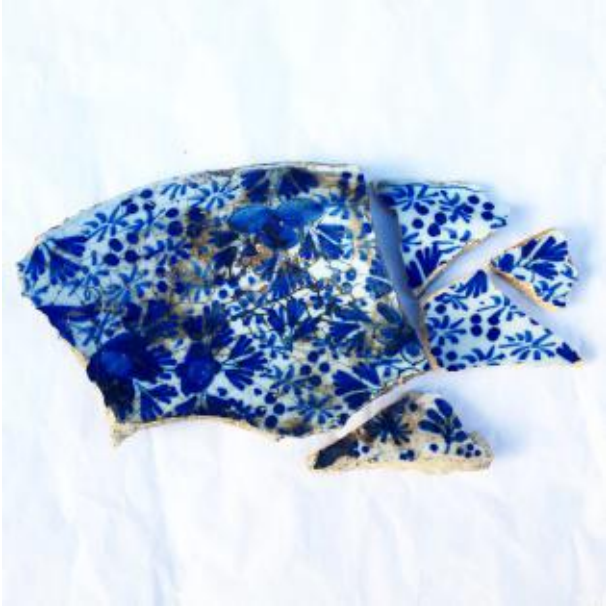
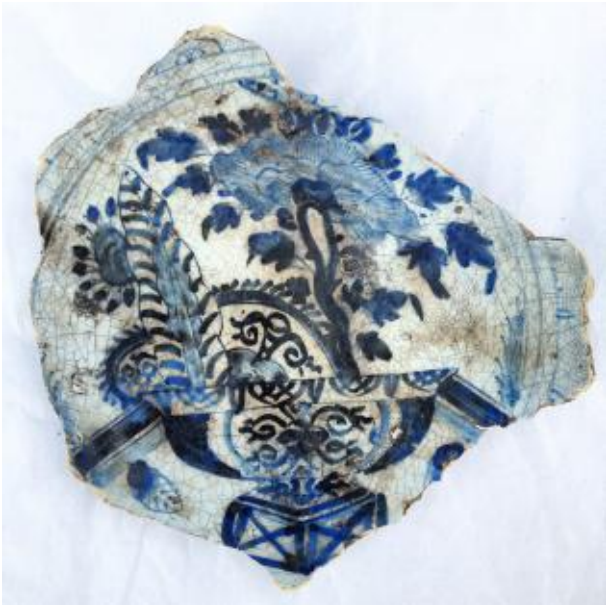
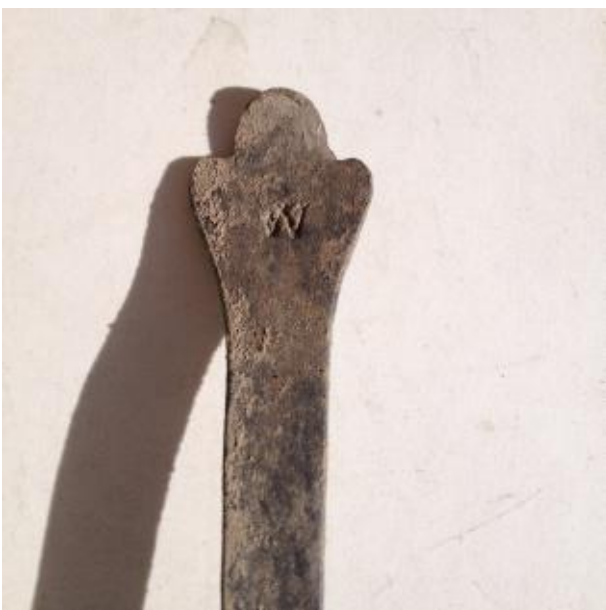
Top left: Dutch tin-glazed earthenware plate
Middle: tin-glazed earthenware plate
Bottom left: pewter spoon with 'W' 2:201

beautiful objects. Although many of the hand-painted designs are derivative of oriental ones, sometimes they achieve great elegance, for example in the case of a pair of Dutch plates with stars and dots from the De Vitte Ster factory c. 1690-1700 (E4468:6:1030-1031).

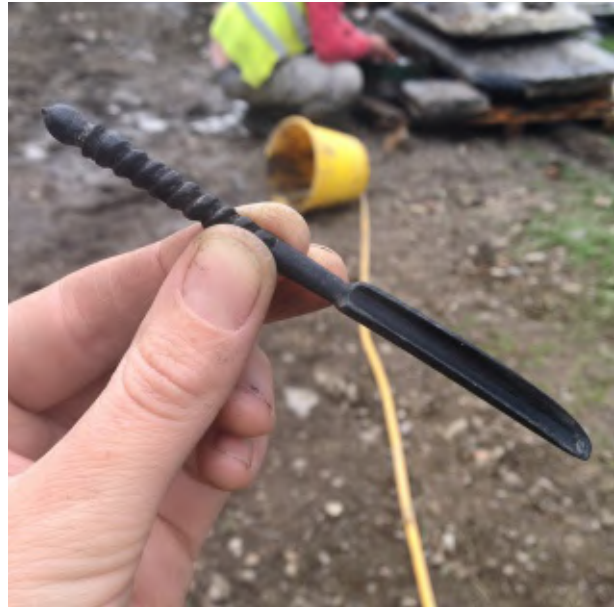
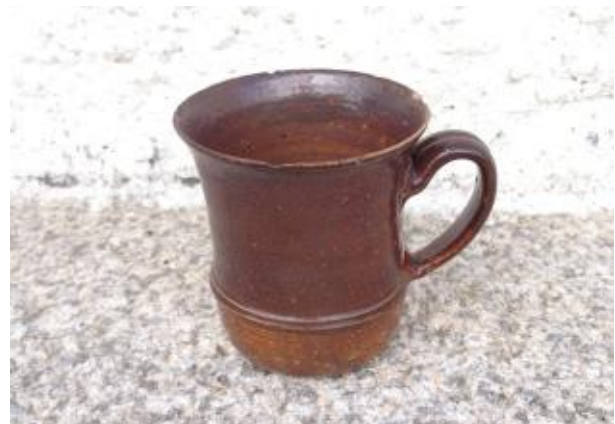
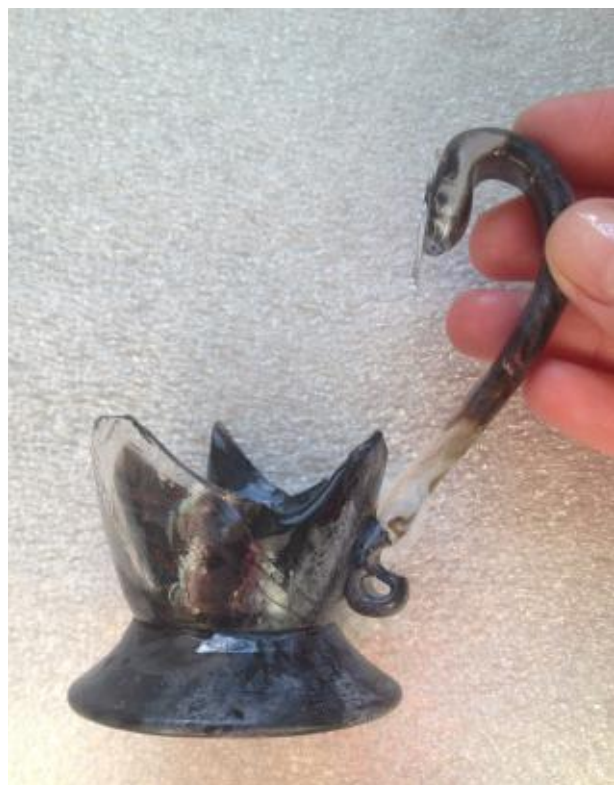
Top right: bone marrow spoon 6:4781
Middle: Fulham stoneware capuchin cup 6:1274
Bottom right: glass handled jelly glass

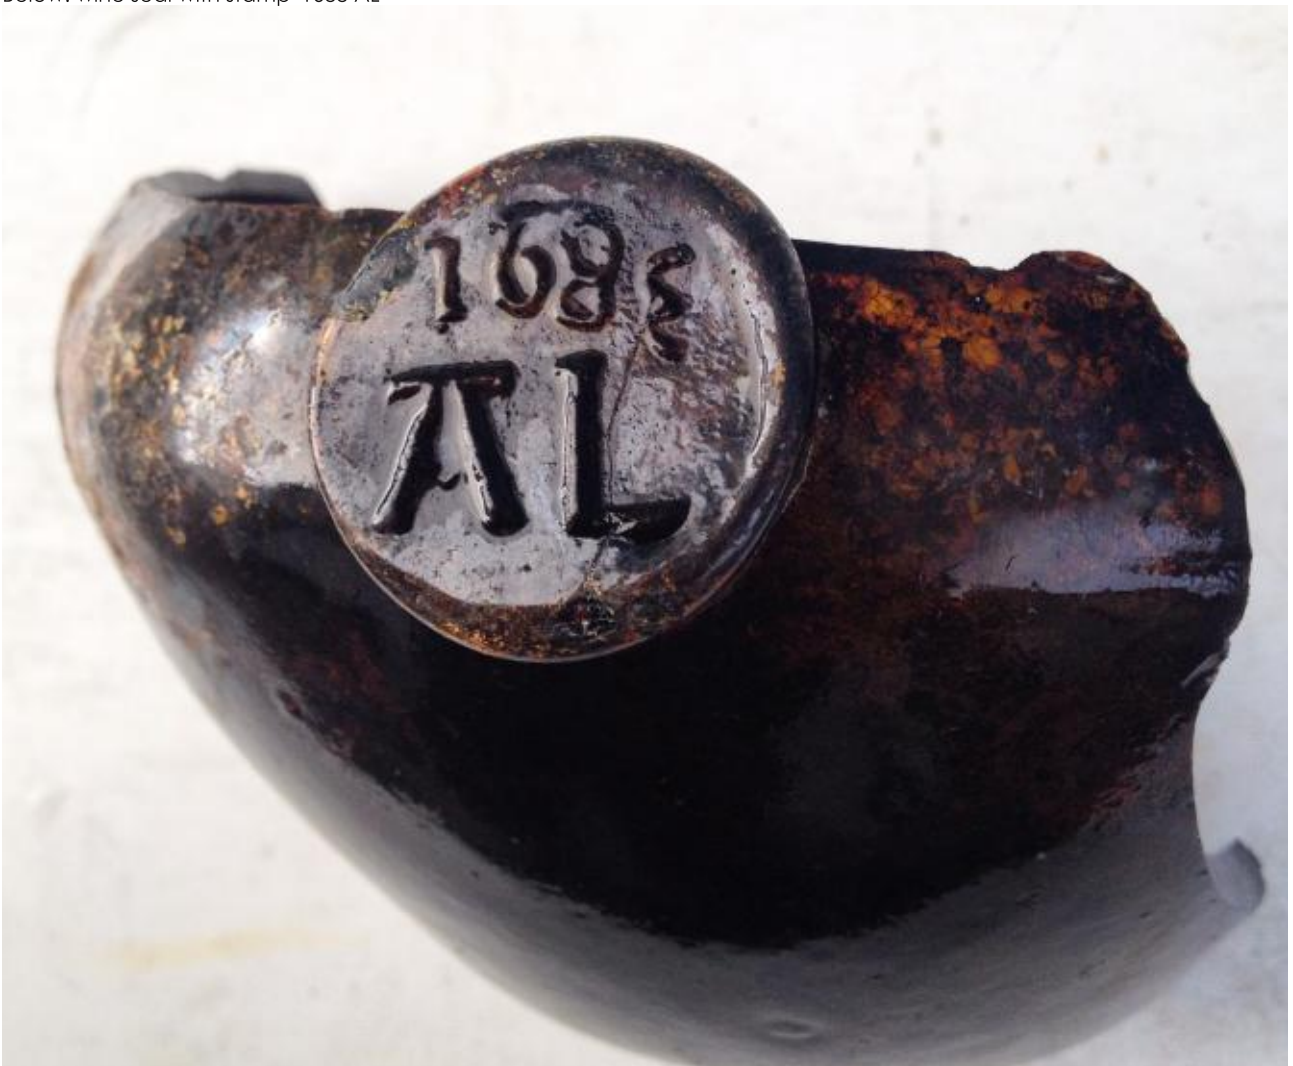
Above: array of glass bottles from the excavation
Below: wine seal with stamp '1688 AL'

Many glass wine bottle fragments were identified during the excavation of the washpit, as well as a number of complete wine and spirit bottles that date from the late 17th and early 18th centuries. Four of the wine bottles have seals stamped with 'AL 1688'. These are likely to have been made especially for Lord Adam Loftus' personal wine cellar, three years before his death. None of the bottle seals belonged to complete bottles.

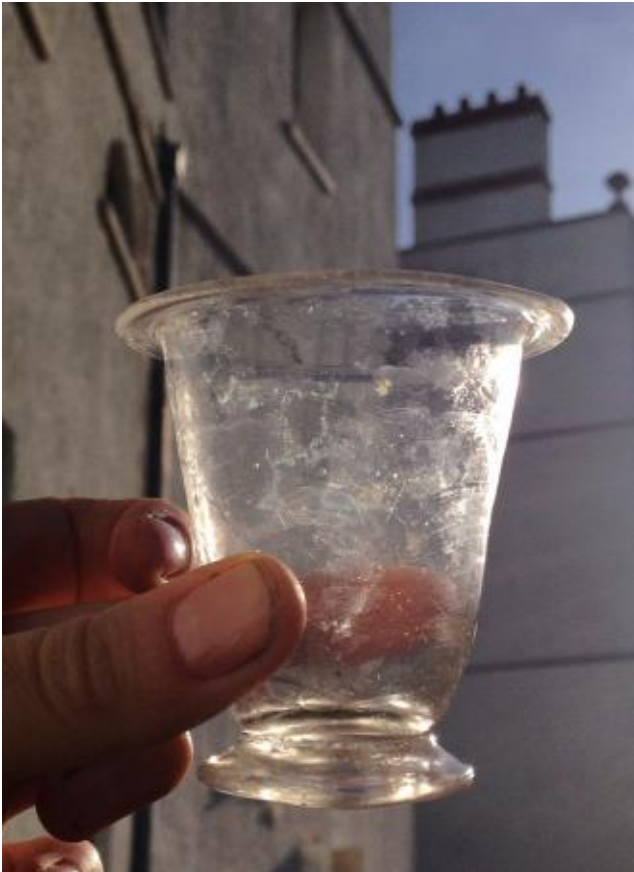
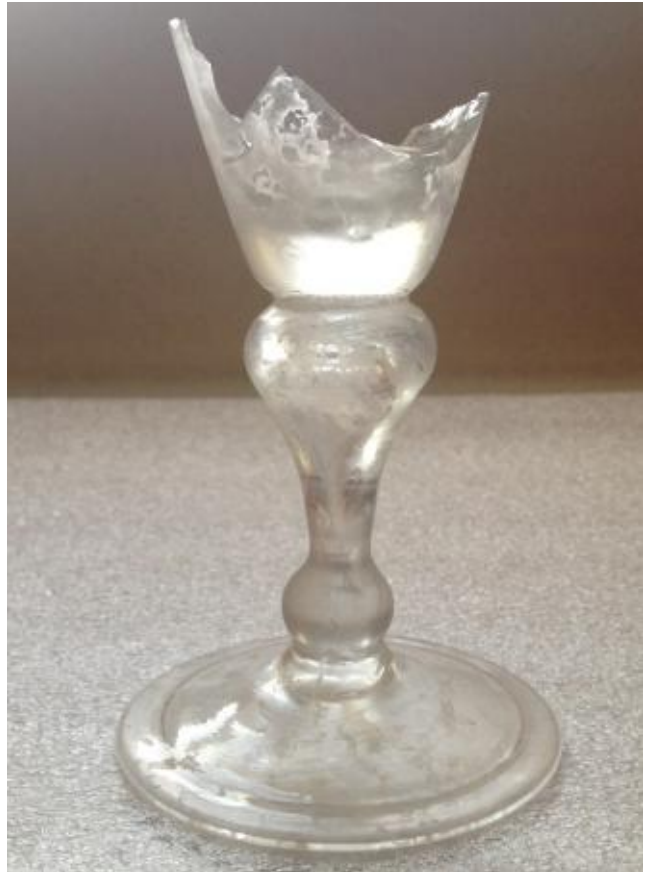
Above left: flint crystal jelly glass 4:367
Above right and below: flint crystal wine glasses

One of the highlights from the excavation is the remarkable collection of crystal drinking goblets. These are made from flint glass. Flint glass, whereby flint pebbles were added instead of sand, was considered a revolutionary new material when it was invented in the 1670s. A wide range of glasses are represented here, including some with Irish and English parallels, and the assemblage as a whole appears to date to the late

17th century. As well as the stemmed wine goblets, one small and intact jelly glass (4:367) for eating desserts and a semi-complete engraved tumbler (which appears much later than the rest of the assemblage - perhaps 1760+) were also recovered.

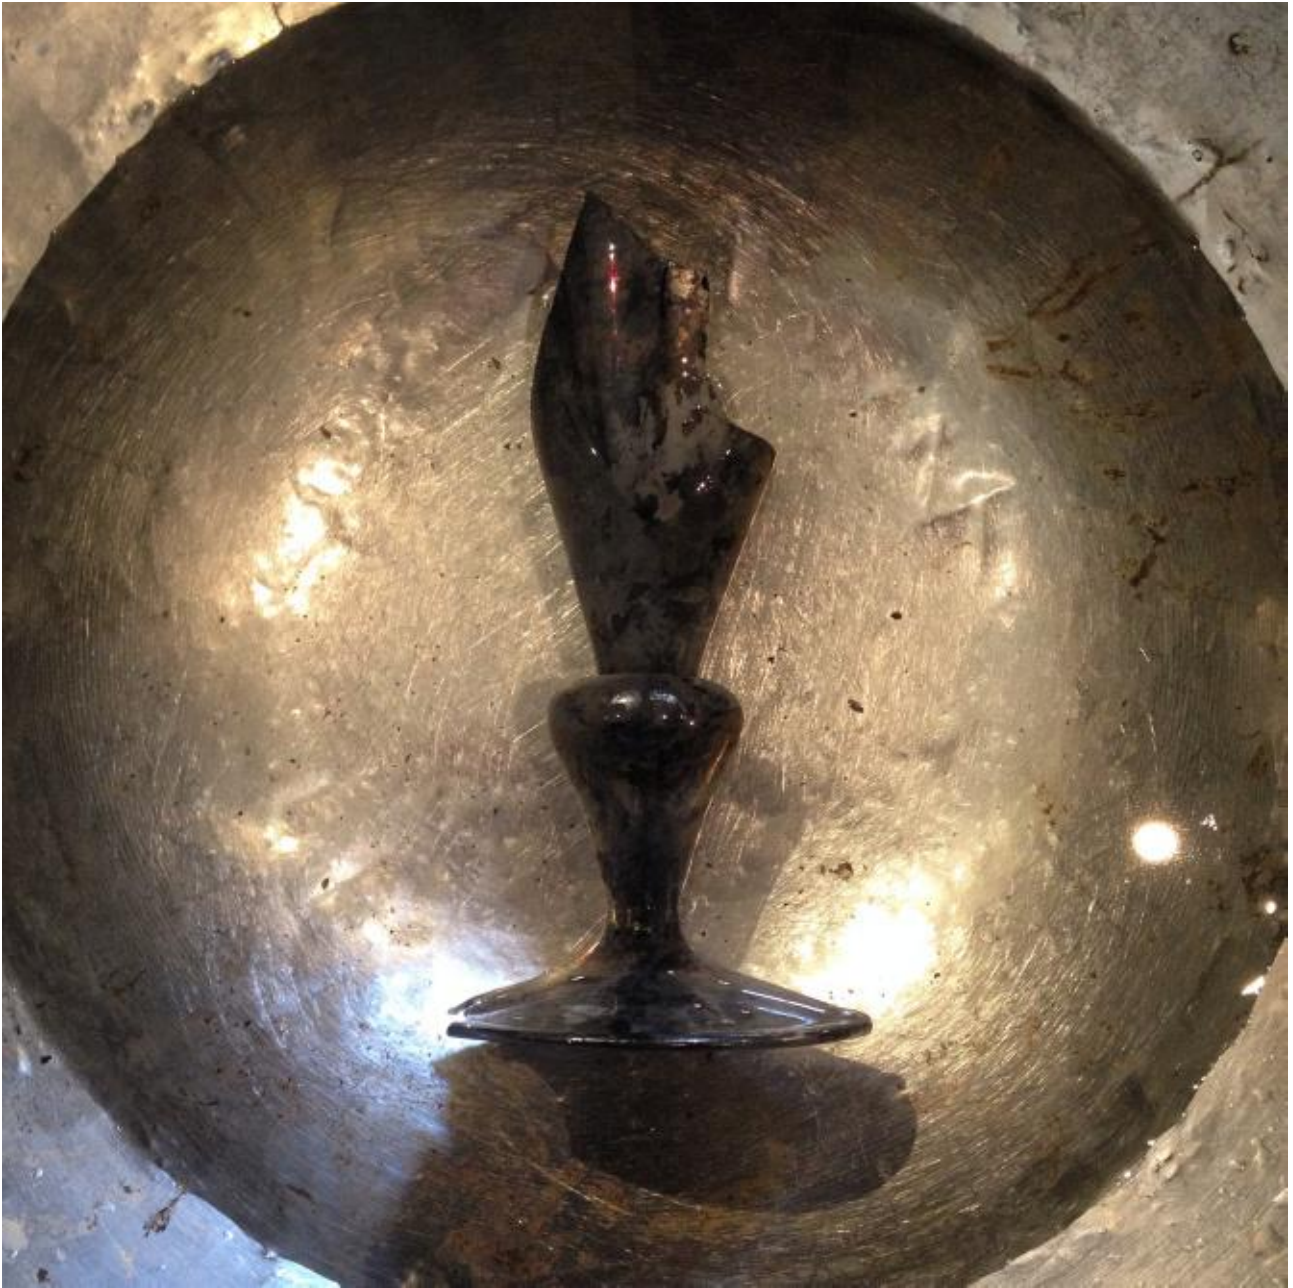
Above: flint crystal drinking glass preserved in water to minimise 'crizzling' (a sort of flaking in glass) after being excavated

The Rathfarnham drinking glasses, of which there are c. 30 in total, are very similar to the Templeogue glasses and the two assemblages must have been related. Flint glass was first commercially produced in London in the 1670s by Ravenscroft. Peter Francis has suggested that the fine-quality glass from Irish contexts may have been manufactured in Dublin since it does not resemble the known Ravenscroft glasses. He suggests a glasshouse on Lazer's Hill (now Townsend Street) in Dublin, shown in de Gomme's map of 1673, as a likely place of manufacture (Francis in Giacometti 2007, Appendix D). An-

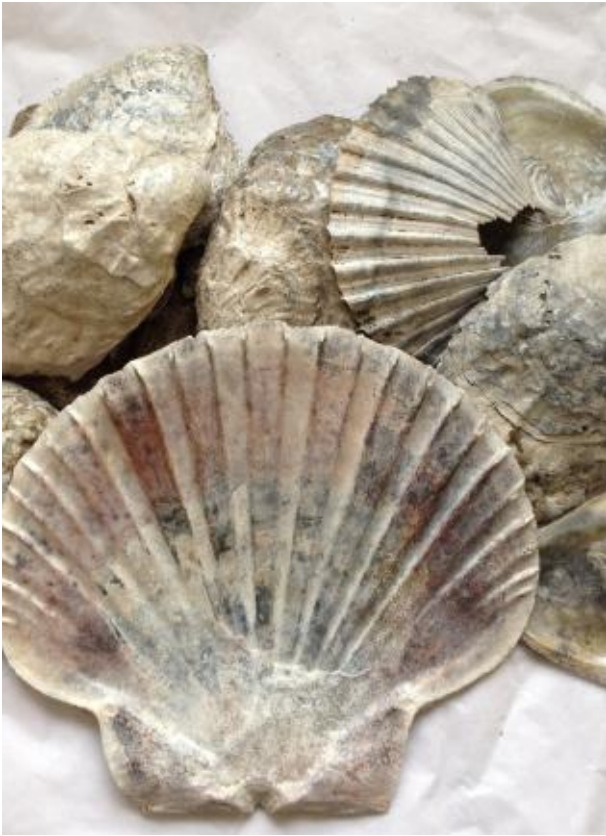
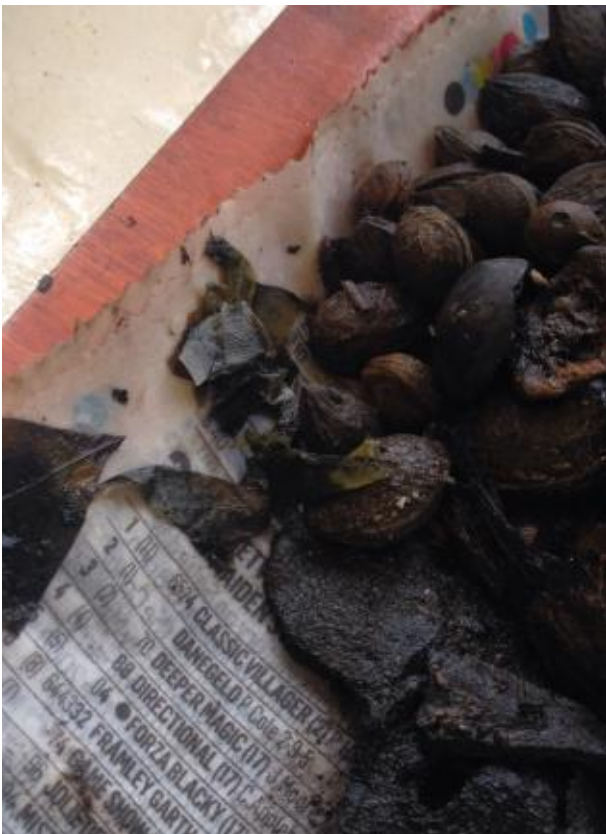
Above: sample of marine shell from excavation
 Below: sample of seeds and leaves from excavation

A moderate assemblage of animal bone included butchered mammal bone, fish bone, bird bone, and antler was uncovered during the excavation, and is likely to represent food preparation. Marine shells included 248 oysters and 80 cockles, as well as crab, scallops, mussels, periwinkles and limpets. Pheasant and pigeon eggshell was also identified. Of particular interest are two fragments of very well preserved banana skin (E4468:4 Sample 10). Bananas could have been eaten in the late 17th century at Rathfarnham Castle, but this find would be unique and the preservation is exceptional. Radiocarbon dating will show if these are intrusive.

A huge number of seeds within the deposit were preserved remarkably well. The most abundant seeds from a sample (E4468:2 Sample 23) were those of various *Prunus* species (M. Jebb pers. comm. 2014 & rest of this section). These probably include cherries (*Prunus avium*), which grow wild in Ireland but have also been selected as 'sweet cherry'. They may include sloes or black-thorn fruits (*P. spinosa*), wild plums or damsons (*P. domestica subsp. insititia*) and domestic plums (*P. domestica*), of several shapes and dimensions suggesting a range of cultivars. Peach (*P. persica*) with its characteristic rough-surfaced seeds may be present, and the largest of the 'smooth' *Prunus* seeds may be apricot (*P. armeniaca*). Most of these fruits could have been cultivated in walled gardens, but peach and apricot would have required glasshouses, since transportation of these soft fruits is notoriously difficult. Only one of the plum seeds had been opened by a mouse. Normally *Prunus* seeds stored in the dry are eaten by mice, suggesting that these seeds probably entered an anaerobic, under-water position very early on after being discarded.

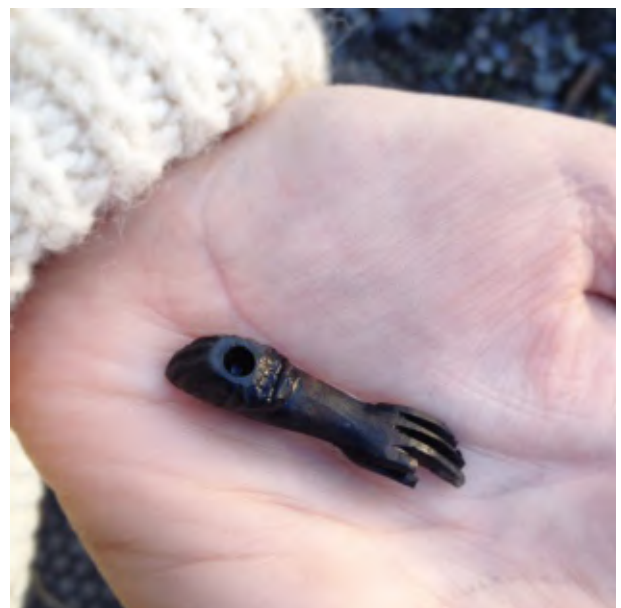
Above left: crab claw
 Above right: Yixing Chinese stoneware crab lid of teapot 6:1351
 Below: wood doll’s arm 6:4783

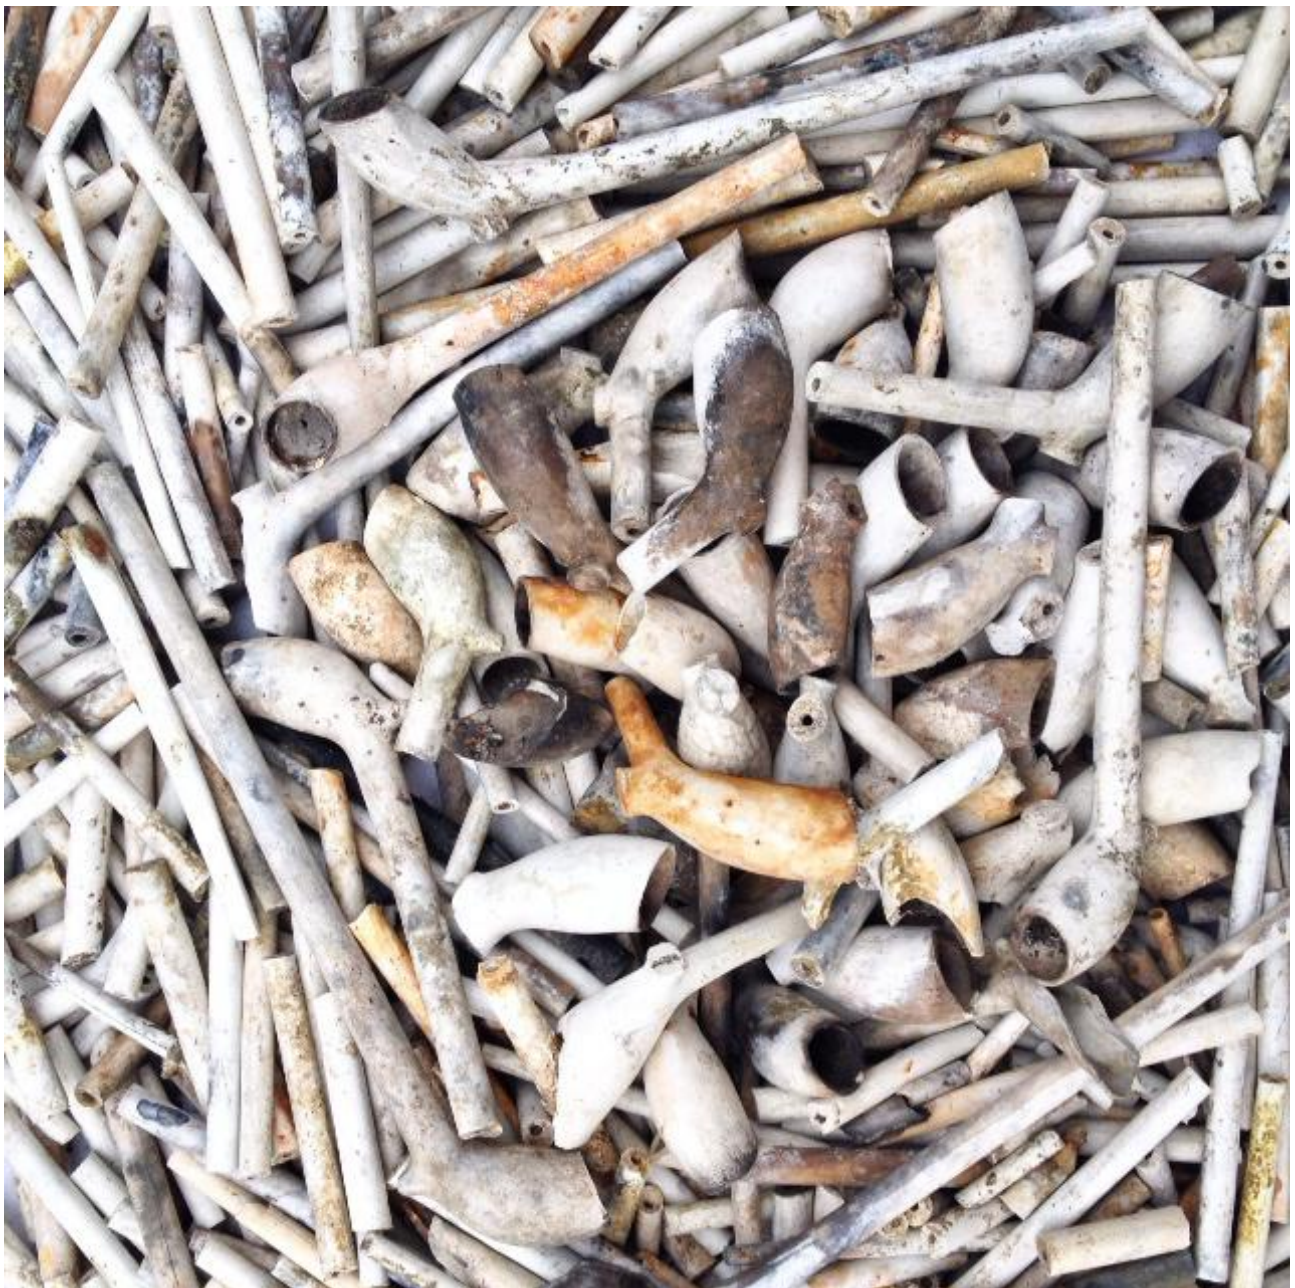
Below: clay pipes from the excavation

range of plain bowl types that can be tightly dated to the late 17th and early 18th centuries.

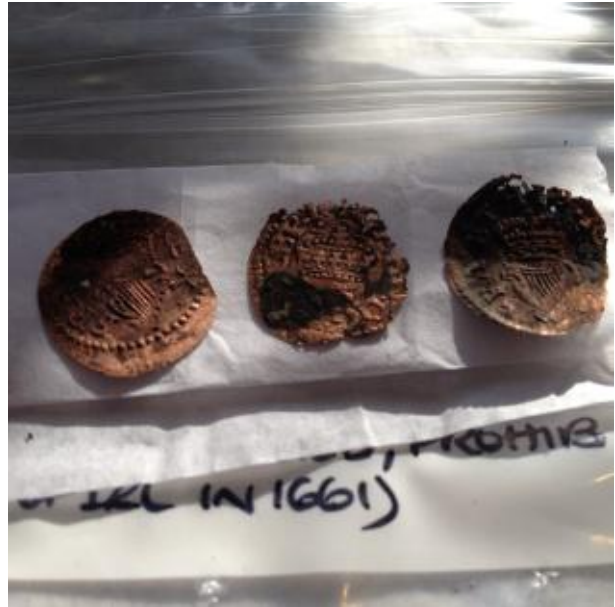
Above: coins from the excavation
Below: drawing of the 1602 Irish copper penny by Alva Mac Gowan

Of the identifiable coins, the earliest is an Irish copper penny of Elizabeth I from 1602 (Michael Kenny pers. comm. 2015 & rest of this section). The issue of copper pennies and halfpennies in 1601-02 coincides with the issue of a base silver coinage of shillings, sixpences and threepences issued by Elizabeth I to help finance the war and pay the troops involved in the campaign against the Ulster chieftains, Hugh O'Neill and Hugh O'Donnell. There are four farthing tokens, one of James I and three of Charles I. As these were issued under royal license they are usually named from the licensees and are therefore known as Harrington or Lennox farthings (reign of James I) and Richmond or Maltravers farthings (reign of Charles I). The first license was issued to Lord Harrington in 1613 and this was taken over later by another royal favorite the Duke of Lennox. In the reign of Charles they were issued by the Duchess of Richmond and later by Lord Maltravers. There are numerous dies, mintmarks and design variations and since the tokens here are in fairly poor condition I have not attempted to subdivide them beyond that of reign.

The other identifiable copper coins include two regular halfpennies of Charles II and William and Mary, a Dublin trade token issued by Mic(hael) Wilson in 1672, and an interesting emergency issue Hibernia halfpenny issued by the Jacobites at Limerick in 1691. The Limerick halfpenny holds particular interest as Rathfarnham Castle's resident at the time, Adam Loftus, the Baron of Rathfarnham and Viscount of Lisburne, lost his head there to a cannonball. It is possible that he managed to pocket a few of these Jacobean coins before dying. The Hibernia halfpenny is in fact an emergency coin produced by over striking an earlier emergency coin. The entire 'gunmoney' issue of James II was an emergency coinage, struck to help finance his war against William III. Struck in brass, lead, pewter and whatever base metals could be found, the denominations bore no relationship to the actual intrinsic metal worth of the coins. Among the issues struck were brass shillings and it was these coins that were over struck during the Siege of Limerick, to circulate at the more realistic value of a halfpenny as Jacobite finances collapsed. Some elements of the original design are still faintly visible on the Hibernia piece. After the war, the entire emergency coinage of James was reduced to its actual metal value

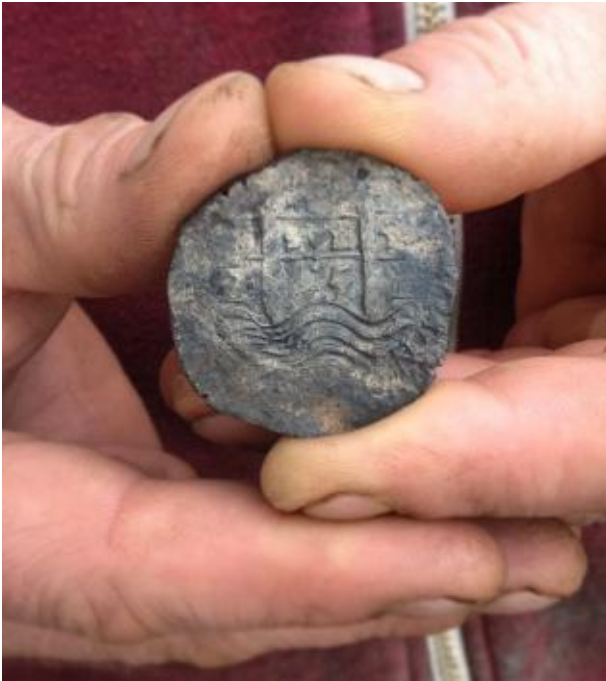
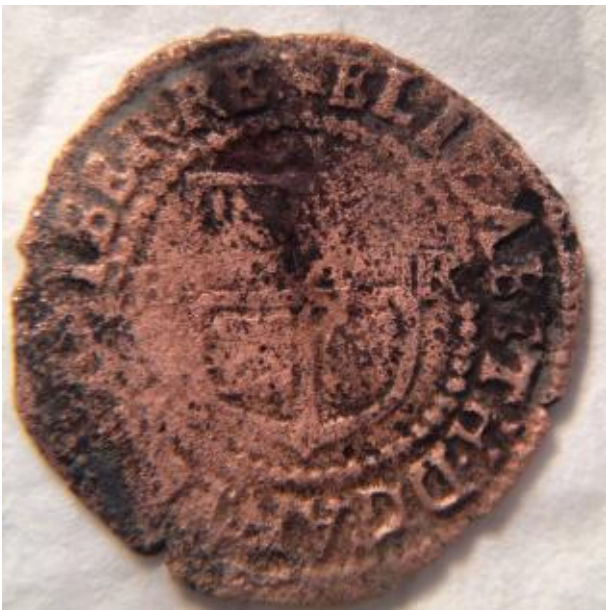
Top: silver Potosi 'piece of eight' reales 1655, 9:270
 Bottom: Irish copper penny of Elizabeth I 1602, 9:179

the coins but is not particularly rare. Spanish silver, especially issues from the mints and mines of South America, circulated widely in Ireland in the 17th century. The authorities issued ordinances at different times, regulating foreign coins by weight and value and had official sets of coin weights made to facilitate their use by merchants and traders. The South American coins are often of poor quality in terms of style and design but mostly of good silver. They are usually very hard to read, with a baffling array of designs, mint-marks and assay masters' initials. Difficulties of identification are made harder by the fact that there were three kings of Spain in succession with the same name, Philip II, III and IV. Luckily the date, 1655, is fairly clear on the Rathfarnham coin, which places it in the reign of Philip IV (1621-65). The number 8, representing the denomination, 8 reales, is also visible, as is the mint initial P for Potosi and the initial E for Antonio Ergueta who was the principal assayer at the mint for nearly three decades, from c.1650 until his death or retirement in 1678. Potosi was hit by a major scandal in the late 1640s, involving corruption, absenteeism, sub-letting of jobs and poor quality silver. A big clear out followed and some officials were executed (by beheading), others jailed and several banished. Ergueta came in as part of the new team and was especially associated with the Pillars of Hercules design type of which the Rathfarnham coin is an example.

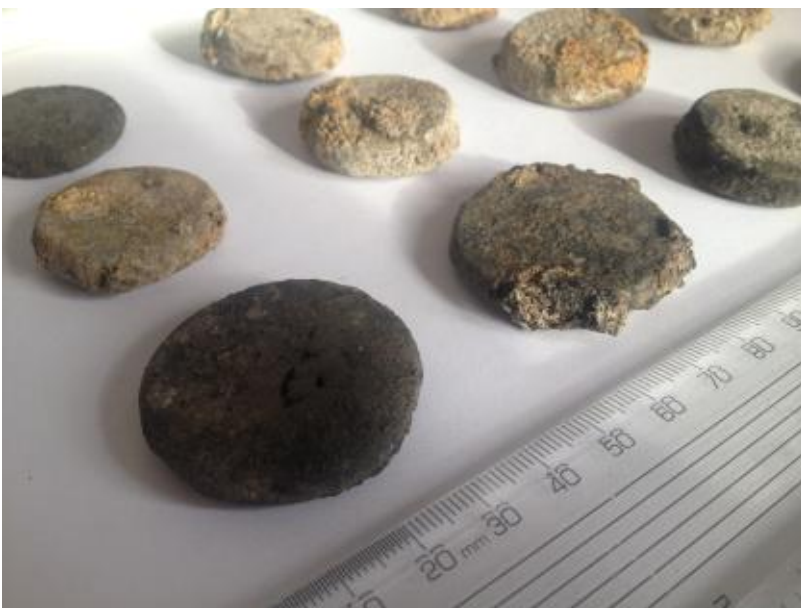
Top: lead weight 9:274
Middle: lead weight or ingot of lead
Bottom: array of lead weights

Forty-four lead discs or fragments were identified in the excavation. In the early medieval period the Vikings used lead alloy weights to weigh silver. By the 17th century commerce had become somewhat more complex. Due to the influx of a variety of foreign currency and England's unstable monarchs, coinage was constantly changing. The value had to be determined in another way, sometimes by metal, other times by weight. Coin weights had particular values etched into them, but most of the weights from Rathfarnham are blank. Some of the weights were marked however, for example one (E4468:9:274) lead disk with a raised rim has the letters 'C O' and other illegible markings.

If not weights, these unmarked lead discs may be related to the musket balls and shot being produced at the castle. It is also possible that these objects were weights on their way to becoming recycled as shot.

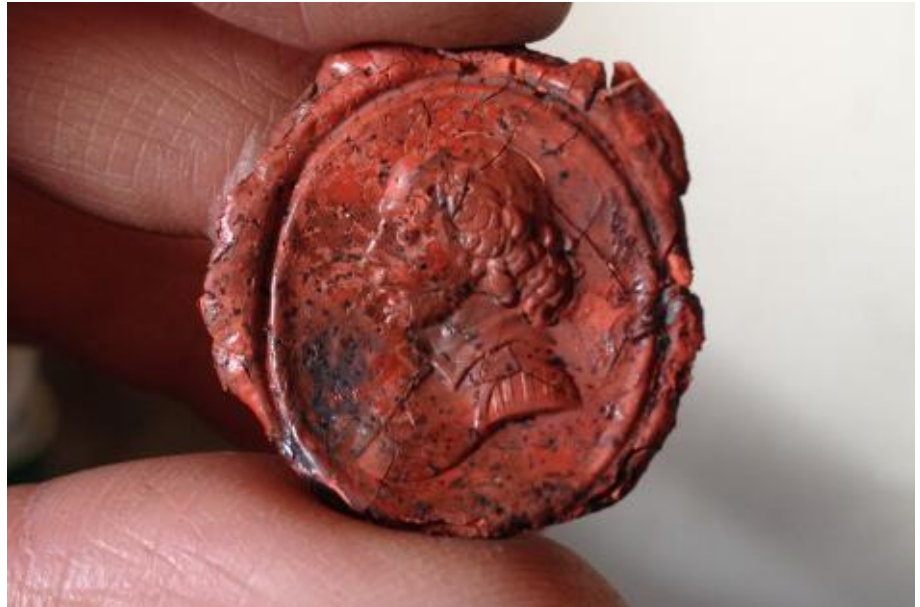
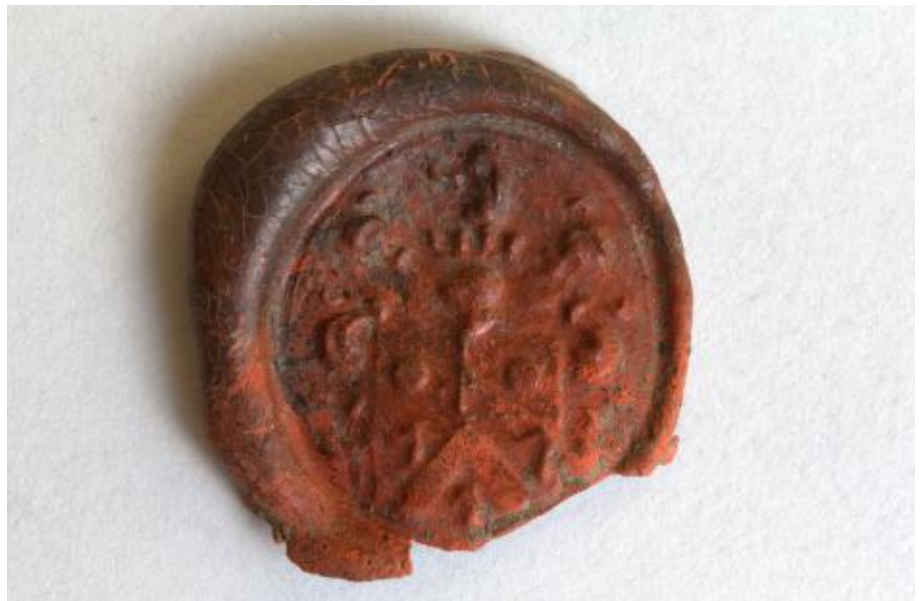
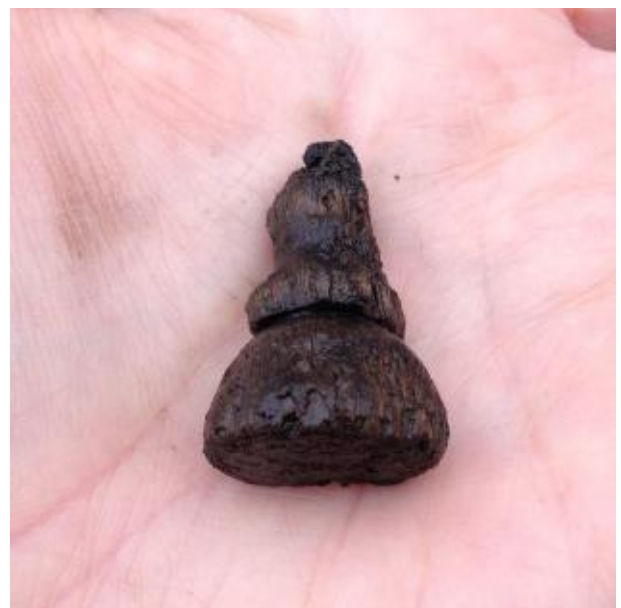
Top: wax seal 6:10
Middle: wax seal 2:3
Bottom: wax seal stamp handle 6:14

The fragments of sealing wax found at Rathfarnham are some of the earliest known wax seal impression fragments recovered from an excavation in Ireland, which rarely survive in archaeological contexts. Three of the wax seal impressions possess decipherable heraldry markings and a portrait. One is complete and shows a side profile portrait of bearded gentleman in 16th century attire (E4468:6:10). Another has the initials 'RH' (E4468:6:8042). Another has a small heart in the centre of a larger diamond (E4468:7:2). All of these seals presumably belong to the sender of letters addressed to Rathfarnham Castle. Identifying the sender could

Two seal-related items are likely to have belonged to the occupants of Rathfarnham Castle. These are a stick of red wax (E4468:6:13) and a wooden wax seal stamp handle (E4468:6:14) with the metal seal unfortunately missing. No Loftus family seals were identified: letters with these were probably posted off to other large houses in Dublin, England, France and beyond.

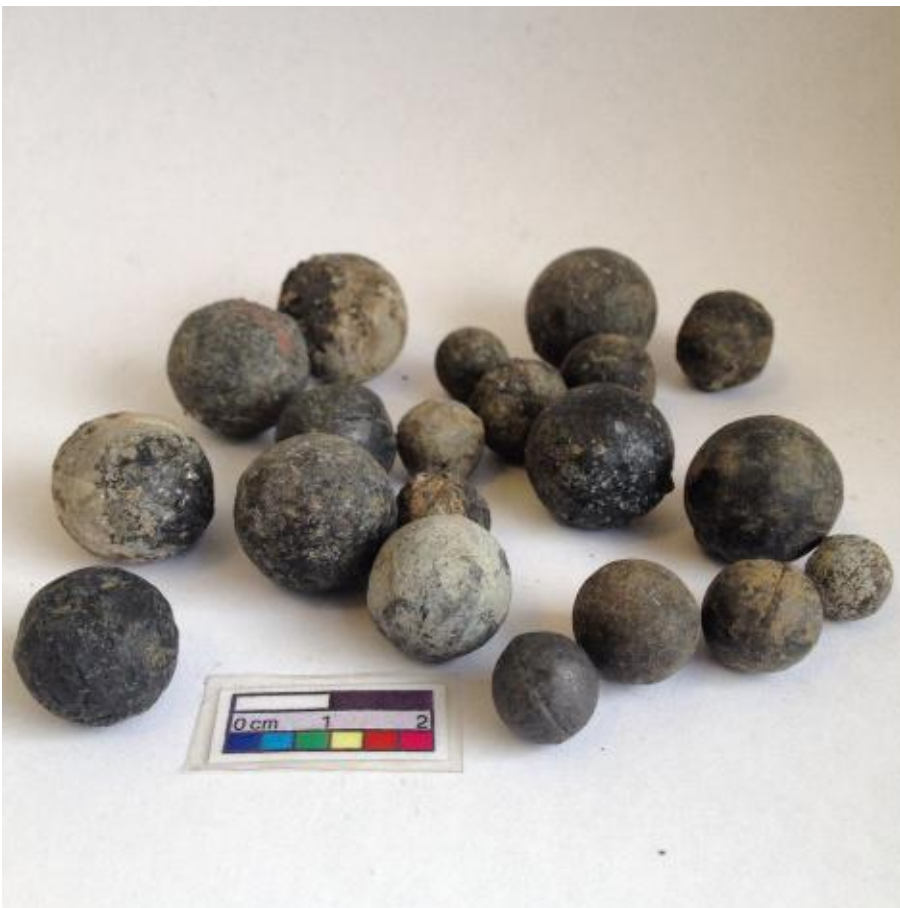
Among the most exciting discoveries in the assemblage was a complete 17th century Cromwellian front armour 'Harquebuzer' steel breast plate (E4468:6:1). It is made from a single medially-formed steel plate with turned neck and arm openings, it has a V-shaped lower edge and is single shot proofed to the centre-right abdomen.

Top: steel breast plate 6:1
Bottom: selection of musketballs

Twenty-one lead musketballs, 78 pieces of lead shot and 15 fragments of gunflint were found. These are all gun-related but no guns or gun fragments were identified. The only weapon found in the assemblage was a miniature glass rapier. Some of the lead shot may have come from kitchen contexts rather than military ones, for example from game hunted on the estate.

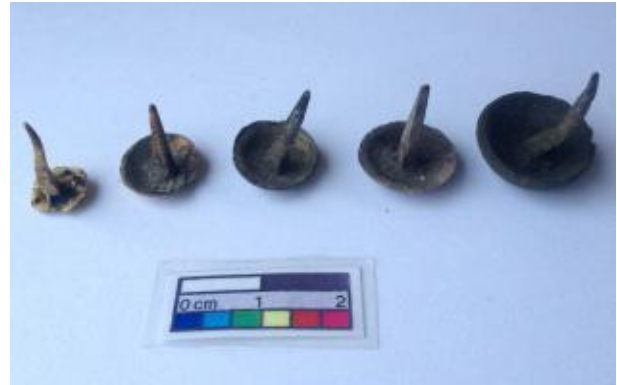
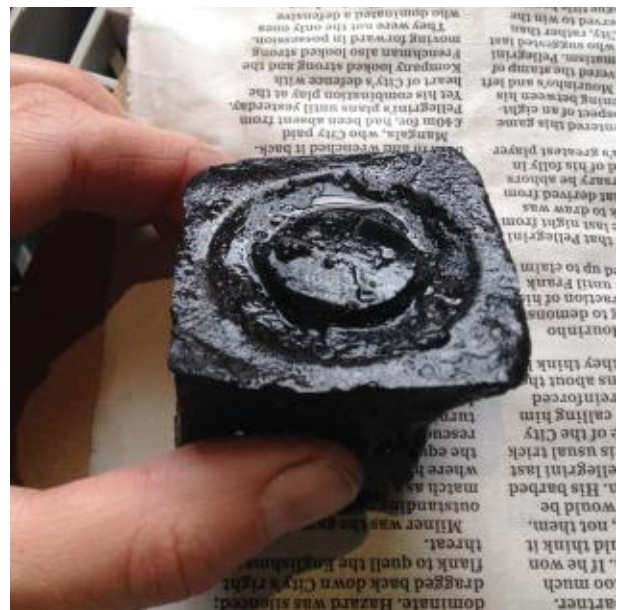
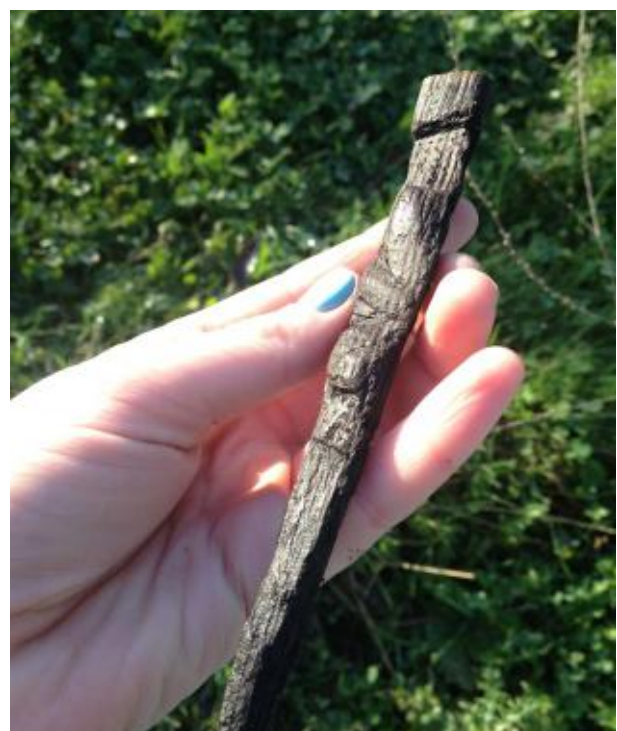
Above: brass tacks arranged by size

Below: part of a small box

Bottom: fragment of decorated wood panel

ing copper alloy, brass and iron. The heads and shafts are integrally cast. The tacks are not uniform and many of them, through use and wear, have been beaten out of shape. Even still, most of them can be roughly divided into seven different sizes. The smallest size may have been used for fixing decorative braid or 'gimp' to upholstery. The rest of the sizes are mainly studs used to decorate leather or textile-covered furniture, though panelling studs could also be functional as well as decorative (P. Boyle 2015, pers. comm.).

Fragments of wooden furniture and leather furnishings were uncovered. These include a leather upholstery panel from a chest or chair (E4468:6:8040), a carved wooden panel with foliate decoration from a section of wall panelling or a piece of furniture like a box or chest (E4468:6:5572), and a wooden finial from a bedpost of chair (E4468:6:5565). One item (E4468:6:5567) has been identified (Patrick Boyle 2015, pers. comm.) as a fragment of a rotten table leg, something that might have been sitting in a basement for a while, sawn off and re-used as a rush light holder. A possible glass lampshade (N. Roche pers. comm. 2015) was also identified.

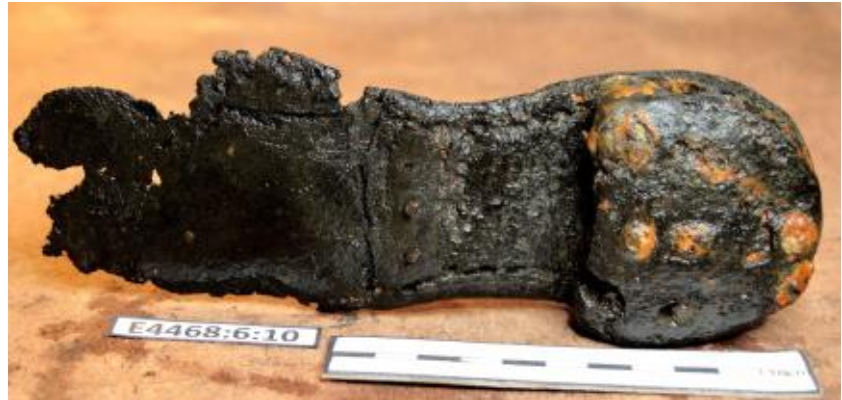
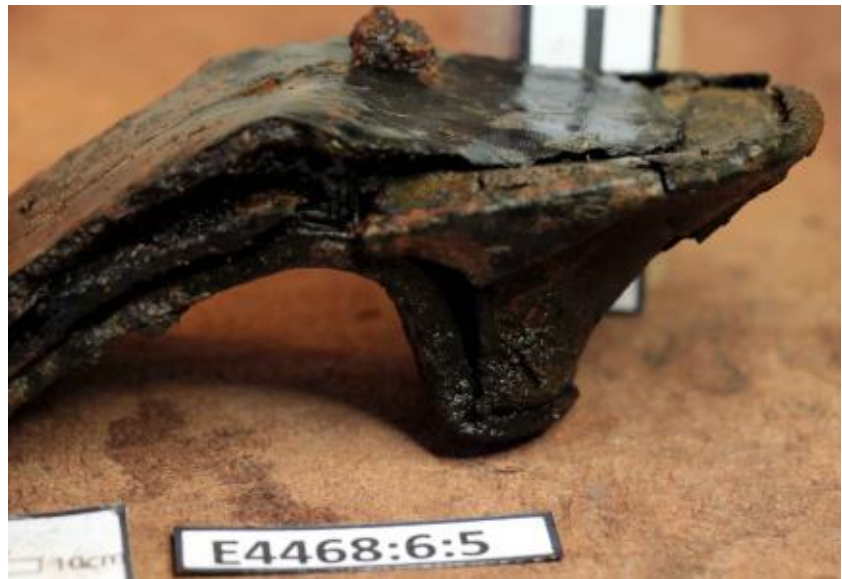
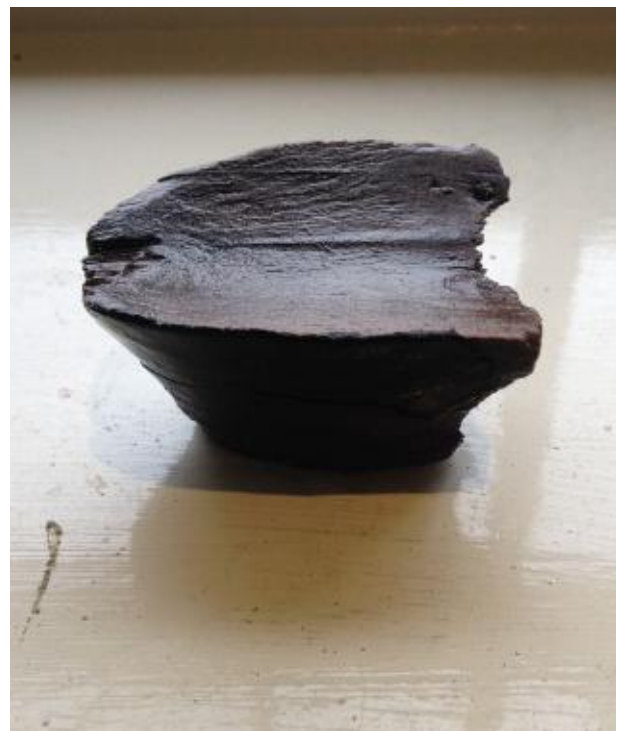
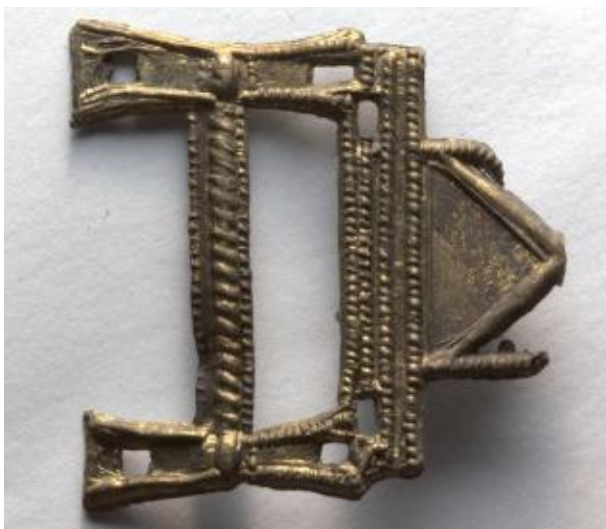
Above: shoes from the excavation
Left: buckle from a shoe or a belt
