# Rathfarnham Castle 2018

## Archaeological test-pits

Rathfarnham Castle (Phase 7 Works), Grange Road, Rathfarnham, Dublin 14

Office of Public Works, OPW Architectural Services

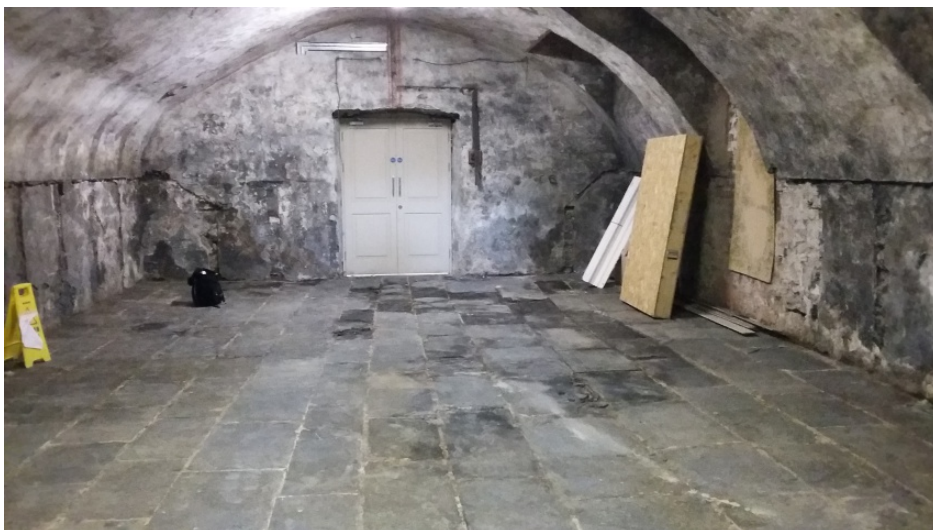
Room B8 facing east, showing 18<sup>th</sup> century paved stone floor. Decayed paving stones are darker in colour in centre of photograph.

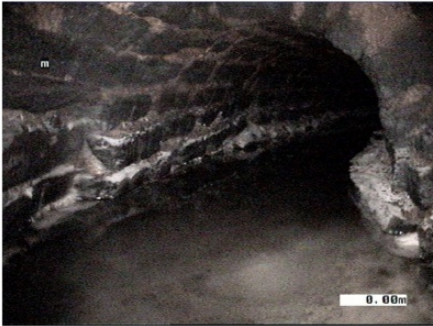
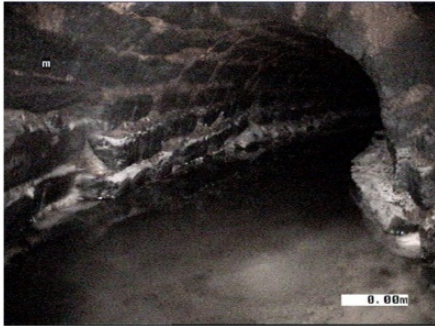
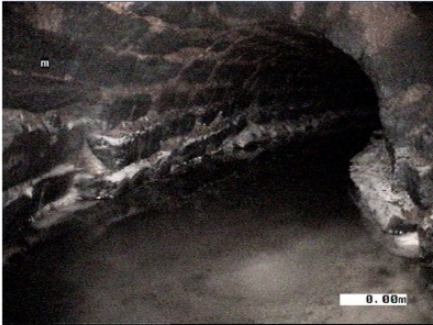
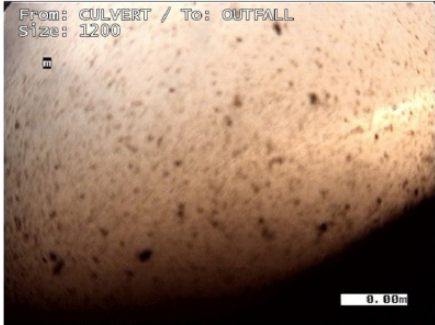
CCTV Inspection Photos

A CCTV inspection of the drain was undertaken by Dyno-Rod Dublin (Benson 2017 ref 78558). The survey hit debris almost immediately so was unable to follow the culvert. From the CCTV footage directly below the manhole, the drain is stone-lined and stone-arched, in good condition, and part-filled with water. From the manhole, the drain extends northwest and southwest. To the southwest, the drain extends only a very short distance (less than 1m) and appears to end intentionally at the spine wall. To the northeast the drain curves immediately towards the east and may continue eastwards parallel to the spine wall. The CCTV survey only extended 100mm due to debris.

Start of Survey Length	Start node type, lamphole, reference CULVERT

Water level 30% height/diameter	Survey abandoned - Remark: DUE TO DEBRIS

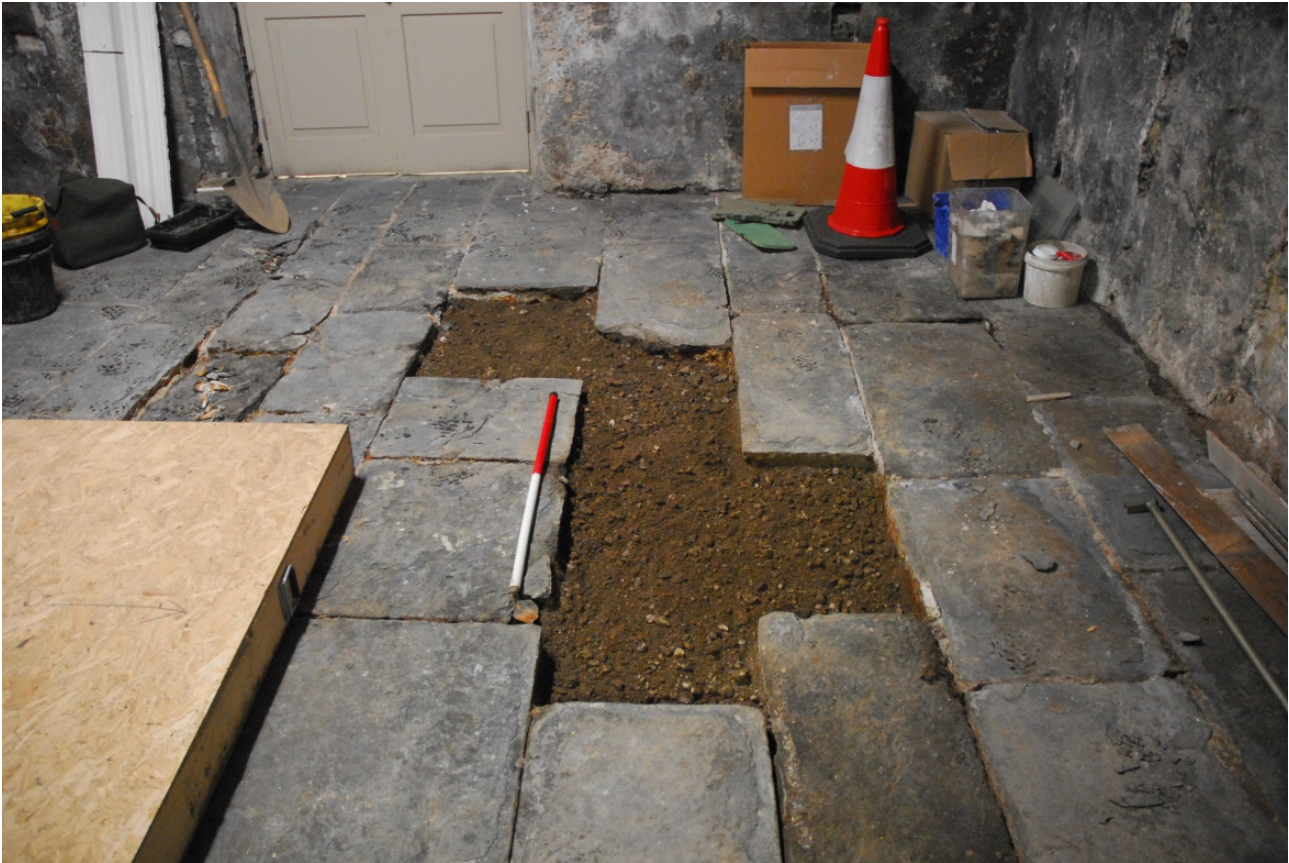
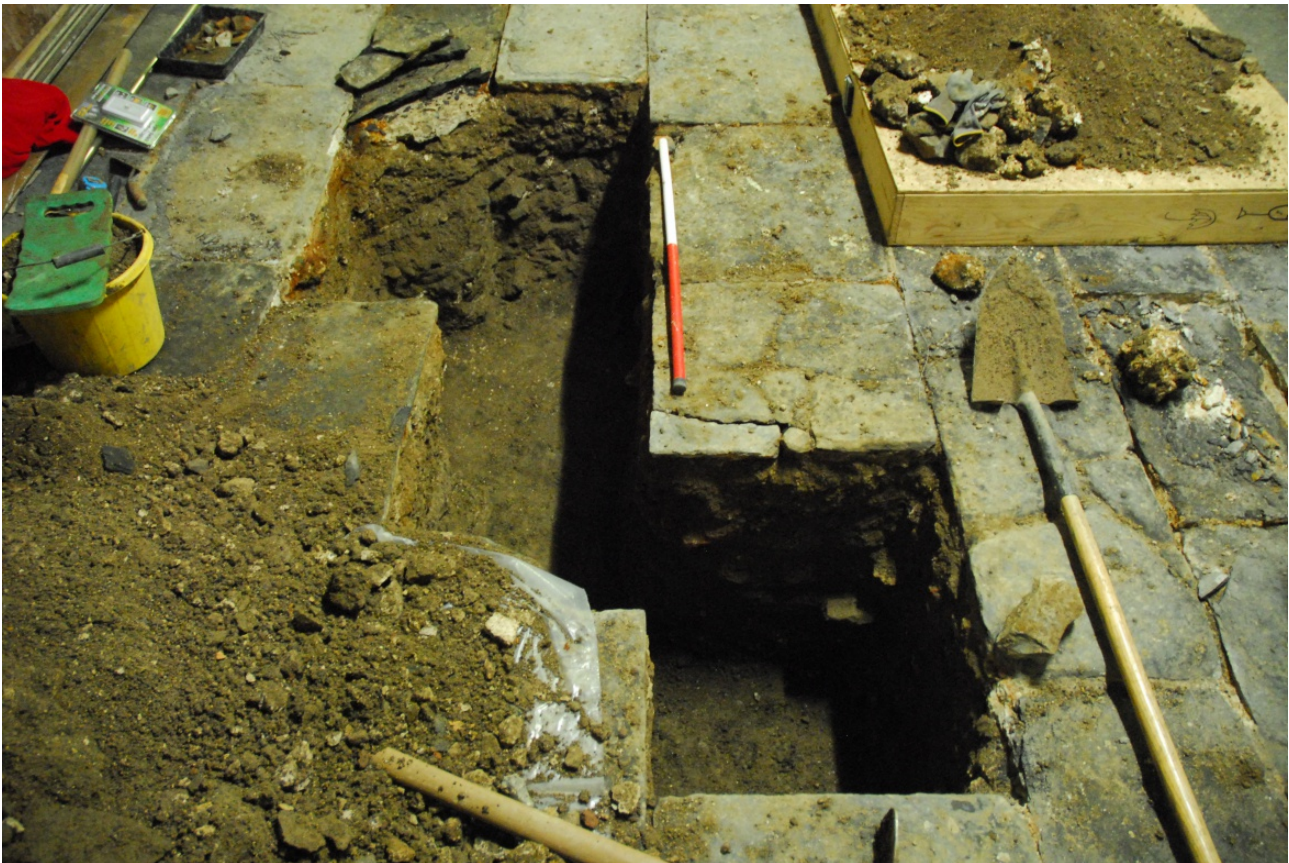
Test-pit 1 prior to excavation, following removal of 18<sup>th</sup> century paving stones, facing west

Test-pit 1 after excavation, showing natural subsoil at a depth of c. 1m, facing east

Four damaged paving slabs (Room B8: slabs C4, D3, D4, E4; 100.02m OD) were removed in the larger (western) northern basement, exposing an irregular area of subfloor measuring up to 2.30m east-west by 1.50m north-south. This area was selected as Test Pit 1. The centre of the test-pit was situated 2.48m from the west wall and 1.70m from the north wall.

A thin (5mm) layer of mortar subfloor (C1aa) had been previously removed by the conservation stonemasons PMAC. Below it was a loose deposit of greyish-brown silty-sand 700mm thick (base at 99.26-99.32M OD) with inclusions of animal bone, handmade red-brick, mortar, bottle glass, tin-glazed wall-tile and lead fragments, with lenses of dumped ash and clay. The upper half of the deposit was darker with ferrous-coloured staining (C1a) while the lower half was paler with a higher proportion of mor-

Below this, two discrete dense patches of mortar at 99.32m OD (700mm below the existing floor) are likely to represent the remains of a 16<sup>th</sup> century sub-floor. The original 16<sup>th</sup> century sub-floor was not present within the test-pit.

Below this, a 200mm thick dense dark greenish-brown silty clay (C2) with inclusions of marine shell and charcoal at 99.26m OD. A fragment of green-glazed earthenware floor tile was recovered. This was underlain by a mixture of the same material and natural subsoil that probably represent a layer of trample dating to the 1583 construction of the castle (C3). It was in turn underlain by natural subsoil comprising a dense sterile greenish-brown clay at 99.03m OD, 1m below the existing floor. The sub-floor castle drain was not present within the test-pit.

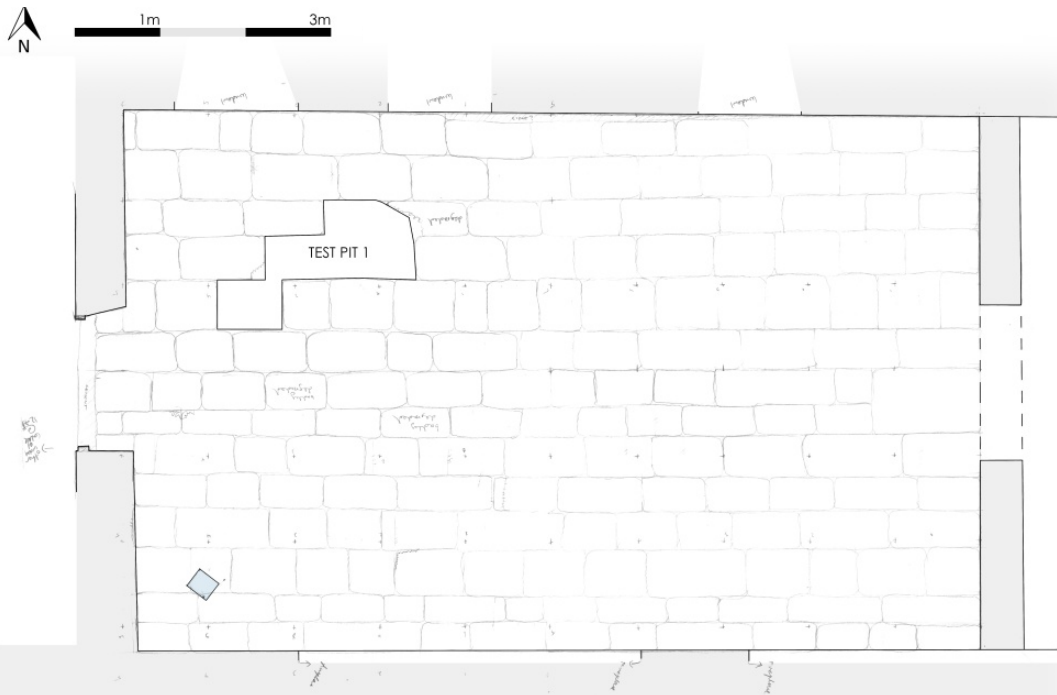
Archaeological plan of Rathfarnham Castle basement room B8 (northwestern room). This plan was surveyed in order to correctly mark the locations of the drain manhole (in blue above) and test-pit 1. The OPW baseplan contains a number of inaccuracies in terms of the placement of individual paving stone (presumably due to the fact that the room is not exactly rectangular) so could not be used for this purpose

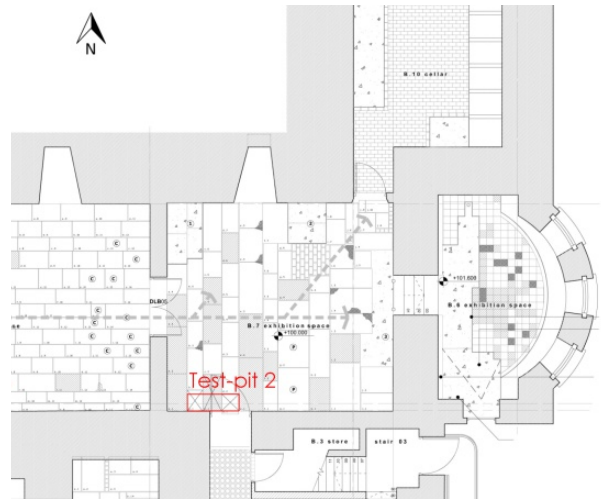
Location of Test-pit 2 on OPW base plan, northeast room of basement

Three damaged slabs (Room B7: slabs B1, C1, D1; 100.02m OD) were removed in the smaller (eastern) northern basement, exposing a rectangular area of subfloor measuring 1.64m east-west by 0.65m north-south. This area was selected as Test Pit 2. The test-pit abutted the southern wall and doorway, and was 0.62m from the west wall.

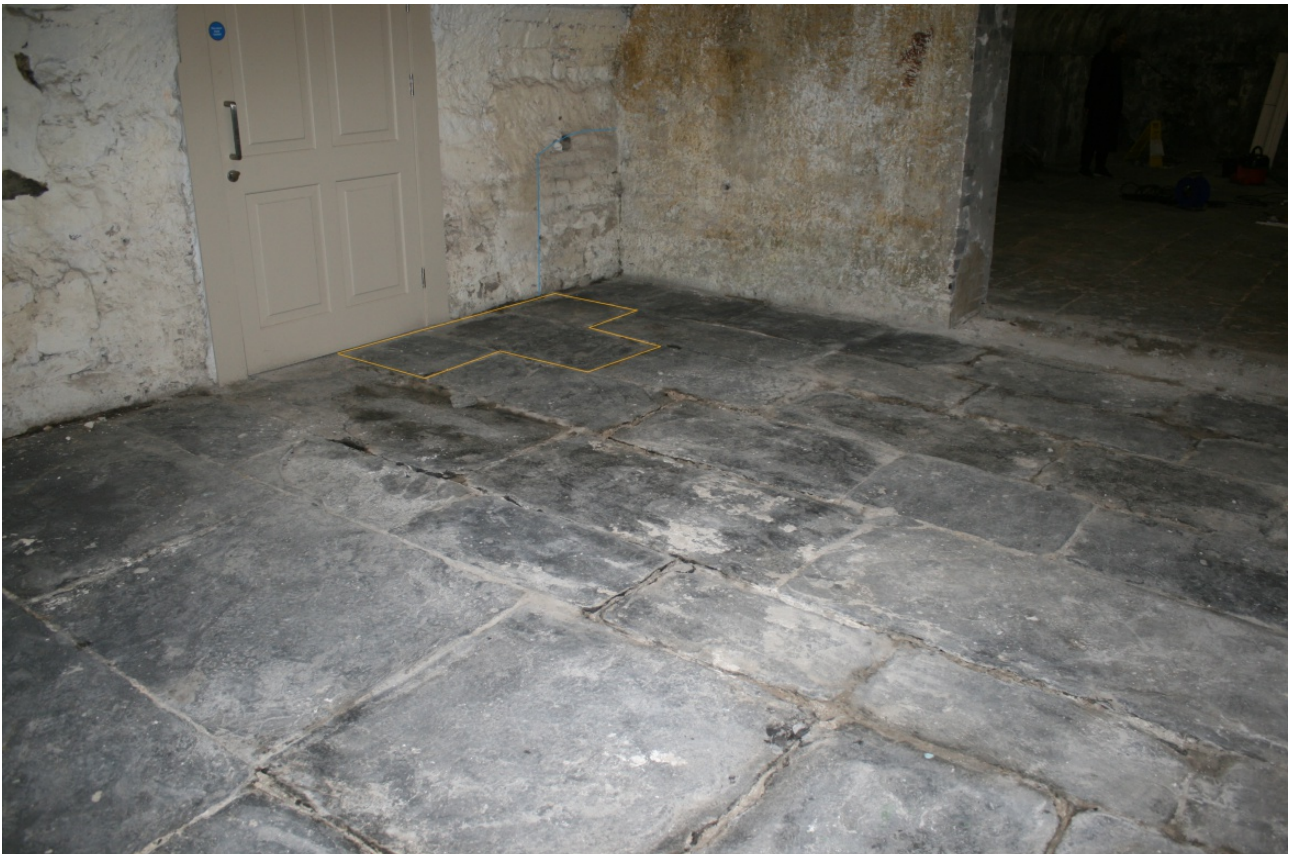
Pre-excavation view of test-pit 2, marked in orange, facing southwest. Archway of oven/fireplace is shown in blue

The excavation of Test-Pit 2 exposed the lower parts of a masonry arch in the south wall. The arch measures 4m wide and was thought to be a blocked 16<sup>th</sup> century fireplace. The excavation demonstrated that the arch did not continue down to the original floor of the basement and instead ended at 100.02m OD, exactly at the 18<sup>th</sup> century floor. This was a surprise, as the

18<sup>th</sup> century floor clearly post-dates the blocking up of the openings. The arched openings are therefore likely to represent a pair of raised ovens, raised fireplaces, or raised stores/shelves constructed behind a fireplace in order to keep things warm. It is possible they are simply structural and were never intended as openings, however the fill to the west is completely different from the rest of the 16<sup>th</sup> century wall masonry.

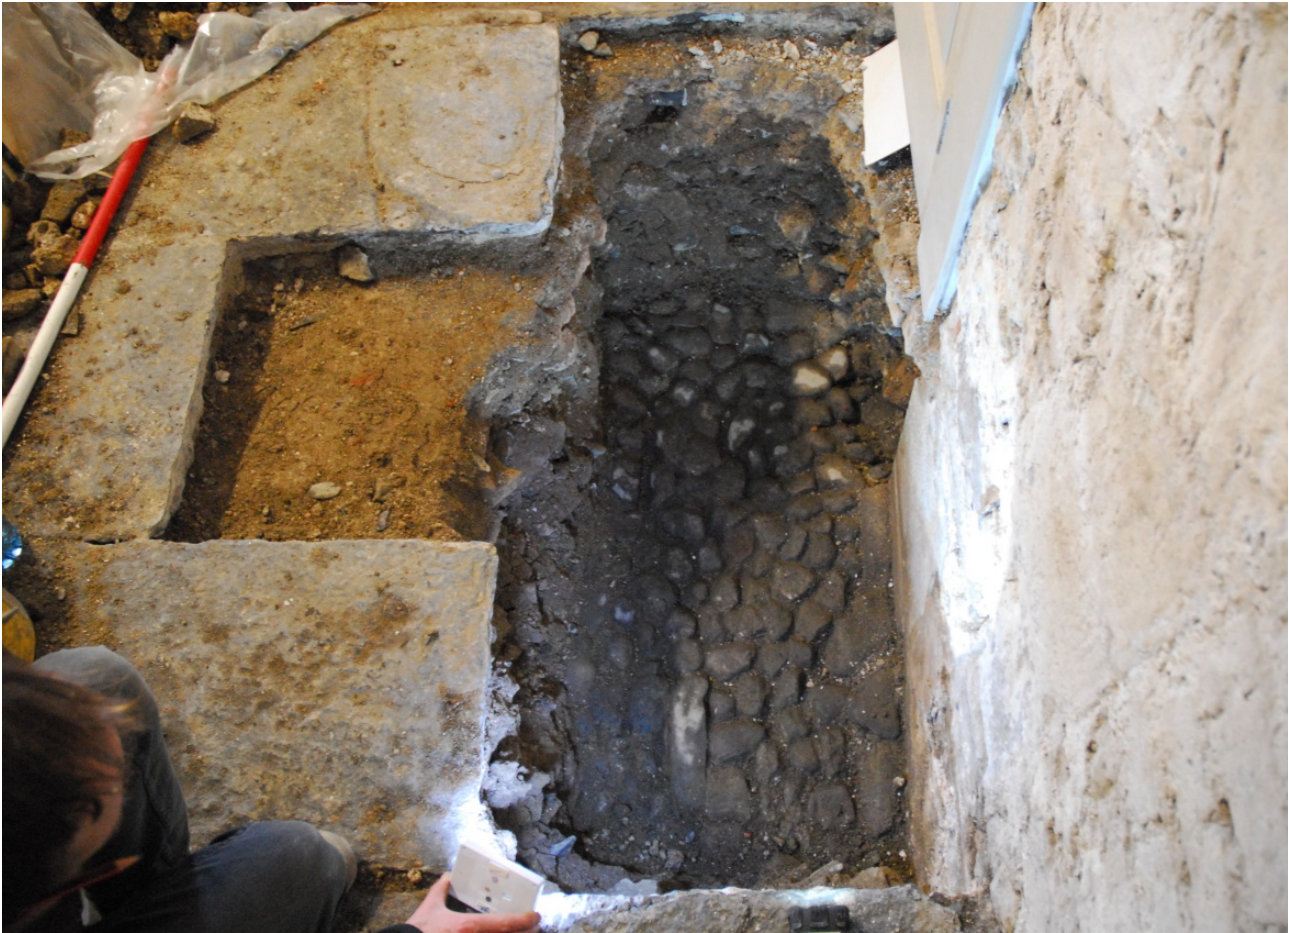
Test-pit 2 showing cobbled floor surface of late 16<sup>th</sup>, or possibly 17<sup>th</sup> century, date, facing east

Below this was a cobbled floor (C6) identical to the cobbled floor identified in the southeast flanker during the 2014 excavations (Giacometti

2014). This was uneven, and was situated between 610mm and 670mm (c. 99.38m OD) below the existing floor. The cobbles stopped at the line of the doorway to the north. Within the doorway the floor level stepped down to a paved and cobbled stone floor or threshold at

715mm below the existing floor (99.31m OD). This compares with a level of 99.40m OD for the floor over the drain in the eastern basement room, and a level of c. 99.30m OD for the cobbled floor in the southeast flanker. A thin layer of dark black organic silt (C5) with frequent charcoal and no artefacts, 20mm thick, lay directly over the cobbled floor. This layer was also identified in the southeast tower. It is unclear if this floor is the original 16<sup>th</sup> century floor, or a later resurfacing predating the raising of the basement floor in the first half of the 18<sup>th</sup> century.

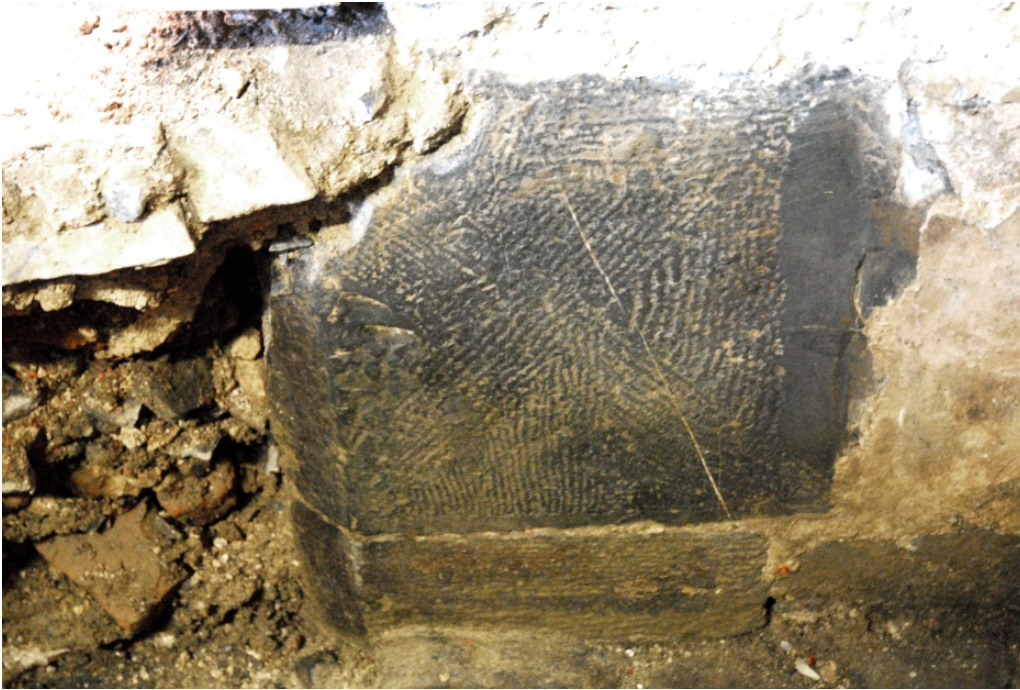
Top - 16<sup>th</sup> century doorjamb from Rathfarnham Castle test-pit 2, facing south

Bottom left - sketch of the doorjamb tooled finish

Bottom right - comparable tooled finish at Loughmoe Castle, Co. Tipperary, photograph courtesy of C oil n   Drisceoil

The excavation of Test-Pit 2 also exposed the 16<sup>th</sup> century door-jamb of the doorway running south from this room. Two stones survived below the 18<sup>th</sup> century floor from 99.95m OD. The upper larger stone (430mm by 450mm in size) displays a distinctive tool-mark finish of diagonal cross-hatched lines with a plain full-height chamfer. The chamfer and material matches the other identified 16<sup>th</sup> century doorways at Rathfarnham Castle, however the cross-hatched finish of the door-jamb stone face does not. The best comparison identified by the author is the finish in the doorjamb of the 15<sup>th</sup> century tower-house of Loughmoe

Castle, Co. Tipperary (pers. com. C oil n   Drisceoil), which was later converted into a fortified house not dissimilar to Rathfarnham Castle.

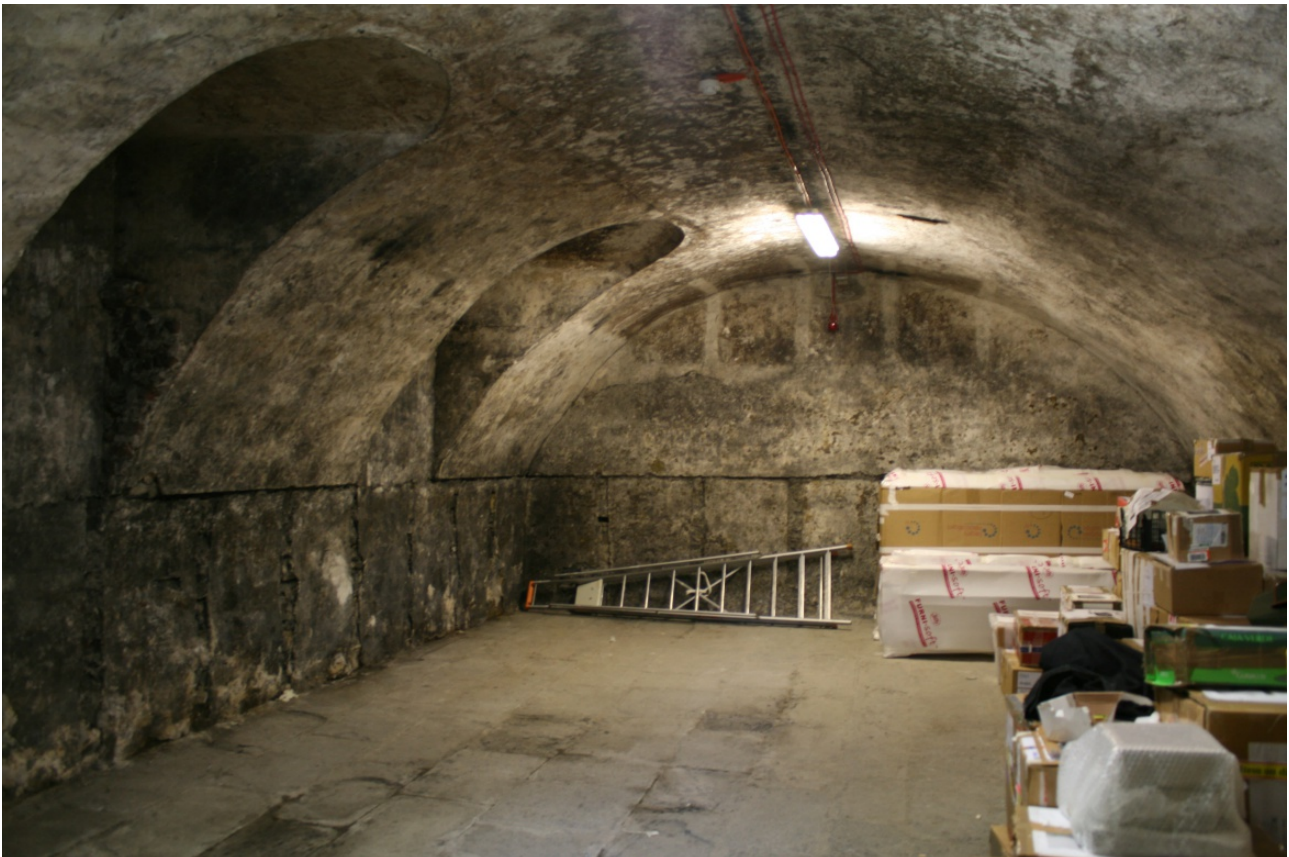
Room B8 facing west, showing partition wall prior to OPW works at rear of photograph

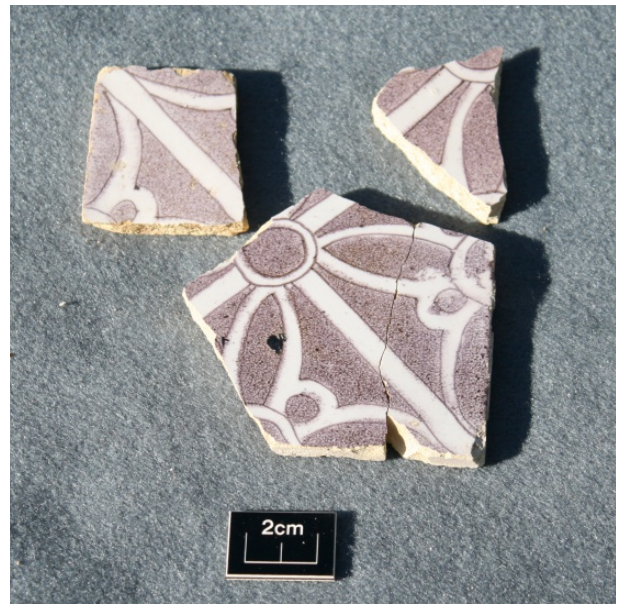
Mid-17<sup>th</sup> century Dutch style tin-glazed wall tile with vase

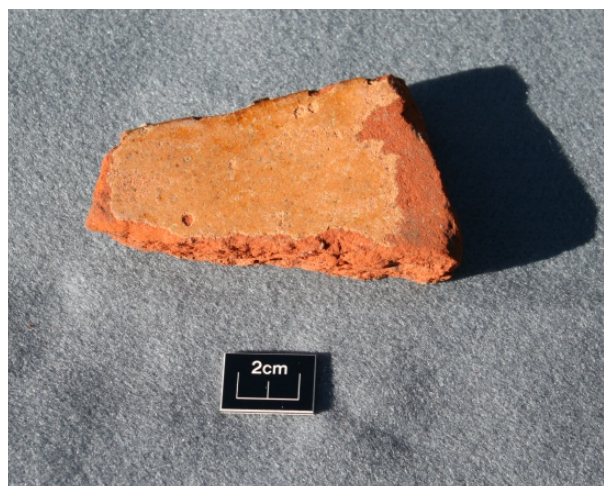
Above and below: slipped and glazed floor tiles

A fragment of a lead-glazed red earthenware floor tile was identified in Test-Pit 1: C1. It is made in a rough fabric, oxidised to brick-red, with inclusions. The tile face was covered by white slip, then glazed on top and on the sides with a clear-brown lead glaze producing an amber-brown colour, and is 25mm thick. A second tile fragment from Test-pit 1: C2 is similar but with a bright green glaze and is 23mm thick. Floor tiles such as these were in use from the 16<sup>th</sup> century and a similar example was identified in the latrine (6:3067). Similar tiles documented in Waterford City, where Wren (1997, 360) has suggested they may be 17<sup>th</sup> century Dutch imports.

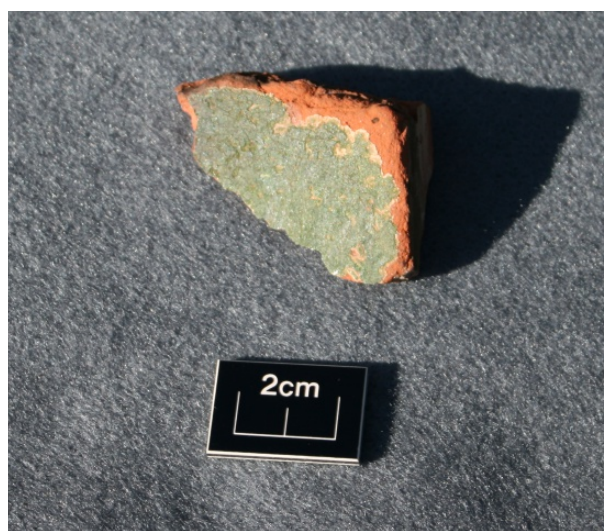
Below: glazed roof ridge tile

One fragment of green lead-glazed roof ridge tile with part-flattened top and curvilinear incisions along the upper side was identified in Test-Pit 1: C1. The fabric is a well-oxidised red earthenware with small inclusions. It is comparable to a roof tile assemblage dating the 17<sup>th</sup> to the early 18<sup>th</sup> century in New Street, Dublin (Giacometti 2008).

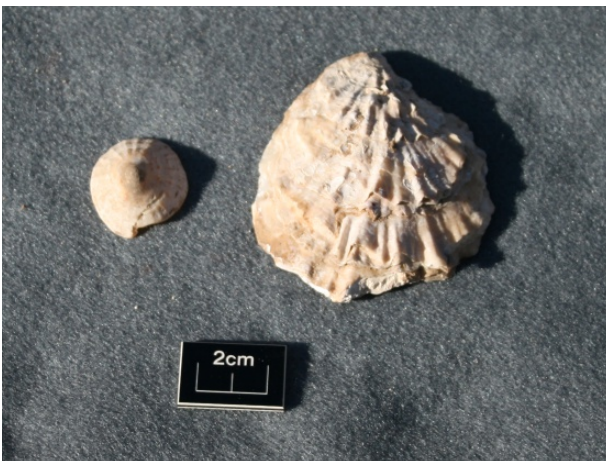
Top: plaster fragment with impressed lathe marks

Centre: animal bone from C1

A number of large fragments of plaster were identified from Test-Pit 1: C1. One of these was retained for analysis. It is a large fragment of lime plaster with concave front section, probably from a rounded ceiling, and with the imprint of overlapping wooden laths on the reverse

583g of animal bone from Test-Pit 1: C1 and 49g of animal bone from Test-Pit 2: C4 was recovered. The bone is in good condition and represents meat and poultry food waste. Oyster and limpet shell were also identified.
