Site:	Pigeon House Fort	Nat. Grid Ref:	320380
	233650		
Road:	Pigeon House Road	O. S. 6" Sheet No:	DU 019
Townland:	Ringsend	Arch-Tech Project Ref:	09-005
Parish:	Donnybrook	Excavation Licence:	09E 259
County:	Dublin 4	RMP Ref.:	DU019-027

- 1.1. This report is an archaeological and architectural survey of the Pigeon House Fort, an 18th century artillery fort on the South Wall of the Poolbeg Peninsula in Dublin Bay (refer Fig. 1).

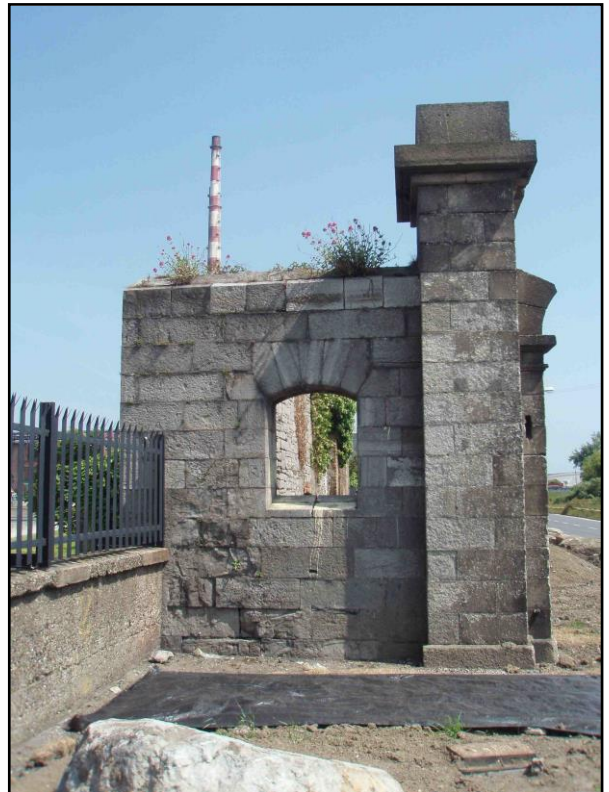
Square coursed granite gate pillar to south measuring 1.6m E-W by 0.9m N-S and 5.8m in height, with coursed granite gate pier abutting to south (0.6m E-W by 0.4m N-S) topped with broken spring of gate arch, also granite. Gate pillar and pier have simple architectural details at top and base.

Coursed limestone wall abuts north of gate pillar, and measures 3.3m N-S, 0.6m in thickness and 4m in height. Pierced off-centre with a single arched

gun-embrasure. The base of the ope is 1.5m above ground level. Minor graffiti and paint splashing noted on wall surface.

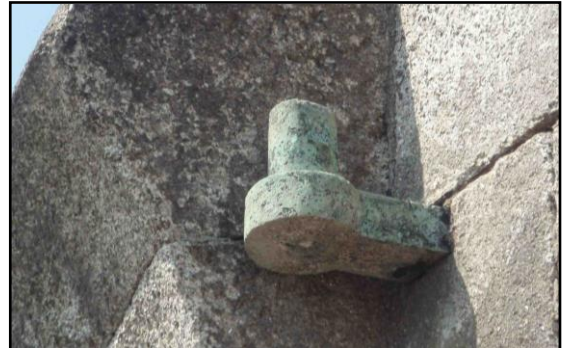
Four fittings are visible in the south-facing façade of the gate pier. One comprises a centrally located rectangular groove in the basal skirting block (0.22m long, 0.1m wide and 3.5m deep). A second is directly above this, at 1.88m

from the ground, and is a rectangular slot (0.16m high, 0.09 m wide) for a missing metal fitting, filled with lead. A third comprises a tapered 0.08m wide angled groove up to 0.05m deep beginning at 1.5m above ground level on the northern side of the gate pier and meeting with the other end of the rectangular slot in the west-facing façade of the gate pier described above. The fourth is a bronze hinge at the top of the gate pier (refer Section 5.7.5 below – Object 4).

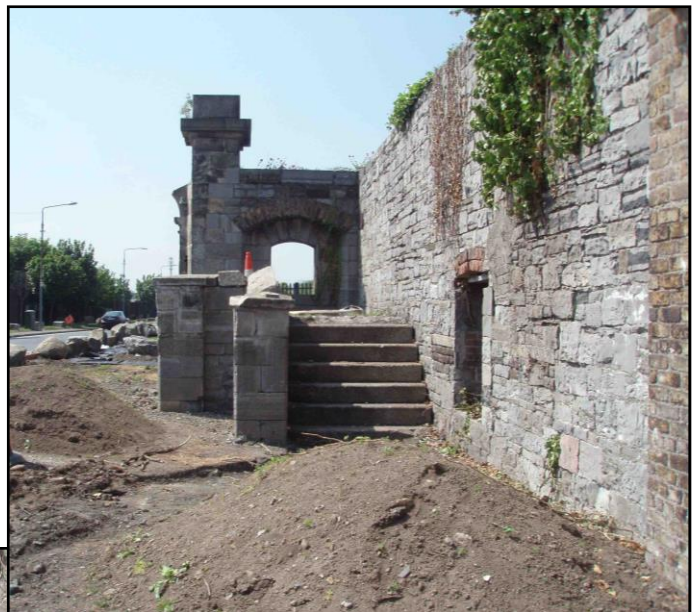
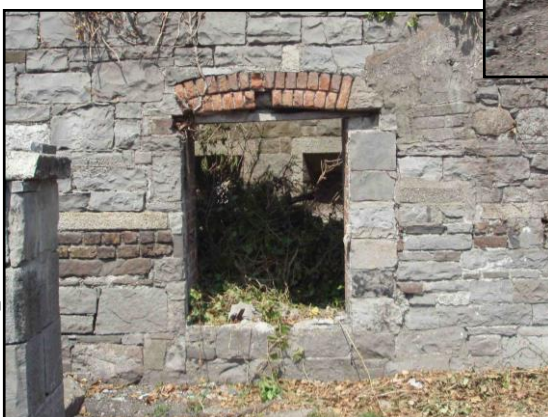
The western portion of the main southern wall is constructed from limestone to a height of 4m and runs for 14.5m eastwards. At this point, the wall is constructed of brick, and continues for a further 7.5m to a total length of 22m, at 4.8m in height, with a series of blocked red-brick features visible.

pierced by the low doorway into the guard hut at *c.* 10m from the western end of the wall. The doorway shows signs of extensive re-working, and was either inserted or re-sized at some point after the wall was constructed. The doorway has a timber lintel. On either side of the low doorway granite and brick features measuring 1.1m across and 0.3m high are built into the wall 1m off the ground.

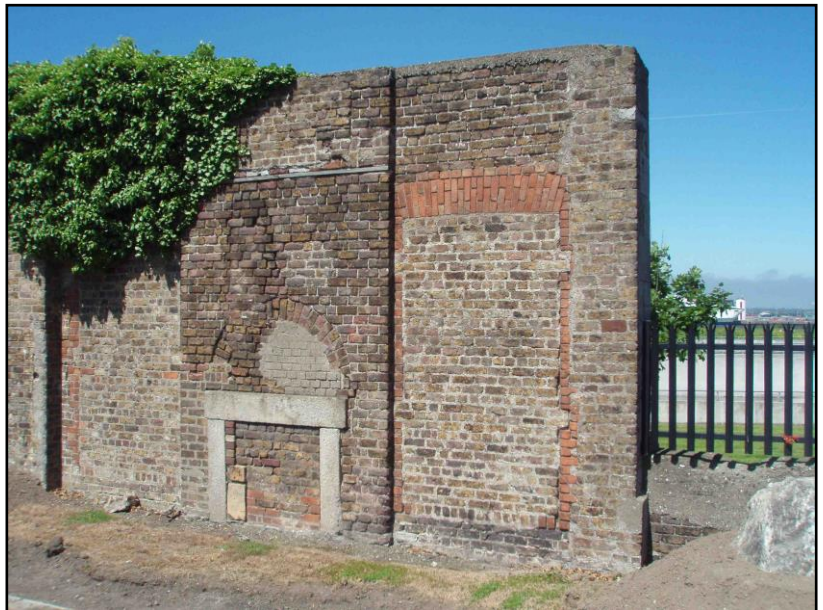
The western (brick) portion of the wall is likely to be older than the rest of the gatehouse, and may be the gable wall of the original Pigeon House or blockhouse, or an associated building, constructed in *c.* 1760. The south-facing façade of the wall displays a granite-lintelled fireplace with possible chimney

elements above, with two very large windows situated to either side overlooking the harbour. Timber lintels and brick surrounds are still visible, although these features were all filled in, probably during the construction of the military fort in 1778 or soon after.

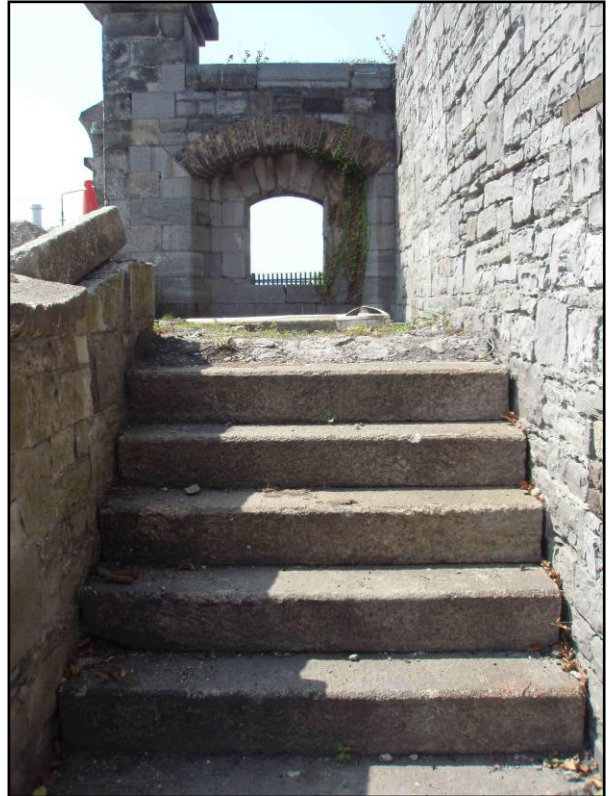
The platform retaining and parapet wall measures 1.7m in high, constructed of limestone, and capped with triangular-sectioned granite for a further *c.* 0.1m in height. The wall takes a dog-leg to the east where it retains and forms the balustrade of the platform steps. The top of the wall slopes down with the steps to a height of 1.45m plus a further 0.1m granite capping.

The granite capping of the parapet/balustrade wall are partially missing: six capstones are *in-situ*, one capstone has been concreted (during recent restoration works) in the wrong place, and two capstones are missing. The capstones are of different lengths, averaging 0.86m by 0.58m in size and 0.10-0.15m in thickness.

A low opening in the south-facing façade of the wall measures 0.79m high (from the present ground level) and 0.77m wide, and is blocked with limestone similar in style to the rest of the wall. This implies that there is a space beneath the platform, which may be of interest in terms of future investigation at the site. Two iron fittings are visible here: one hinge fitting to the upper left side of the opening 0.57m off the ground (refer Section 5.7.2 below – Object 1), and one bolt-loop fitting located centrally on the right side of the opening 0.32m off the ground (refer Section 5.7.3 below – Object 2).

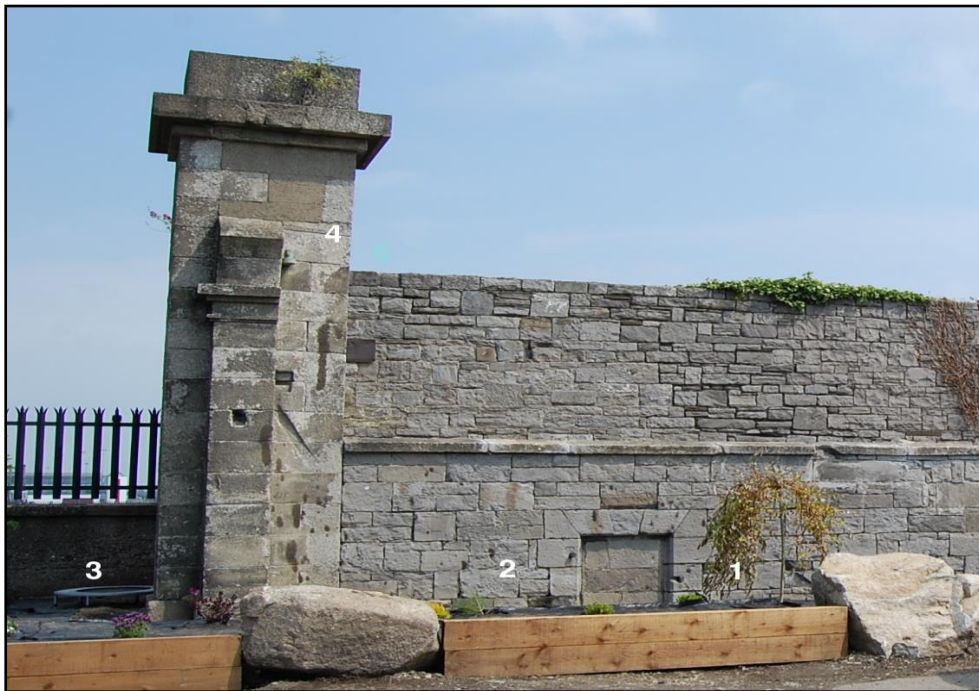
Object 1 consists of an iron fitting inserted almost fully in to the stone, with only the head visible. It is located on the left (east) side of an opening, which has been blocked at some stage.

The object presents a relatively good state of conservation, the internal structure is still in perfect condition and has stabilised with the environmental conditions. Despite this, there are a number of alterations to consider.

- The original surface suffers superficial corrosion presenting the characteristic dark-orange red colour of iron corrosion.

- The main alteration to consider is the appearance of a crack in the stone that continues along the lower left corner. This crack is due to the corrosion of the metal within the stone, or to a poor re-fitting of the object.
